Whitefish Bay D.P.W. Service Yard Assessment

5111 N. Lydell Avenue
Glendale, Wisconsin

Report Date: November 20, 2023

Condensed Property Condition Report

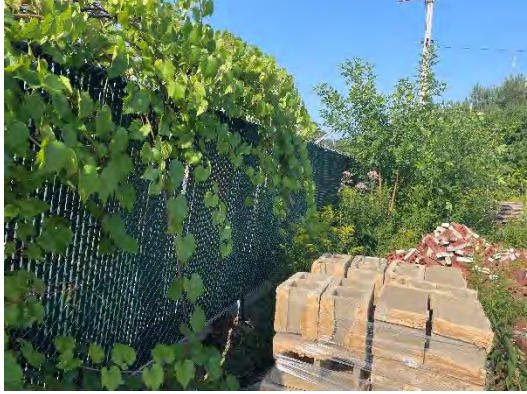
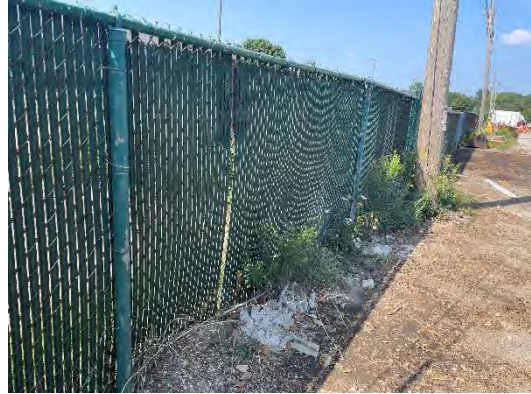
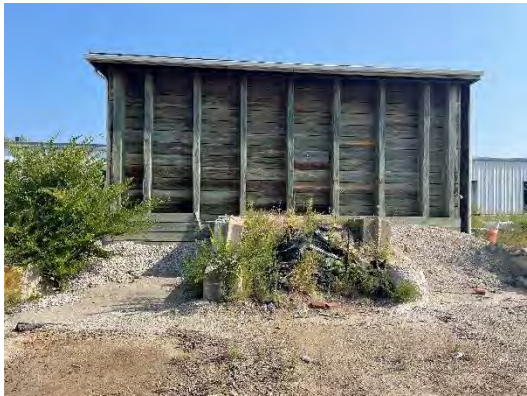
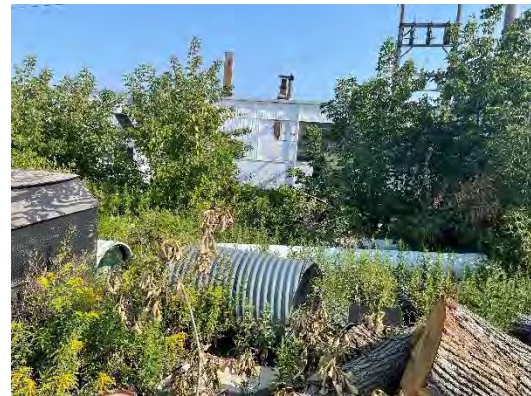
Overgrown Vegetation Throughout Storage Yard

Photo 1 – Overgrown Vegetation

Photo 2 – Overgrown Vegetation

Photo 3 – Overgrown Vegetation

Photo 4 – Overgrown Vegetation

Repair: The storage yard and the fence around the site's perimeter were observed to be overgrown. Remove weeds and other plants growing into the site's fence and storage yard.

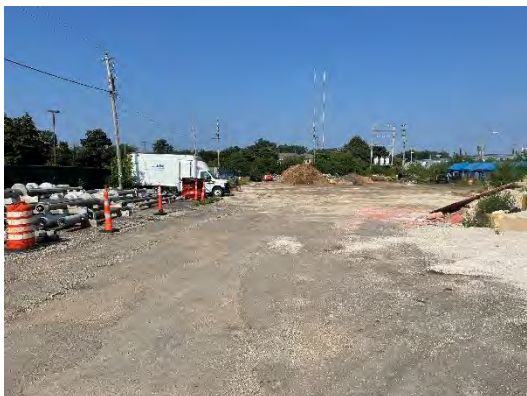
Damaged Asphalt

Photo 5 – Asphalt Raveling

Repair: Asphalt was observed to be in various states of disrepair throughout the site. Seal cracks in moderately damaged areas. Remove sections of severely cracked asphalt and patch.

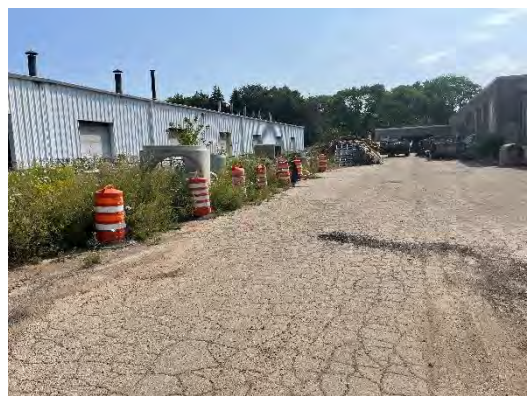
Photo 6 – Asphalt Cracking

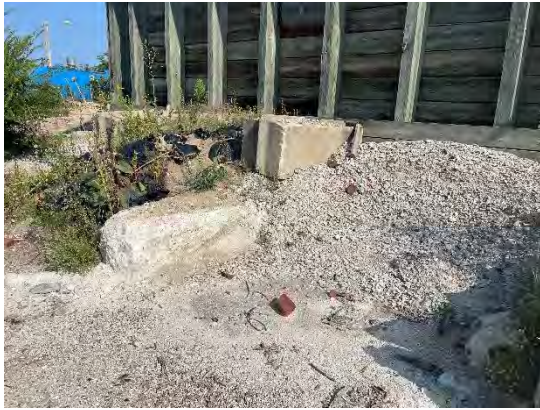
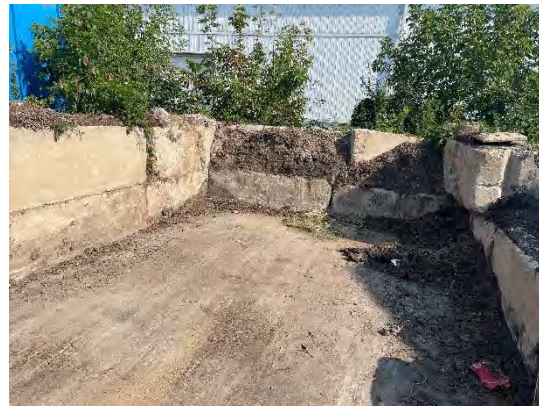
Damaged Concrete Bin Block Storage

Photo 7 – Damaged Concrete Bin Blocks

Photo 8 – Damaged Concrete Bin Blocks

Replace: Concrete bin blocks were observed to be damaged and deteriorating in limited areas of the site's outdoor storage yard. Replace damaged blocks and reposition any disarrayed blocks.

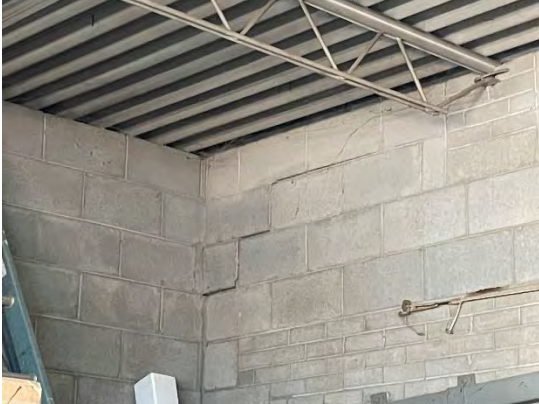
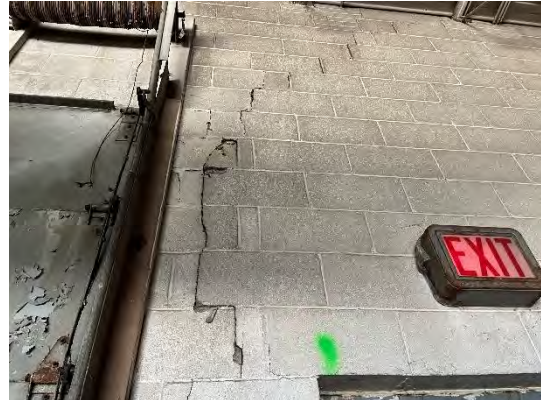
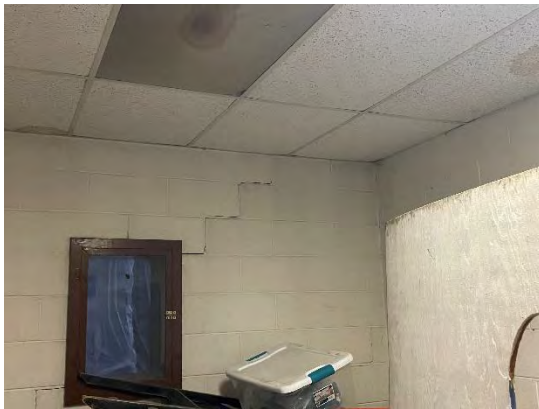
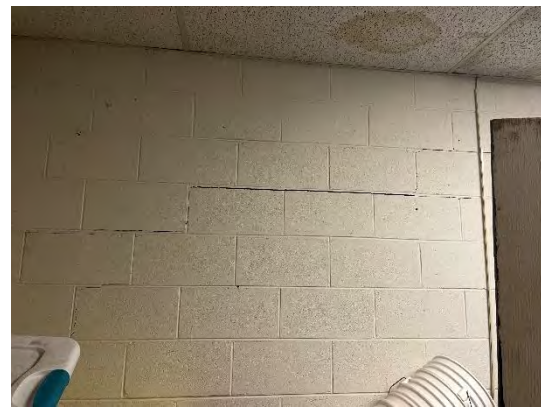
Damaged Concrete Masonry Unit (CMU) Walls

Photo 1 – Cracking Interior CMU Wall

Photo 2 – Cracking Interior CMU Wall

Photo 3 – Cracking Interior CMU Wall

Photo 4 – Cracking Interior CMU Wall

Repair: CMU walls throughout the salt storage building's interior walls and exterior envelope were observed to be in various states of disrepair around all sides of the building. Tuckpoint/seal cracks and replace blocks in areas of more severe disrepair. Investigate the cause of the damage. "This step cracking throughout the CMU building's envelope appears to be an indicator of structural degradation. We recommend a structural engineer is consulted to determine the cause."

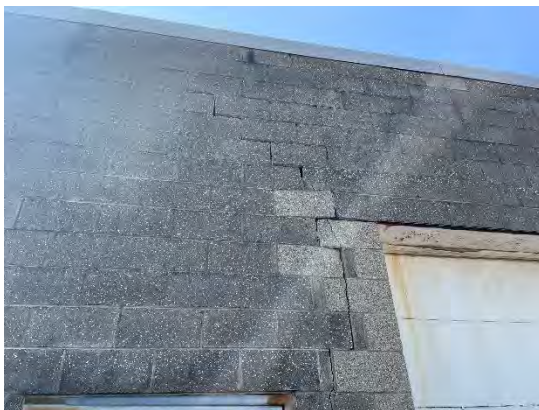
Photo 5 – Cracking Exterior CMU Wall

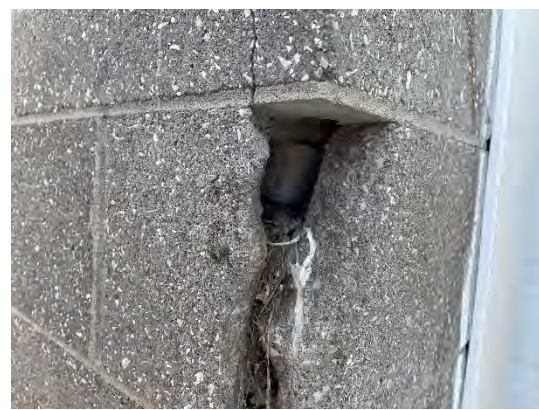
Photo 6 – Deteriorating Exterior CMU Wall

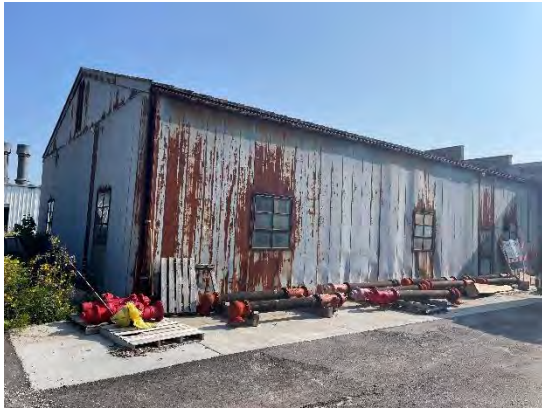
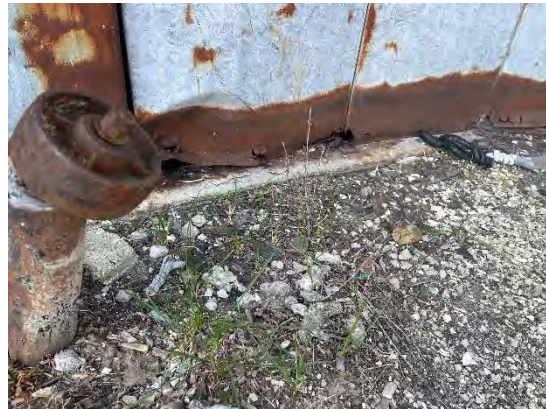
Damaged & Corroding Metal Siding

Photo 7 – Corroding Metal Siding

Photo 8 – Corroding Metal Siding

Repair: Metal siding was observed to be damaged and corroding throughout the exterior envelope of the metal building addition. Prep and paint corrosion. Replace damaged siding.

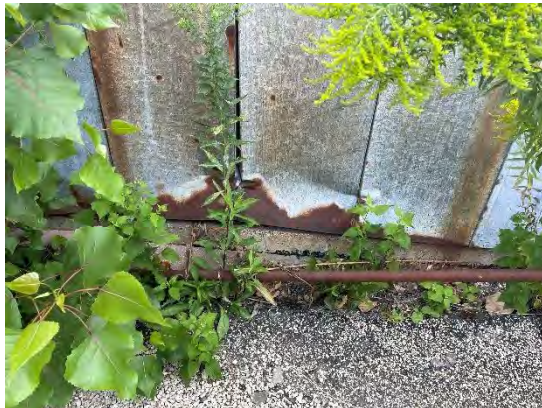
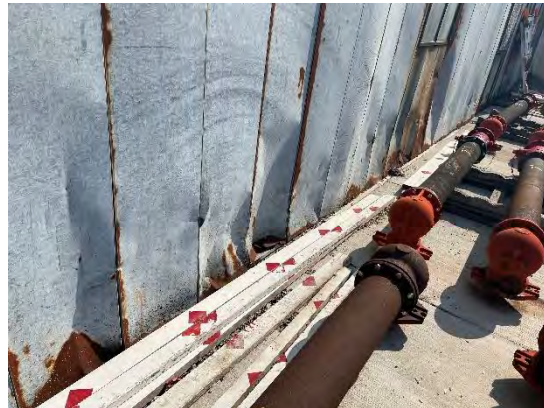
Photo 9 – Damaged Metal Siding

Photo 10 – Damaged Metal Siding

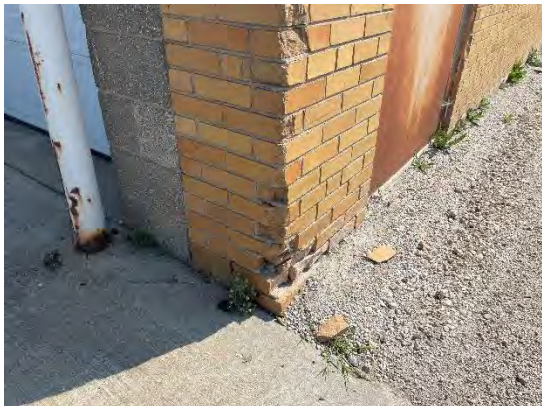
Damaged/Deteriorating Bricks

Photo 11 – Damaged/Deteriorating Bricks

Repair: Exterior bricks were observed to be deteriorating and damaged in limited areas near the building's southeast corner. Replace damaged/deteriorating bricks. Tuckpoint brick exterior.

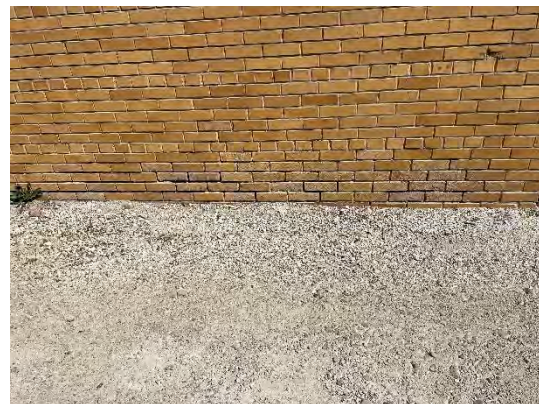
Photo 12 – Deteriorating Mortar

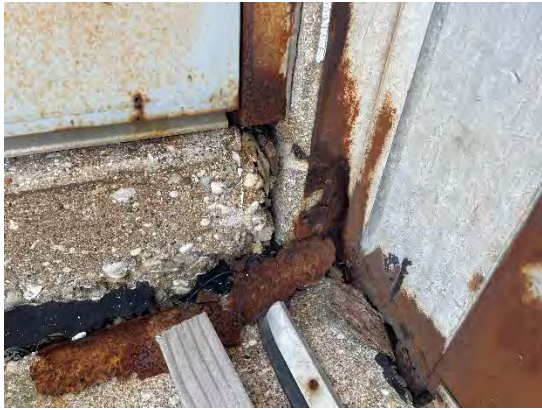
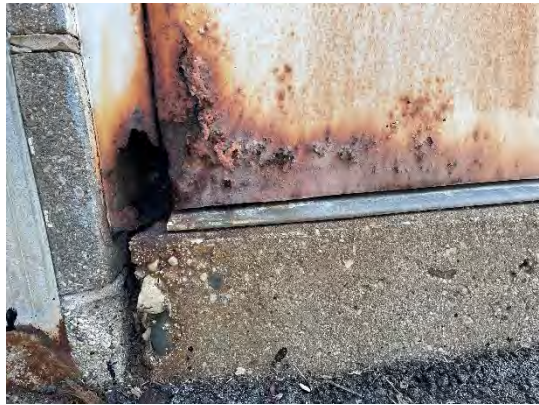
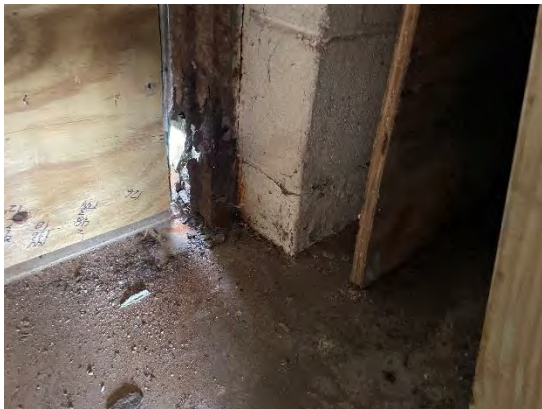
Corroded Metal Door Frames

Photo 13 – Corroding Metal Door Frame

Photo 14 – Corroding Metal Door Frame

Photo 15 – Corroding Metal Door Frame

Replace: Corrosion was observed on exterior metal doors and frames throughout the metal and salt storage buildings. Replace corroded doors and frames.

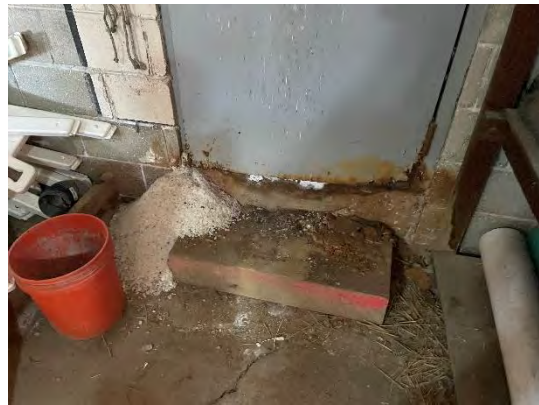
Photo 16 – Corroding Metal Door

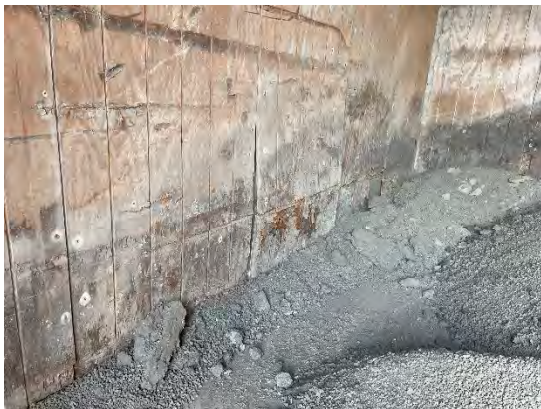
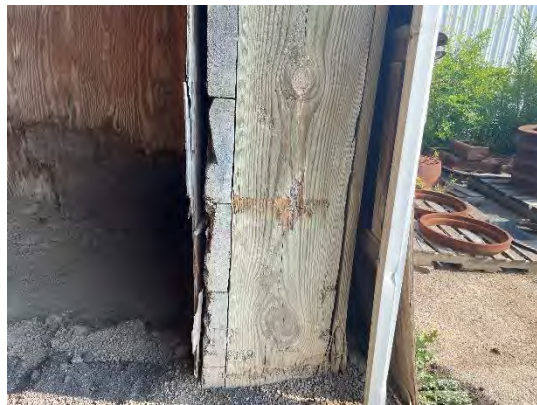
Damaged Wood Siding

Photo 17 – Damaged Wood Siding

Photo 18 – Damaged Wood Siding

Repair: Wood siding was observed to be damaged in limited areas of the topsoil storage building. Replace damaged wood siding.

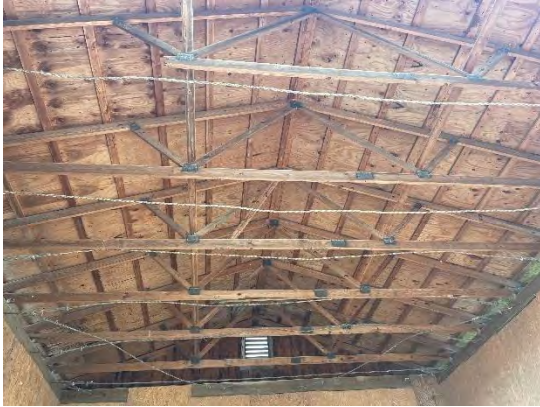
Broken Wood Truss

Photo 19 – Broken Truss

Repair: One of the wood trusses on the topsoil storage barn’s ceiling was observed to be broken. Replace broken truss.

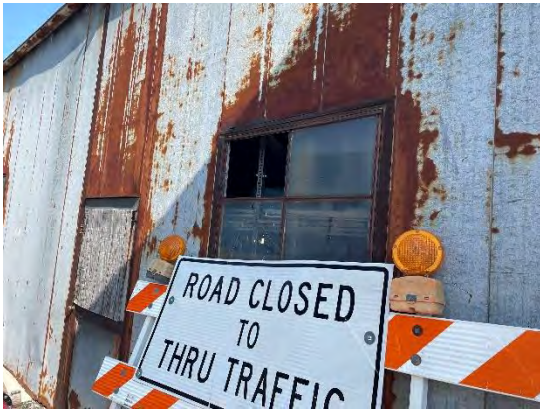
Broken Window

Photo 20 – Broken Window

Replace: An isolated window was observed to be broken on the south side of the metal addition building. Replace the broken window.

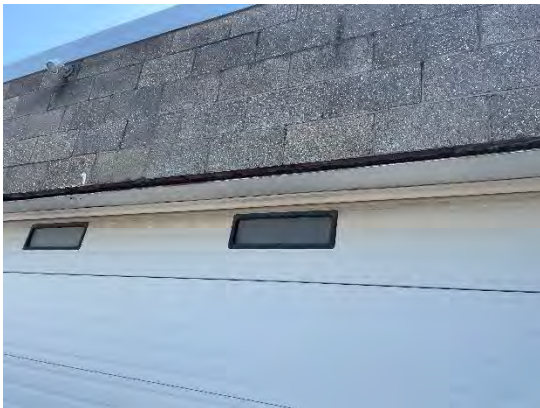
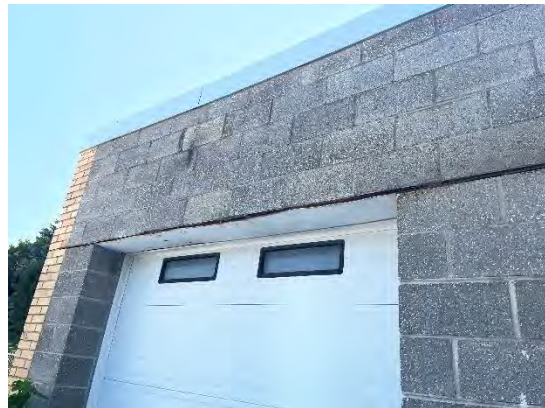
Damaged Lintel

Photo 21 – Damaged Lintel

Photo 22 – Damaged Lintel

Replace: Lintels above overhead doors were observed to be damaged on the North & South sides of the salt storage and tenant buildings. Replace damaged lintels.

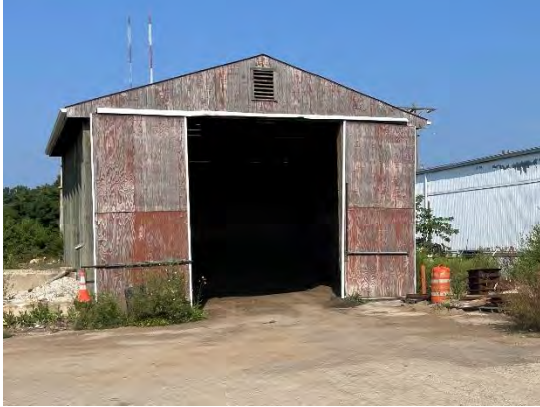
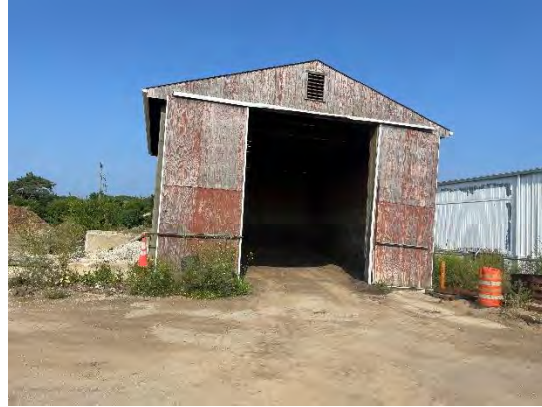
Deteriorating/Faded Paint

Photo 23 – Faded Paint

Photo 24 – Faded Paint

Replace: Paint was observed to be deteriorating/fading throughout the east side of the topsoil storage building. Prep and apply new paint.

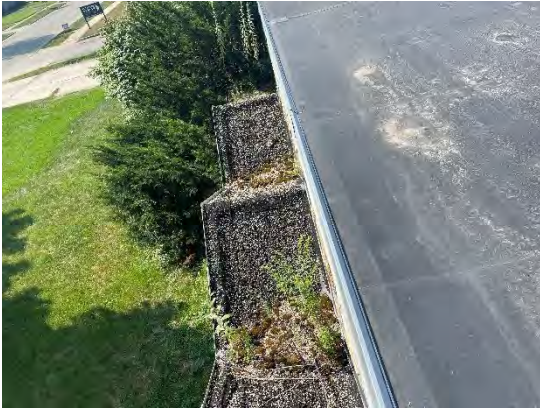
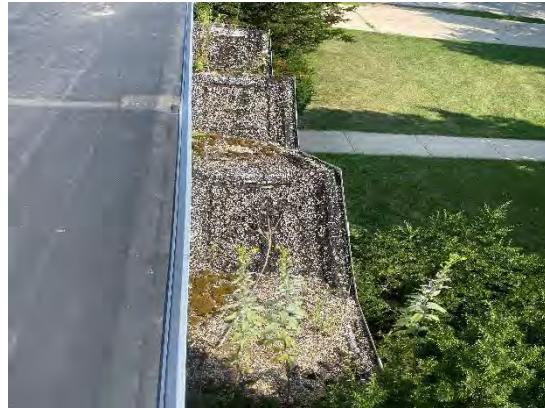
Vegetation Growth

Photo 1 – Vegetation Growth

Photo 2 – Vegetation Growth

Repair: Vegetation was observed to be growing in isolated areas of entry-door overhang. Remove vegetation from the top of the overhang.

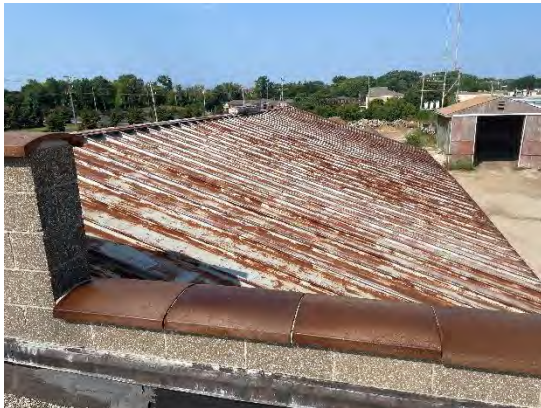
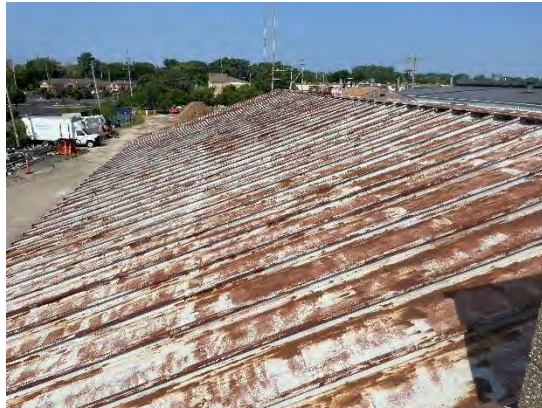
Aging Ballasted and Metal Roofs

Photo 3 – Sloped Corrugated Metal Roof

Photo 4 – Sloped Corrugated Metal Roof

Replace: The ballasted portion of the flat EPDM roof was observed to be nearing the end of its useful life, and leaks were reported in the building. Replace aging ballasted EPDM roof. The corrugated metal roof was observed to be nearing the end of its useful life. Apply new roll-on-seal and expect higher than normal maintenance costs until replaced.

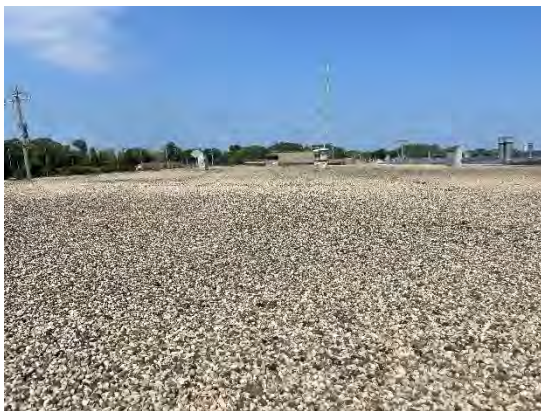
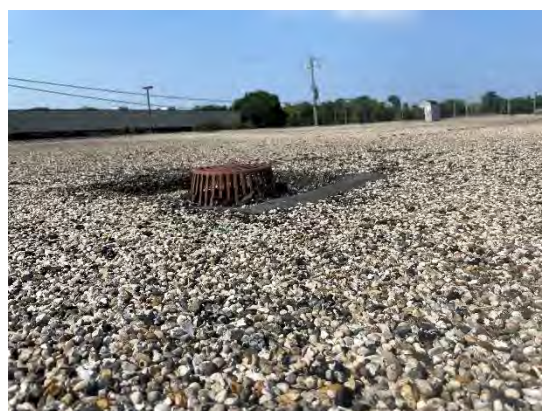
Photo 5 – Aging Ballasted Roof Membrane

Photo 6 – Aging Ballasted Roof Membrane

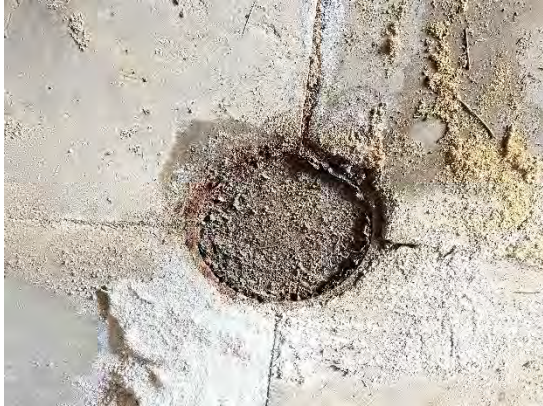
Blocked Floor Drain

Photo 1 – Floor Drain Blockage

Repair: An isolated floor drain was observed to be blocked in the salt storage building. Clean out the blockage from the floor drain.

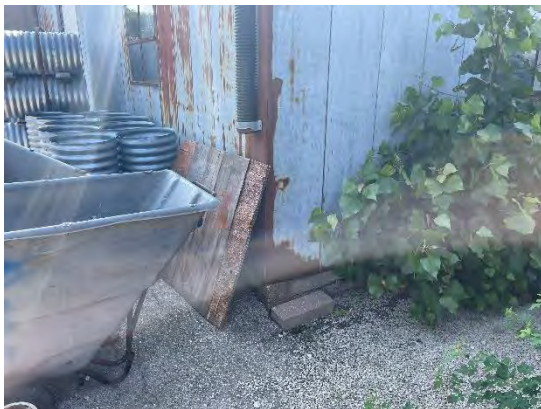
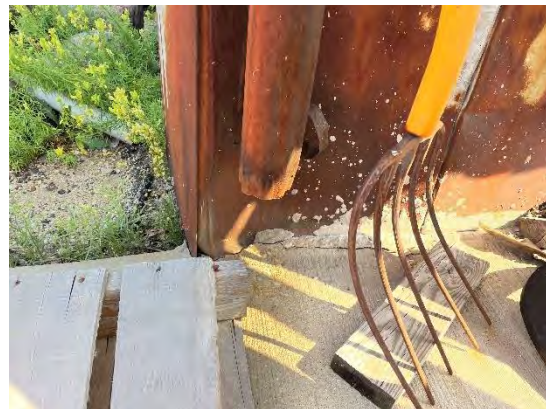
Metal Roof Downspouts

Photo 2 – Metal Downspouts

Photo 3 – Metal Downspouts

Repair: The downspouts on the metal building were observed to end too close to the building, which was observed to be contributing to the corroding metal siding. Extend downspouts to carry water a minimum of four (4) feet away from the building façade.

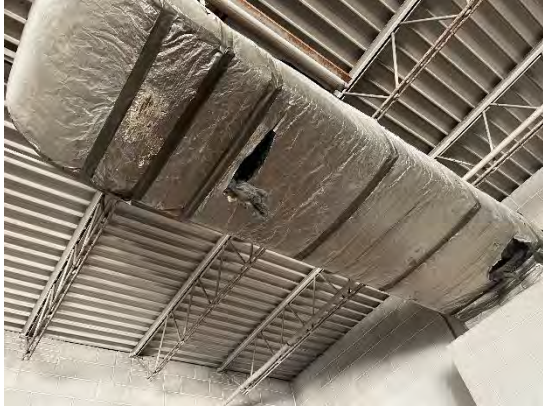
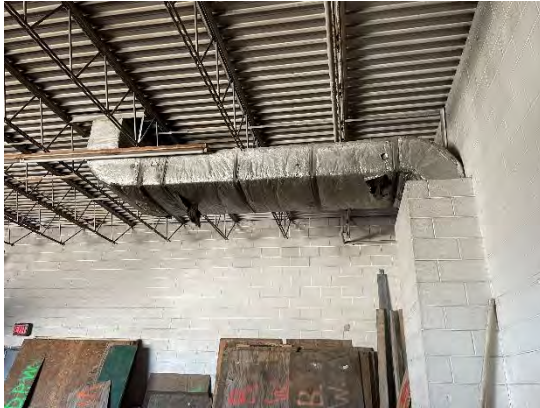
Damaged Insulation Around Ductwork

Photo 1 – Damaged Ductwork Insulation

Photo 2 – Damaged Ductwork Insulation

Repair: Insulation around ductwork in the salt storage building was observed to be damaged in isolated areas. Repair damaged insulation.

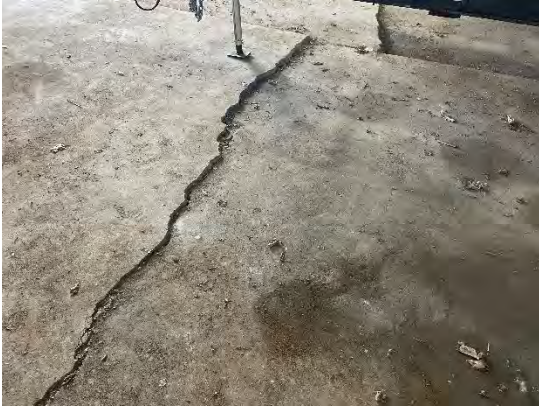
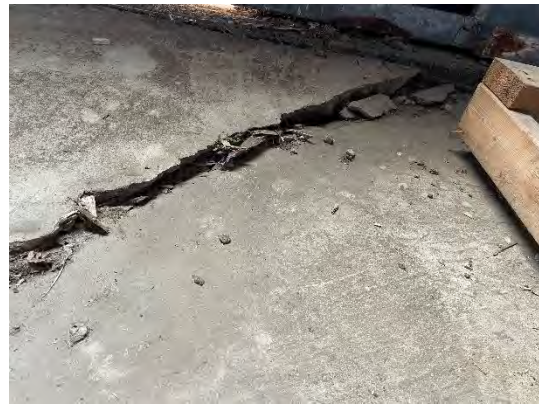
Concrete Slab Settling

Photo 1 – Cracking Interior Concrete Slab

Photo 2 – Cracking Interior Concrete Slab

Repair: The concrete slab on grade was observed to be settling and therefore cracking in isolated areas of the metal building addition's floor. Cut and patch the cracking concrete slab, and relevel the surface using PolyLevel expanding foam or similar product.

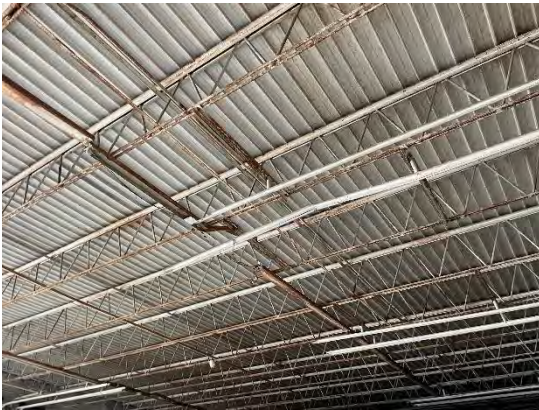
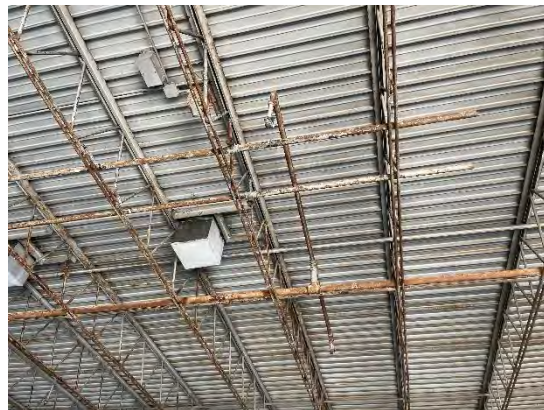
Corroding Metal

Photo 3 – Corroding Metal

Photo 4 – Corroding Metal

Repair: Metal was observed to be corroding throughout the interior of the salt storage building on various pipes, structural steel, and overhead doors. Prep and paint corroding metal.

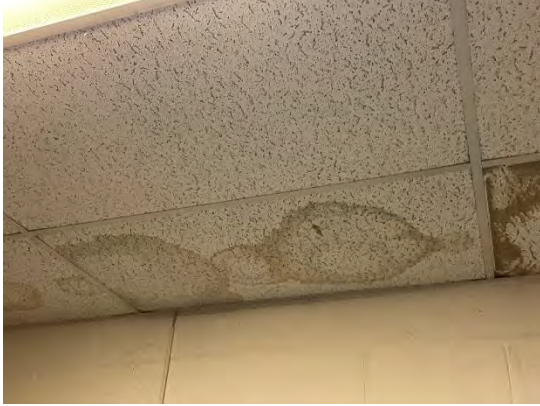
Damaged Ceiling Tiles

Photo 5 – Stained Ceiling Tiles

Repair: Ceiling tiles were observed to be damaged from water staining in limited areas of the tenant space building. There did not appear to be any active leaks in these areas. Replace stained ceiling tiles and repair any damage that may be present beyond the ceiling tiles.
