Village of Whitefish Bay Public Works Department

Re: Visual Roof Survey Report

VISUAL ROOF SURVEY

SIX (6) FACILITIES PER THE ATTACHED FACILITY LIST

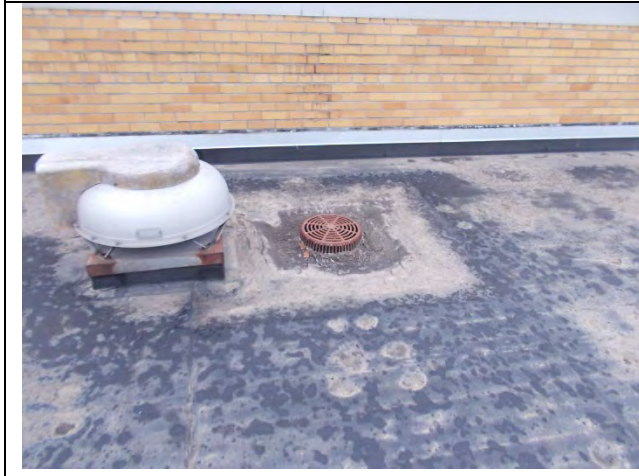
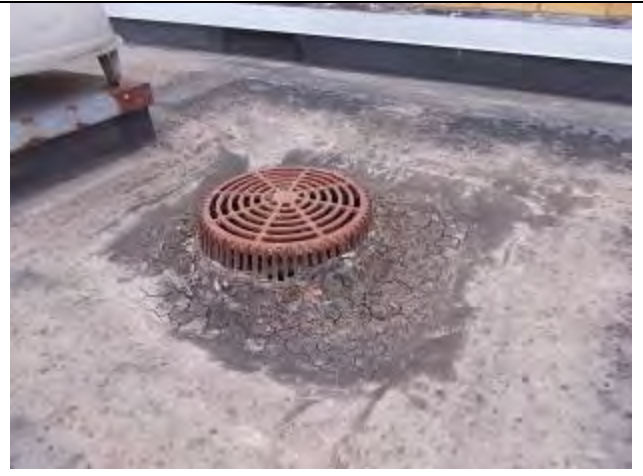
Roof Drainage

The roof system appears to be drained moderately well via a single roof drain. We noted evidence of ponding water around the drain, which is likely worsened by debris clogging the drain strainer.

The EPDM single-ply roof system on Roof Area 1 remains in serviceable condition. It appears to be adequately drained and does not require any repairs at this time (besides debris removal from around the roof drain). Provided the roof system receives continued proactive annual maintenance, we believe it should be capable of performing properly for an additional 6-9 years, or more.

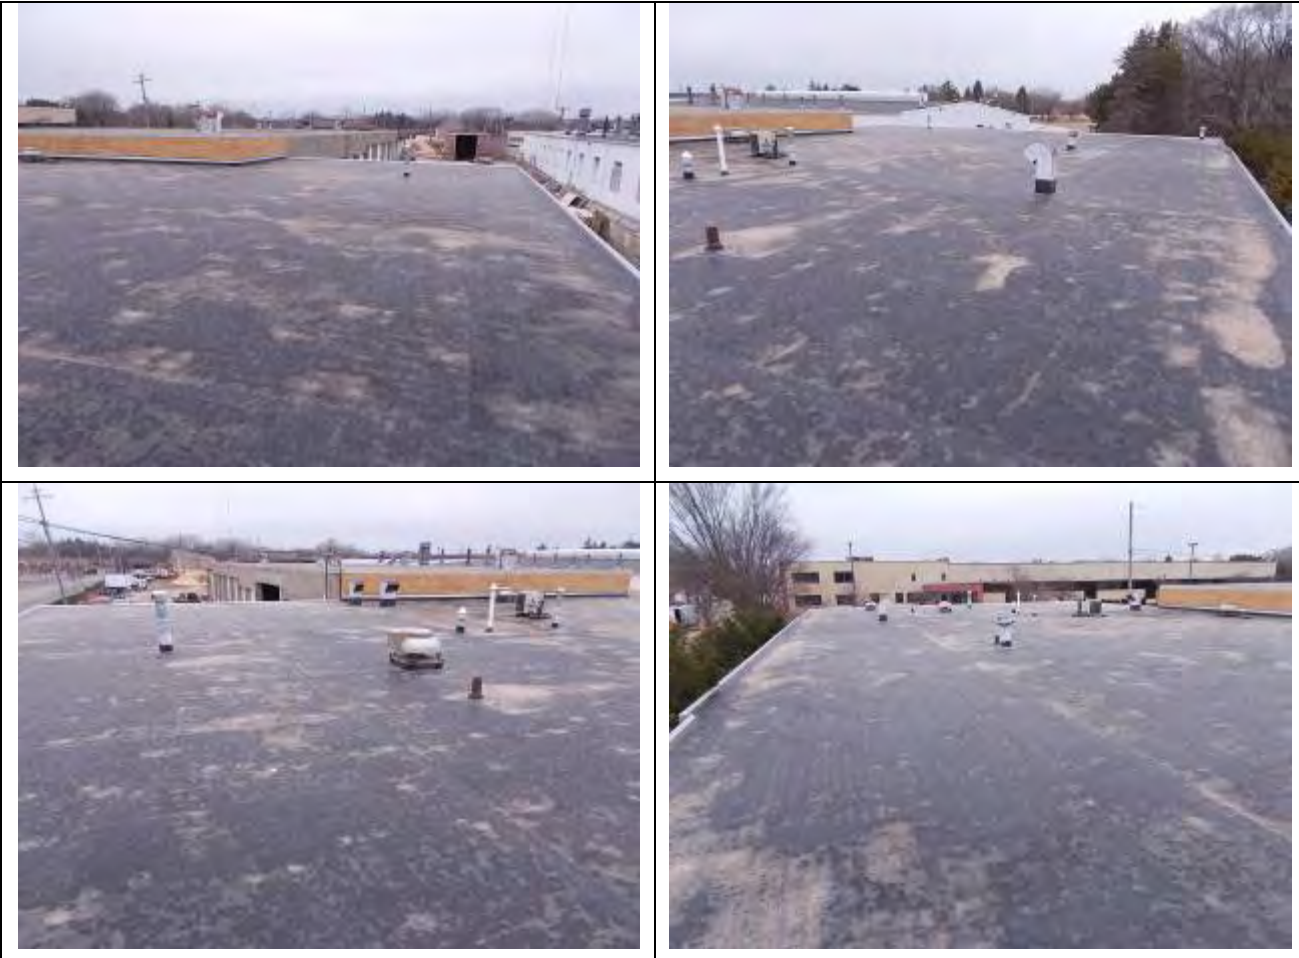
Roof Membrane

The EPDM single-ply membrane remains in serviceable condition. No notable deficiencies were found within the field of the roof membrane.

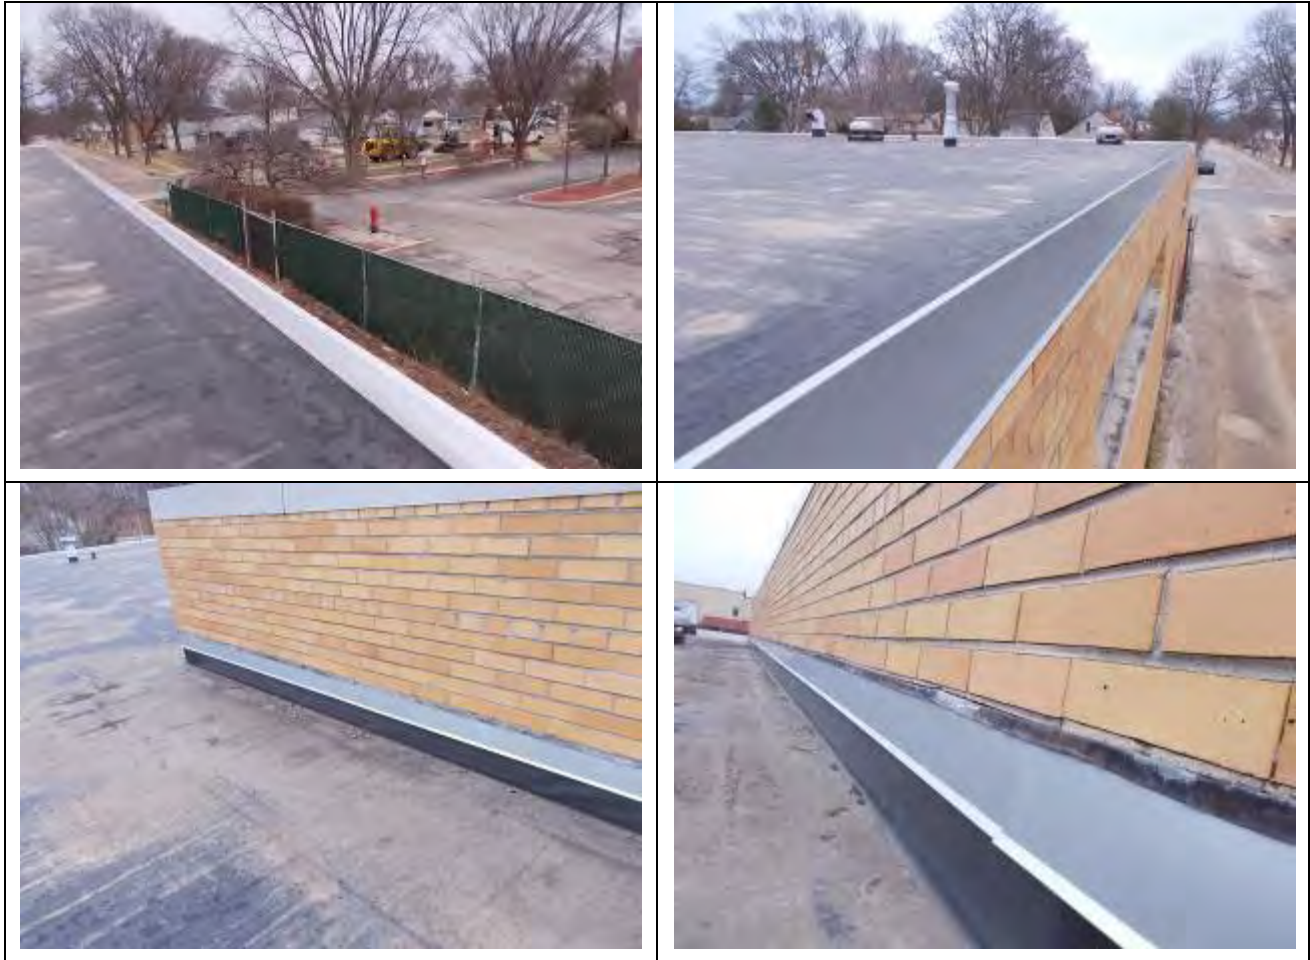
Roof Perimeters

The roof system terminates at its perimeters via cap flashing and counter flashing, which remain in serviceable condition.

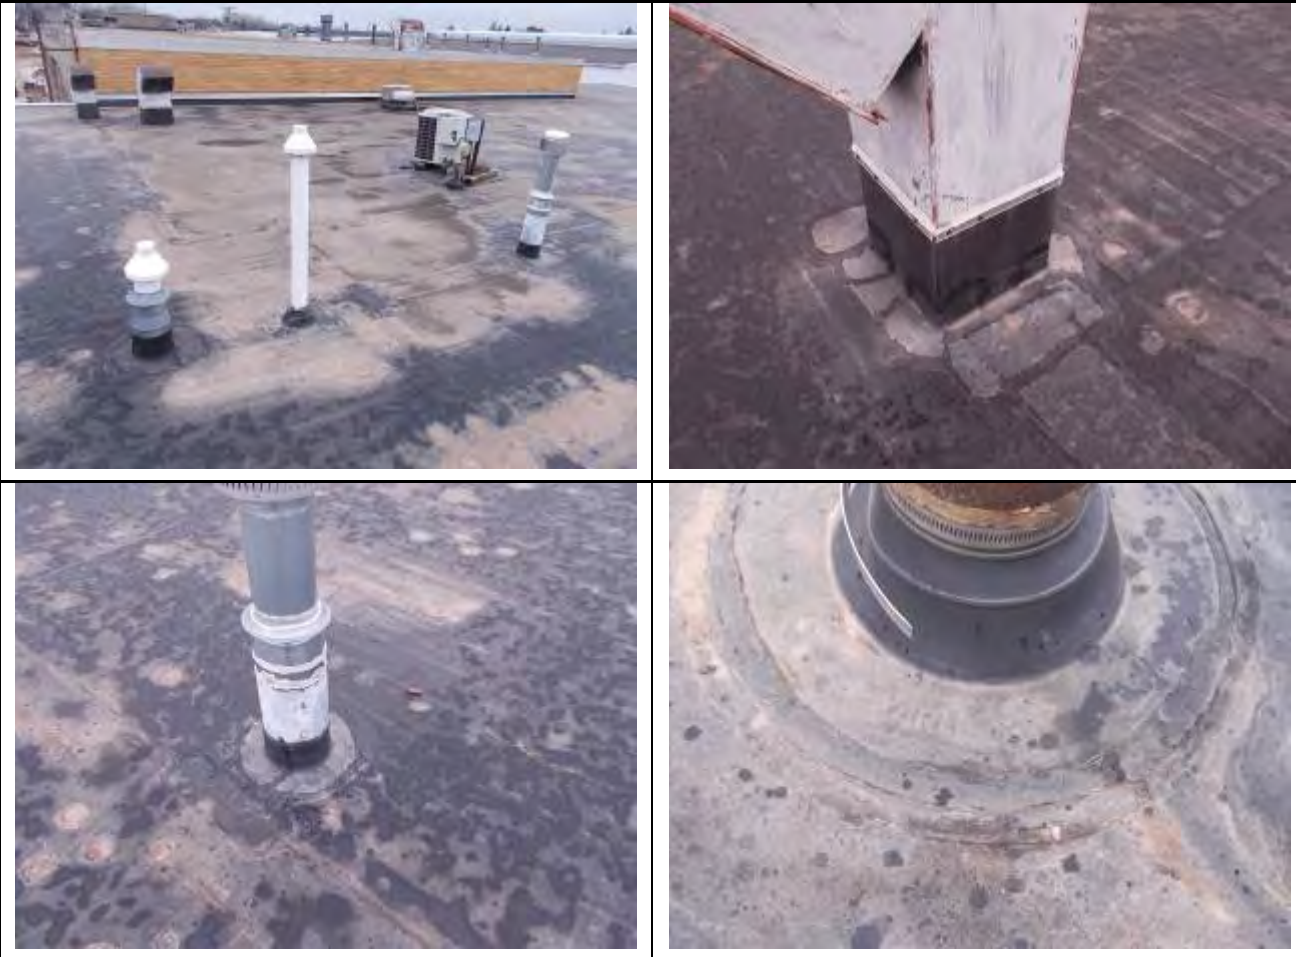
Roof Projections

The roof system is penetrated by pitch pockets, small pipes, soil stacks, and AC units on rails. The flashings associated with each of these projections remain in serviceable condition, with no notable deficiencies.

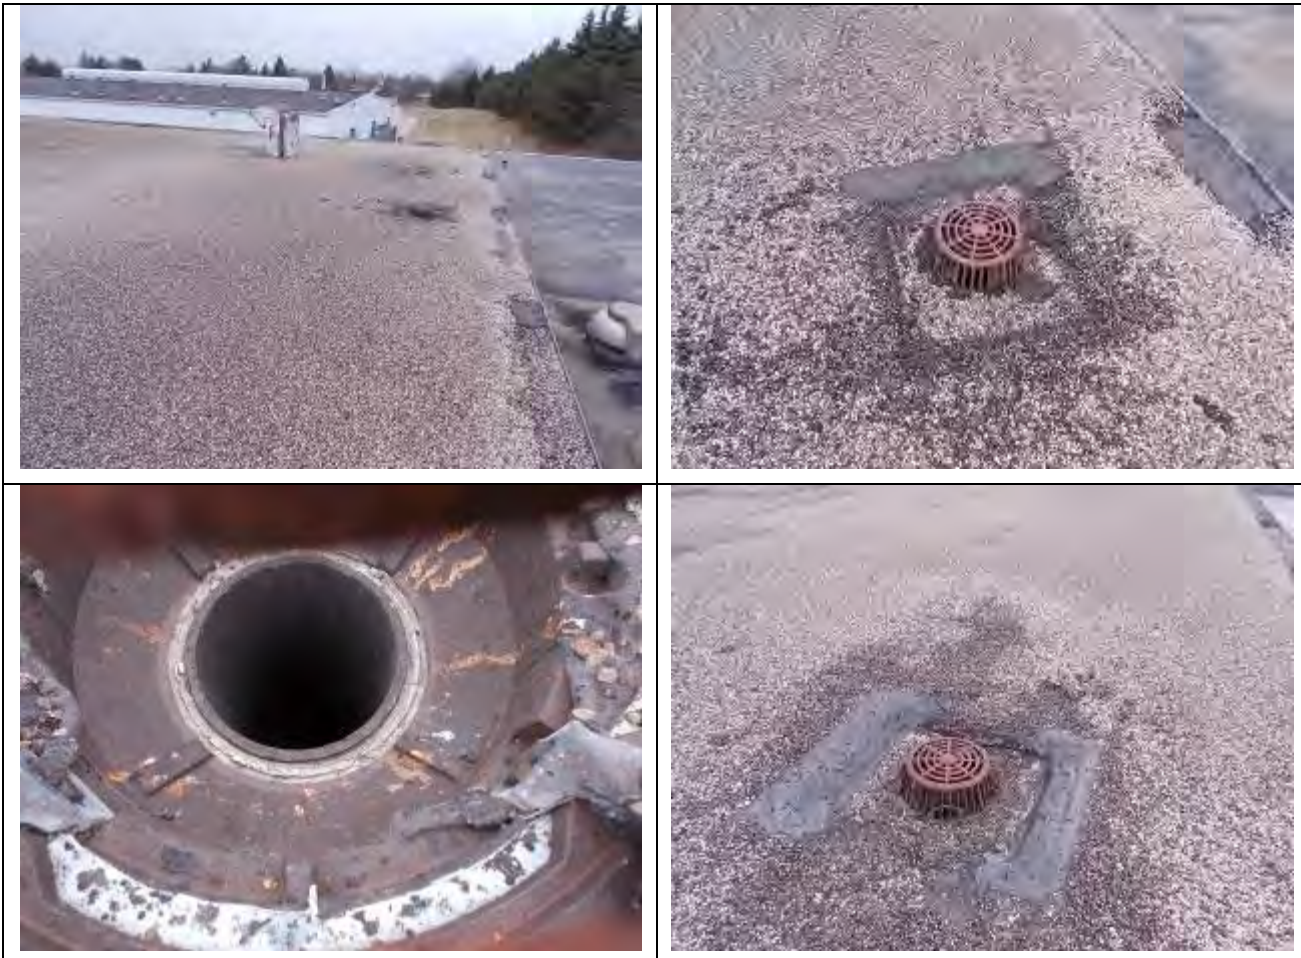
Roof Drainage

The roof system appears to be suitably drained via internal roof drains; however, we noted previous repairs around the roof drains.

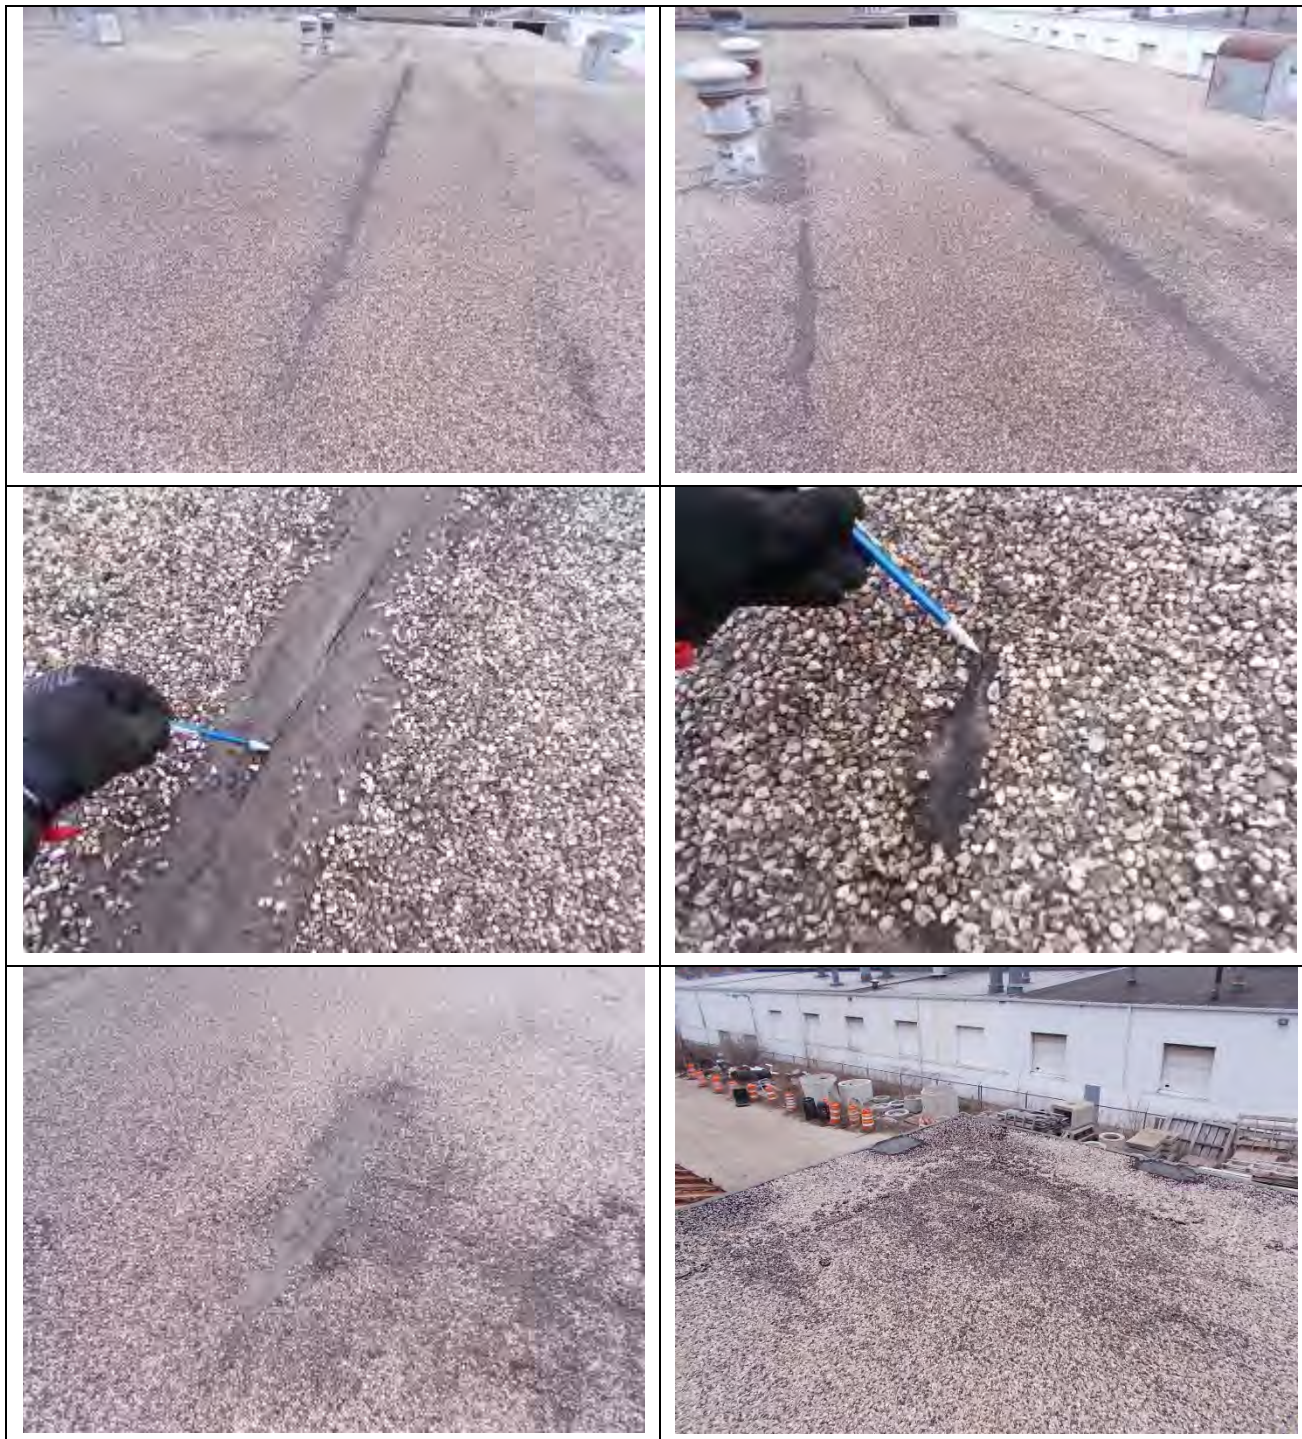
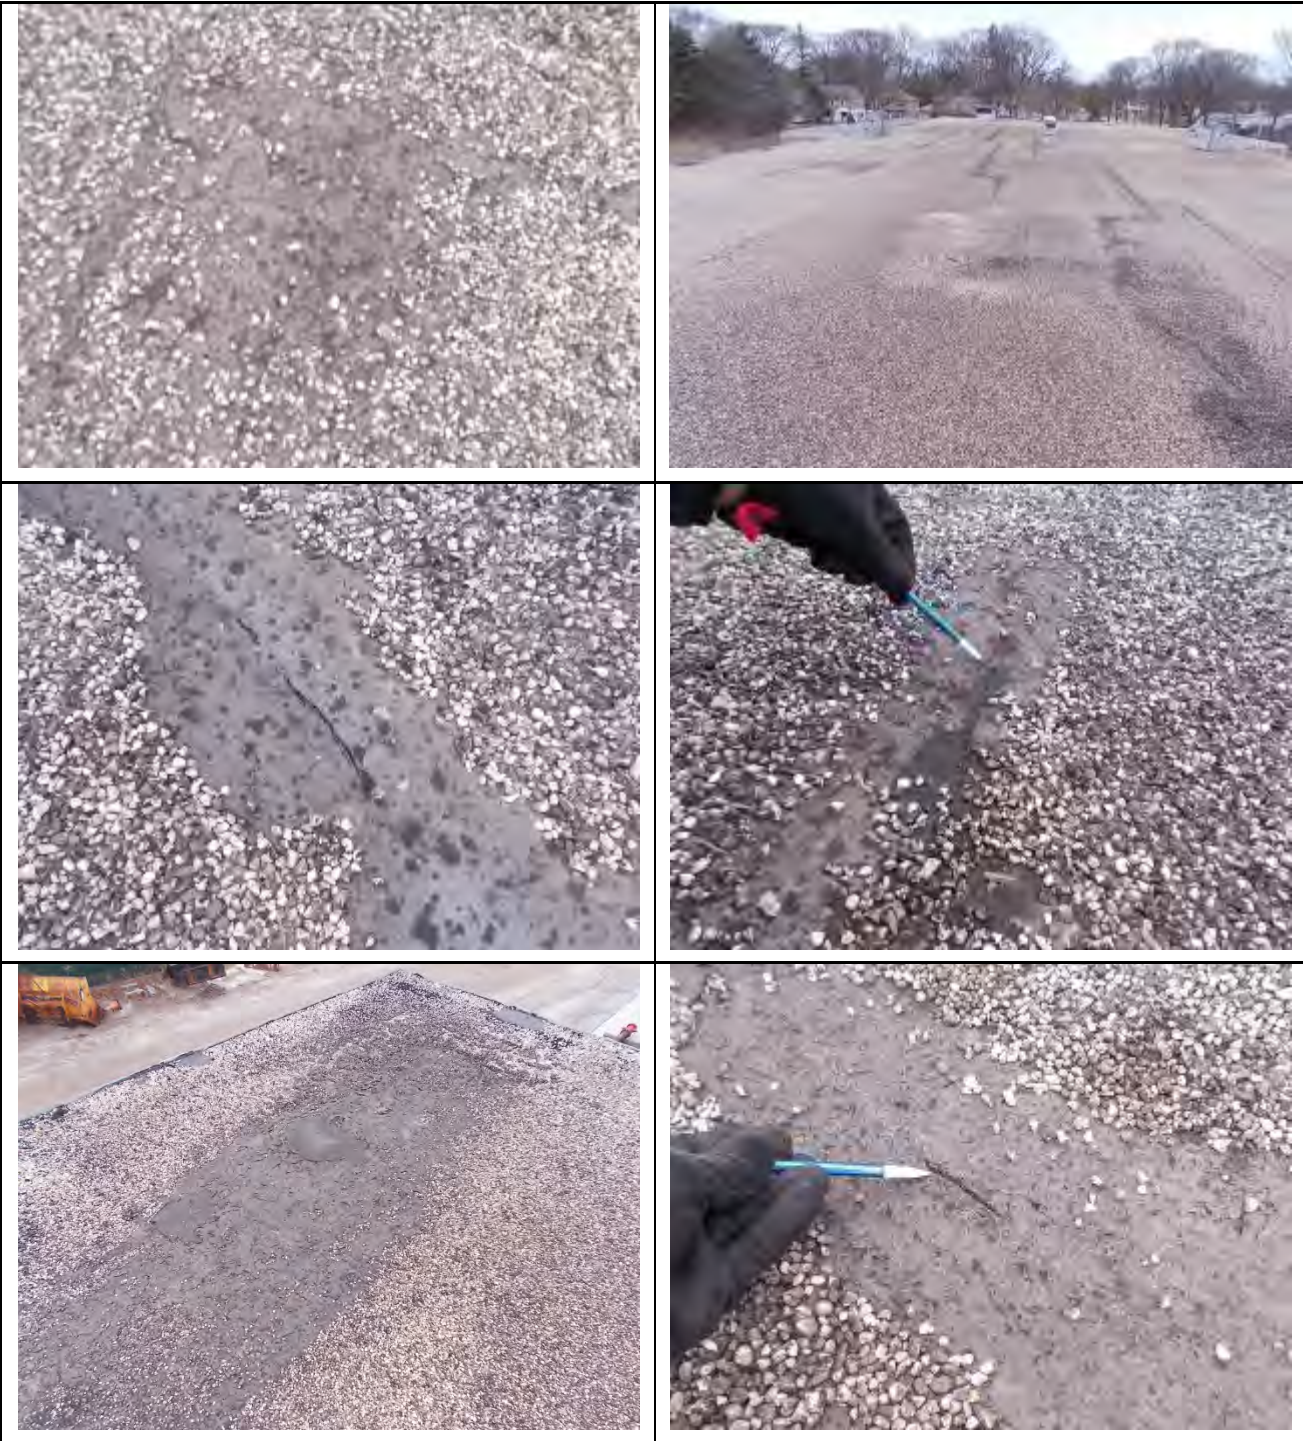
Roof Membrane

The built-up roof membrane is in poor condition and is reportedly suffering from ongoing leakage. We believe it has reached the end of its useful service life. Noted deficiencies include bare felts, blistering, eroded flood coat, ridging, splitting, and wind-blown corners. There have been numerous repairs attempted and the roof system will likely continue to develop leaks until replacement is accomplished.

The asphalt BUR system on Roof Area 2 is in poor condition and suffering from ongoing leakage. Based on the numerous deficiencies noted and reported leak history, we believe this roof system has reached the end of its useful service life and should be scheduled for replacement as soon as budget allows.

Ownership should begin to plan and budget for replacement of Roof Area 2 as soon as budget allows. In the meantime, complete only emergency repairs on an as needed basis to address any leaks that arise.

Year	Roof Area	Work Required	Estimated Cost
2026	2	Roof Replacement <i>(includes drain replacement, likely isolated rusted deck replacement, and removal of unused duct penetrations)</i>	\$230,000
2027	All	No Capital	\$0
2028	All	No Capital	\$0
2029	All	No Capital	\$0
2030	All	No Capital	\$0

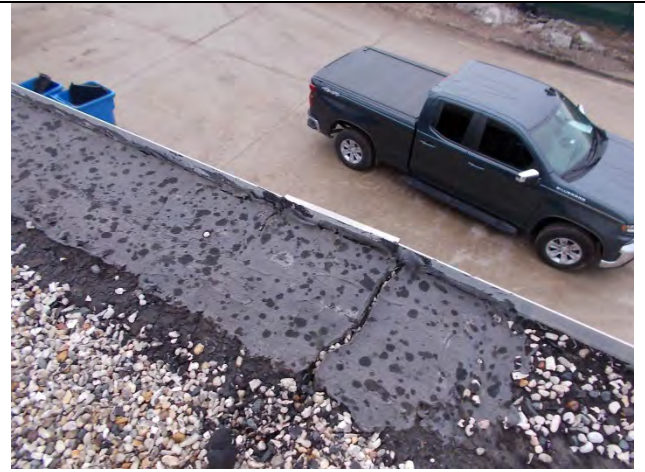
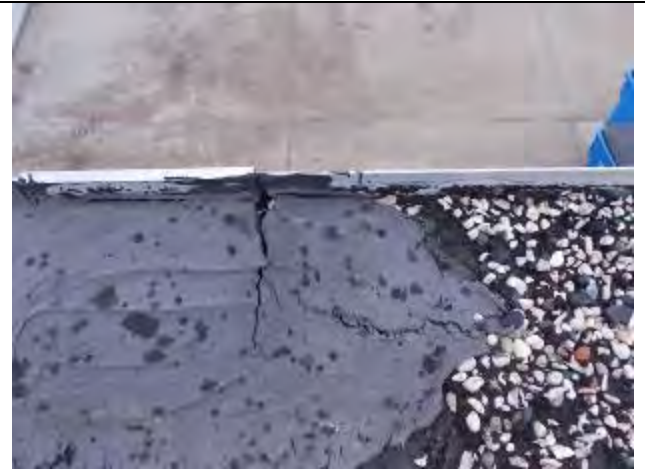
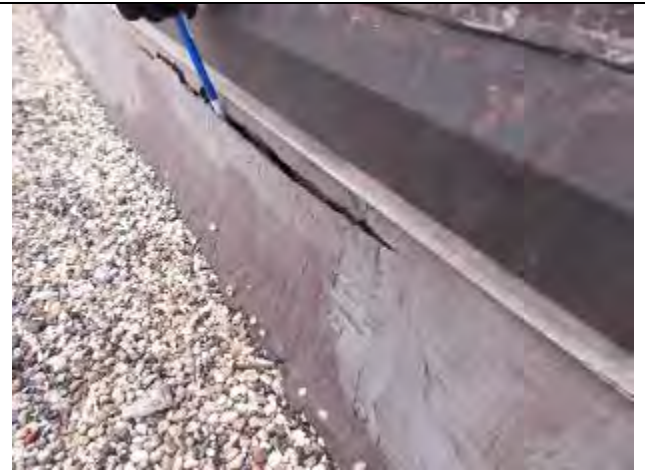
Roof Perimeters

The roof system terminates at its perimeters via counter flashing and metal edge which are in poor condition and require replacement. The flashings associated with these perimeters require replacement.

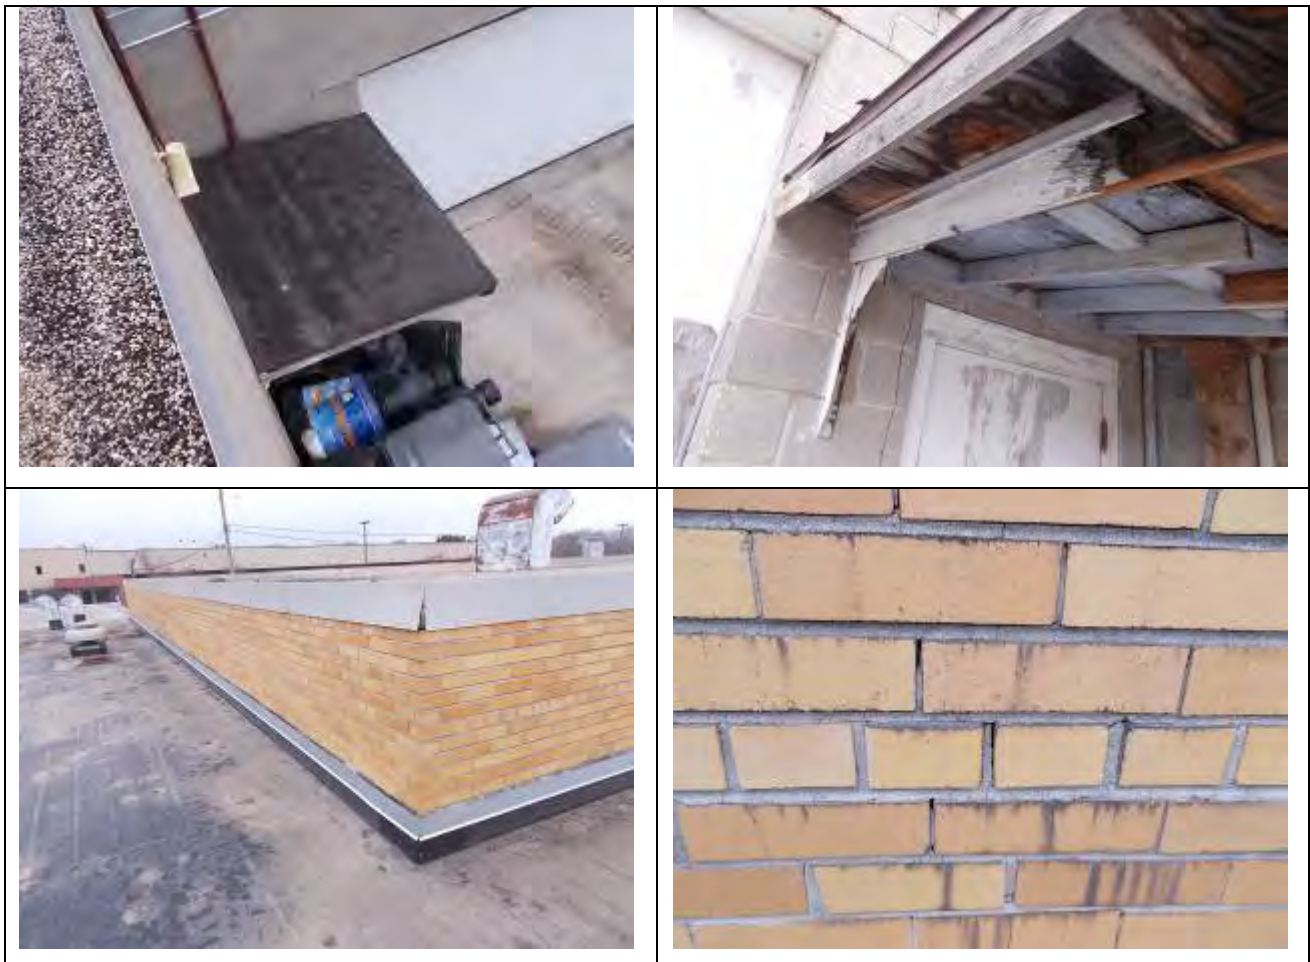
Additional Comments

During our survey, we noted deficiencies within adjacent masonry walls and a deteriorated/abandoned canopy. Ownership should consider removing the unused canopy and completing repairs to the masonry wall to prevent leakage into the adjacent roof system.

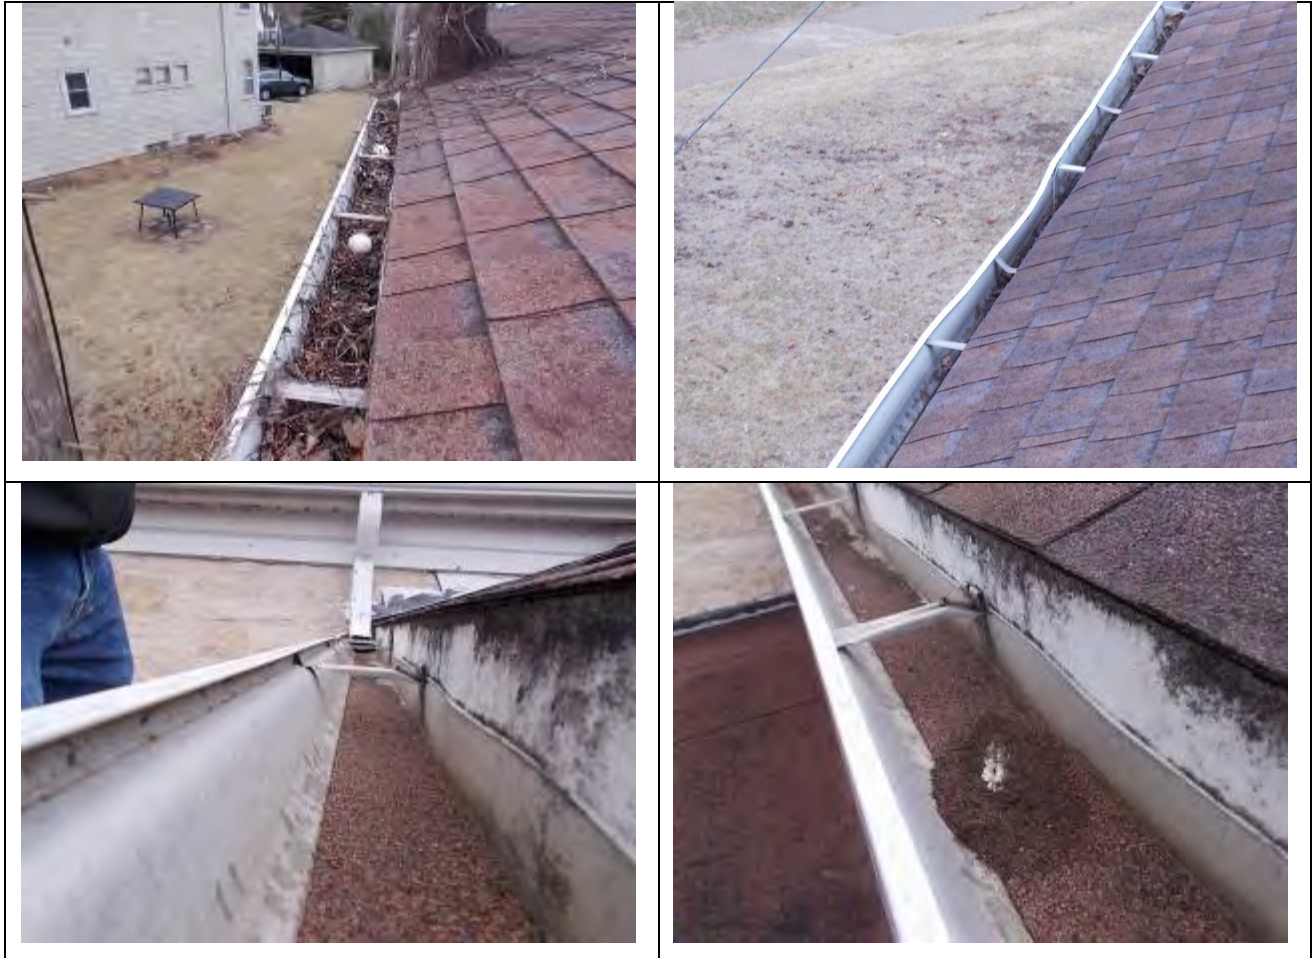
Roof Drainage

The roof system appears to be adequately drained via sheet metal gutters; however, the gutters are damaged and filled with debris.

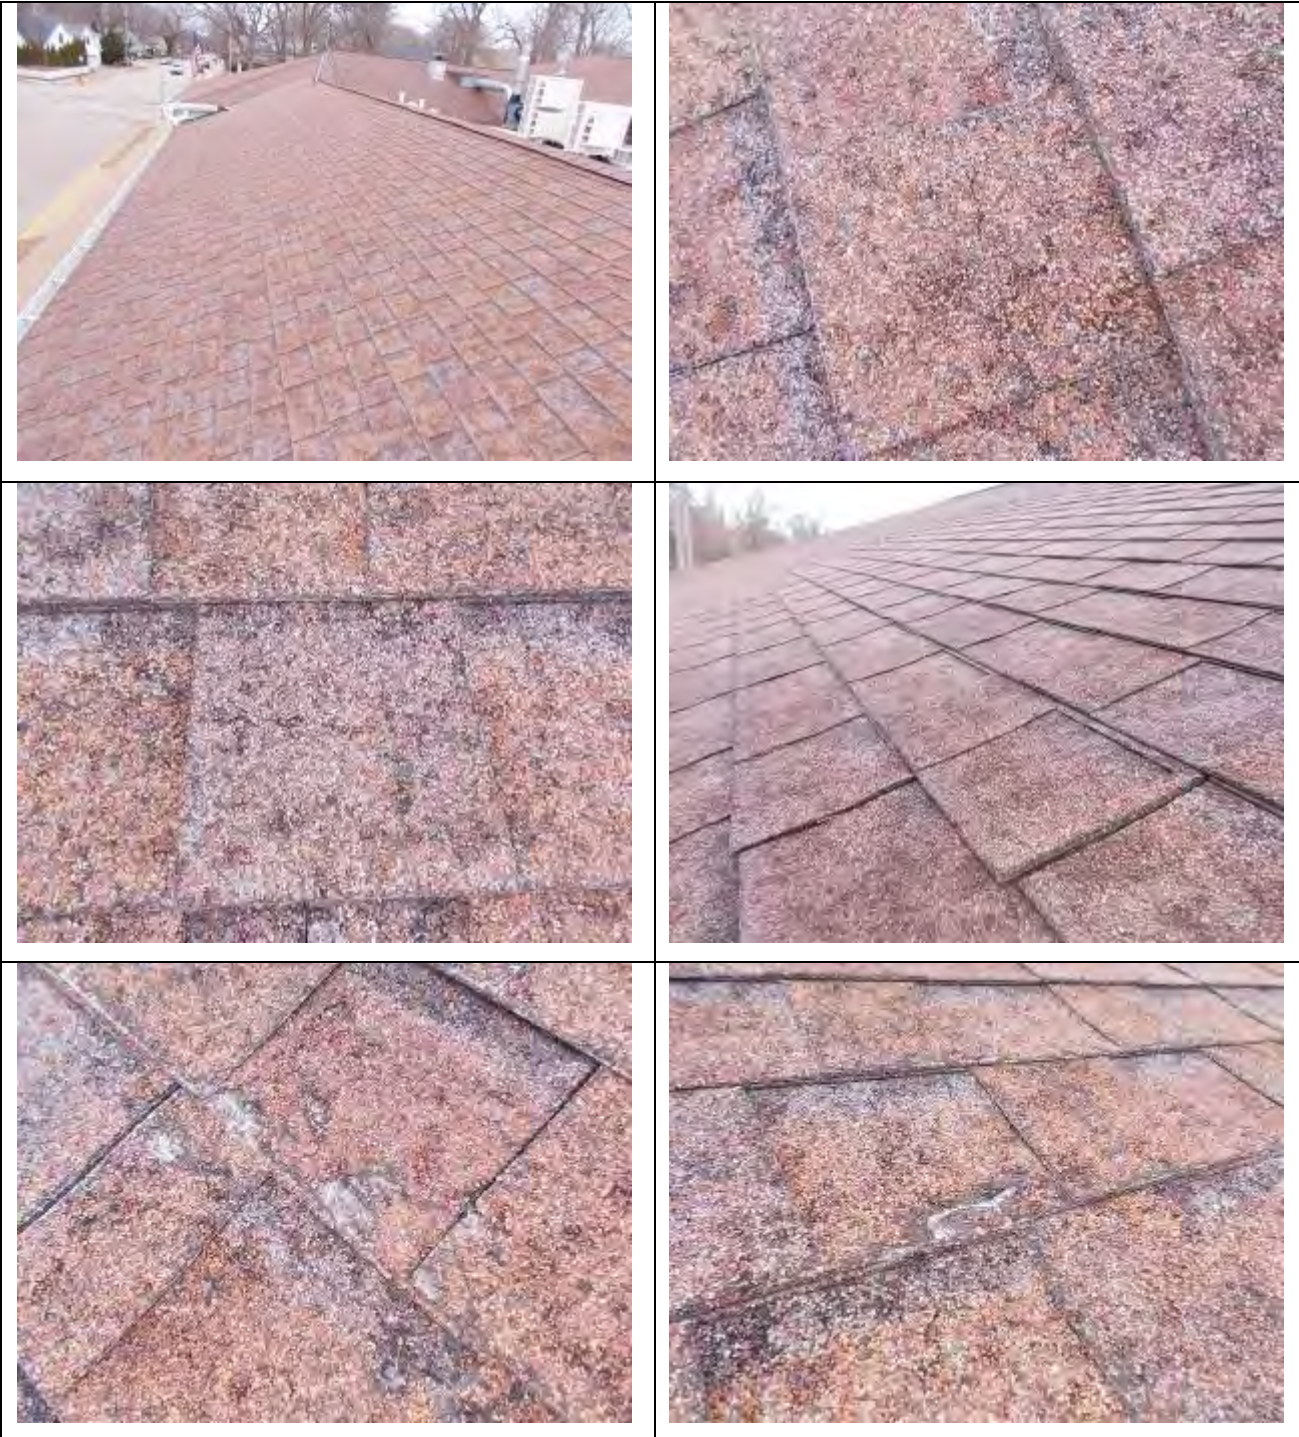
Roof Membrane

The shingles remain in serviceable condition, but are beginning to near the end of their useful service life. We noted slippage, granule loss, haze cracking, and embrittlement of the shingles.

The shingle roof system on Roof Area 1 remains in serviceable condition; however, based on the noted deficiencies, we believe it is beginning to near the end of its useful service life. It will likely require replacement in the next 3-5 years.

Ownership should begin to plan and budget for replacement of all Roof Areas in the next 3-5 years. In the meantime, complete only emergency repairs on an as needed basis to address any leaks that arise.

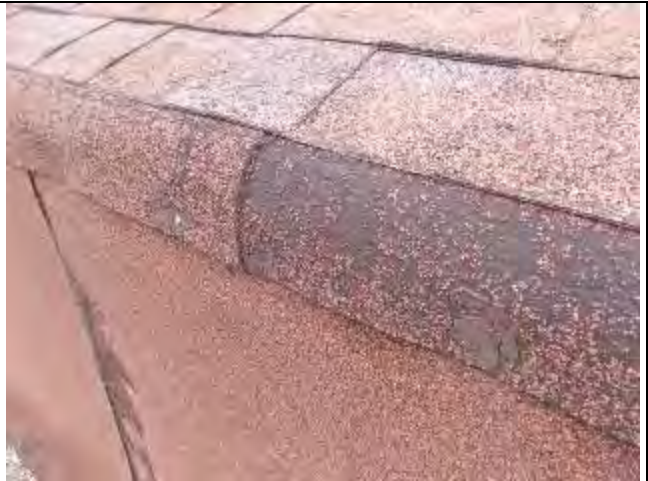
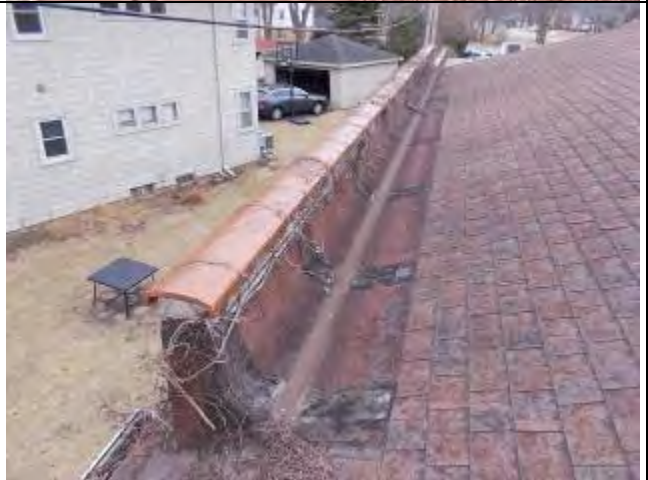
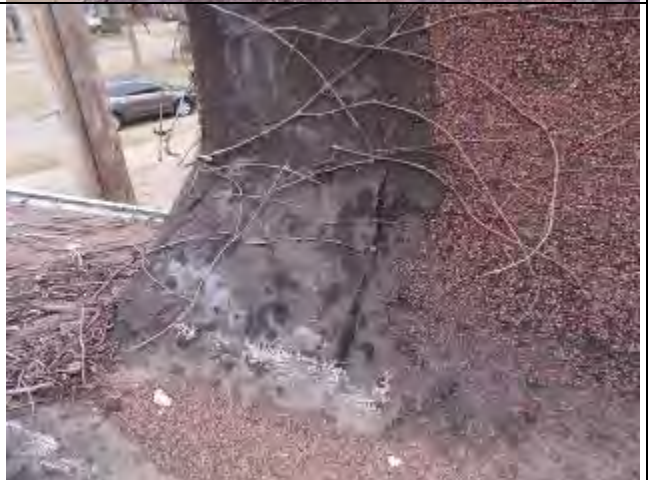
Roof Perimeters

The roof system is improperly terminated where it transitions to Roof Area 2 (lacking sheet metal drip edge). There is also a low-slope saddle at a parapet wall that is deteriorated.

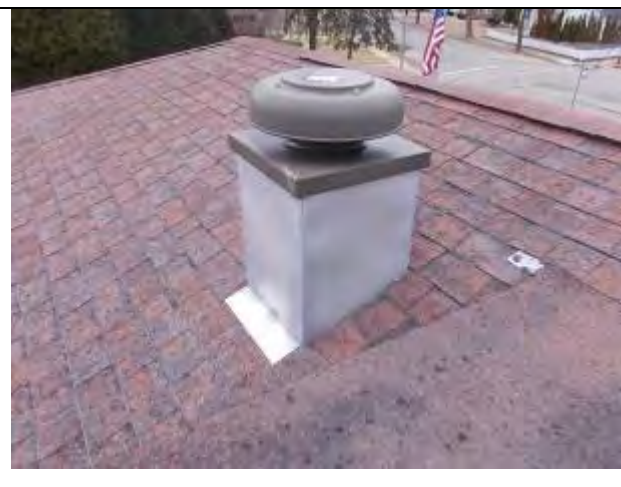
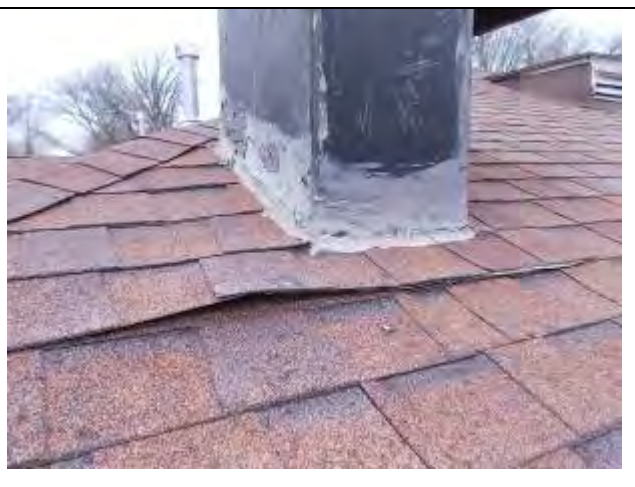
Roof Projections

The roof system is penetrated by hot stacks, soil stacks, ducts, attic vents, and square curbs which are improperly flashed into the roof system and have received previous repairs.

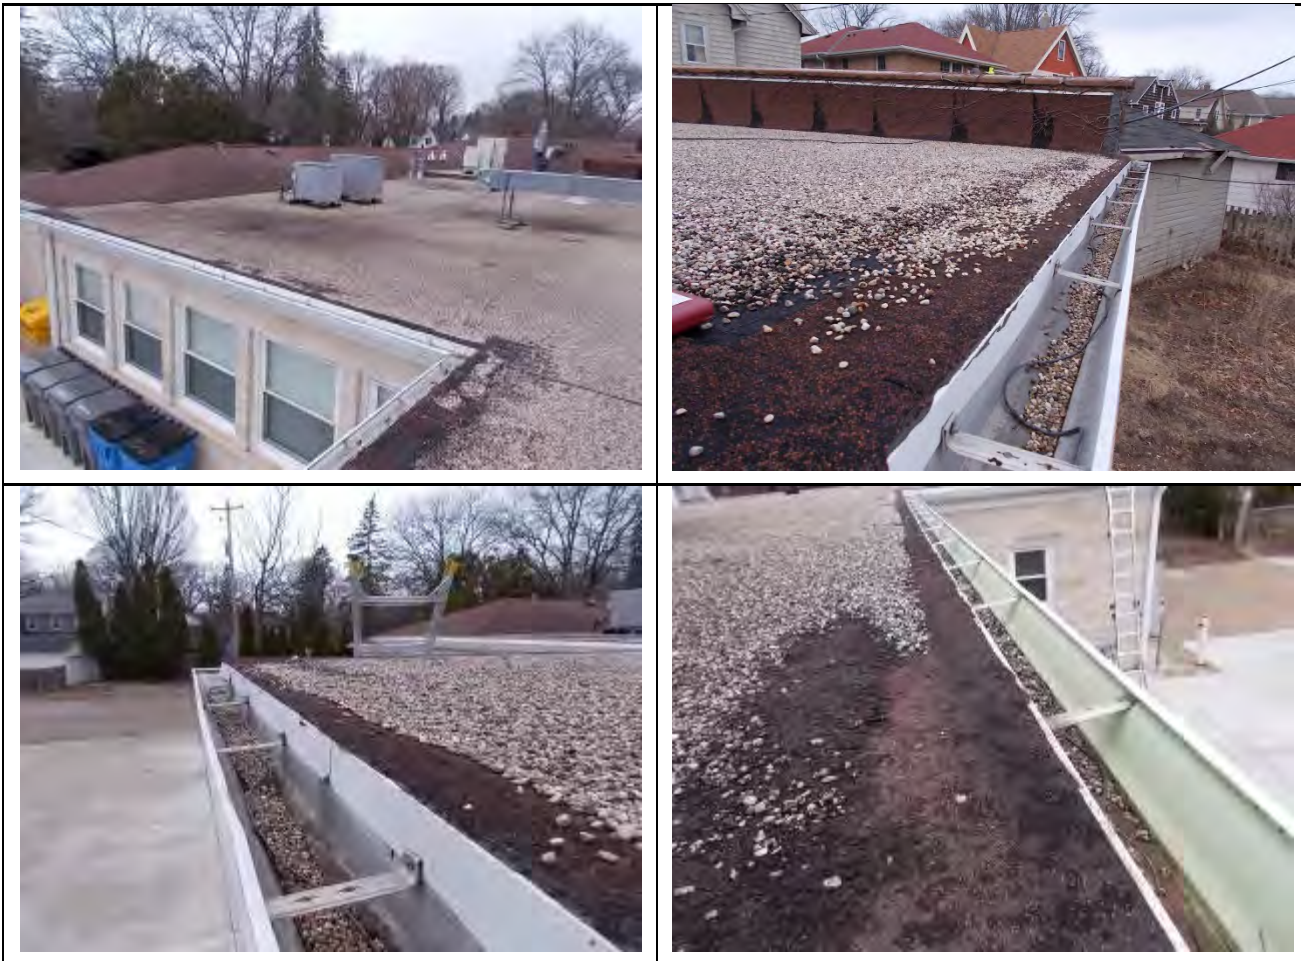
Roof Drainage

The roof system appears to be suitably drained via perimeter gutters, though the gutters have debris.

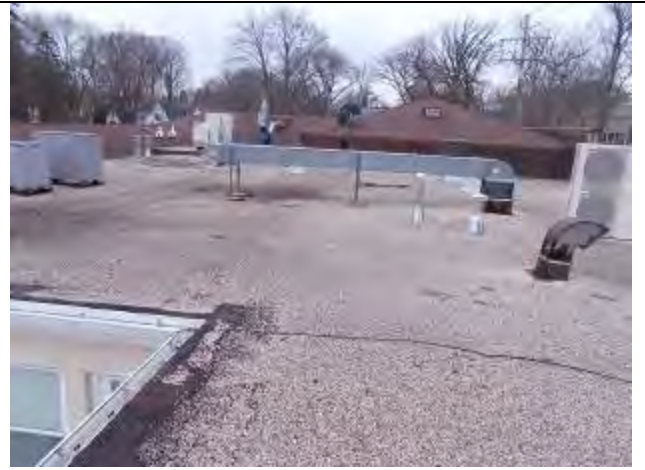
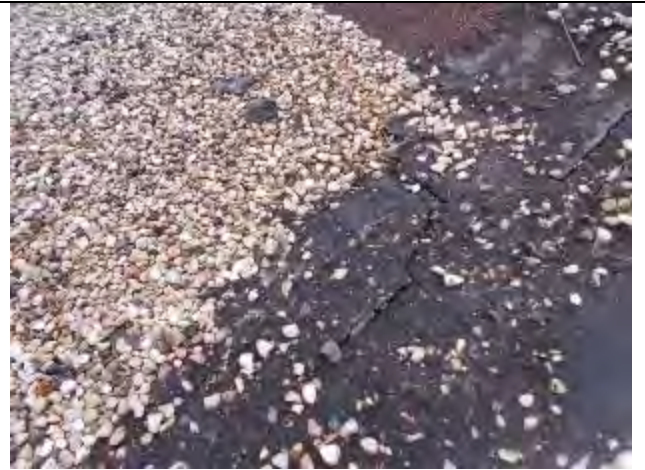
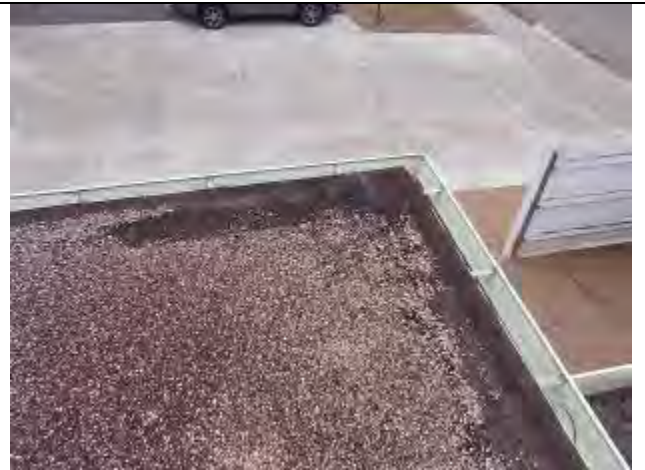
Roof Membrane

The built-up roof membrane is beginning to near the end of its useful service life. We noted previous repairs, splitting, eroded surfacing, and general deterioration.

The asphalt BUR system on Roof Area 2 is also beginning to near the end of its useful service life, based on the observed deficiencies. It should be scheduled for replacement in conjunction with Roof Area 1.
