Village of Whitefish Bay Public Works Department

Re: Visual Roof Survey Report

VISUAL ROOF SURVEY

SIX (6) FACILITIES PER THE ATTACHED FACILITY LIST

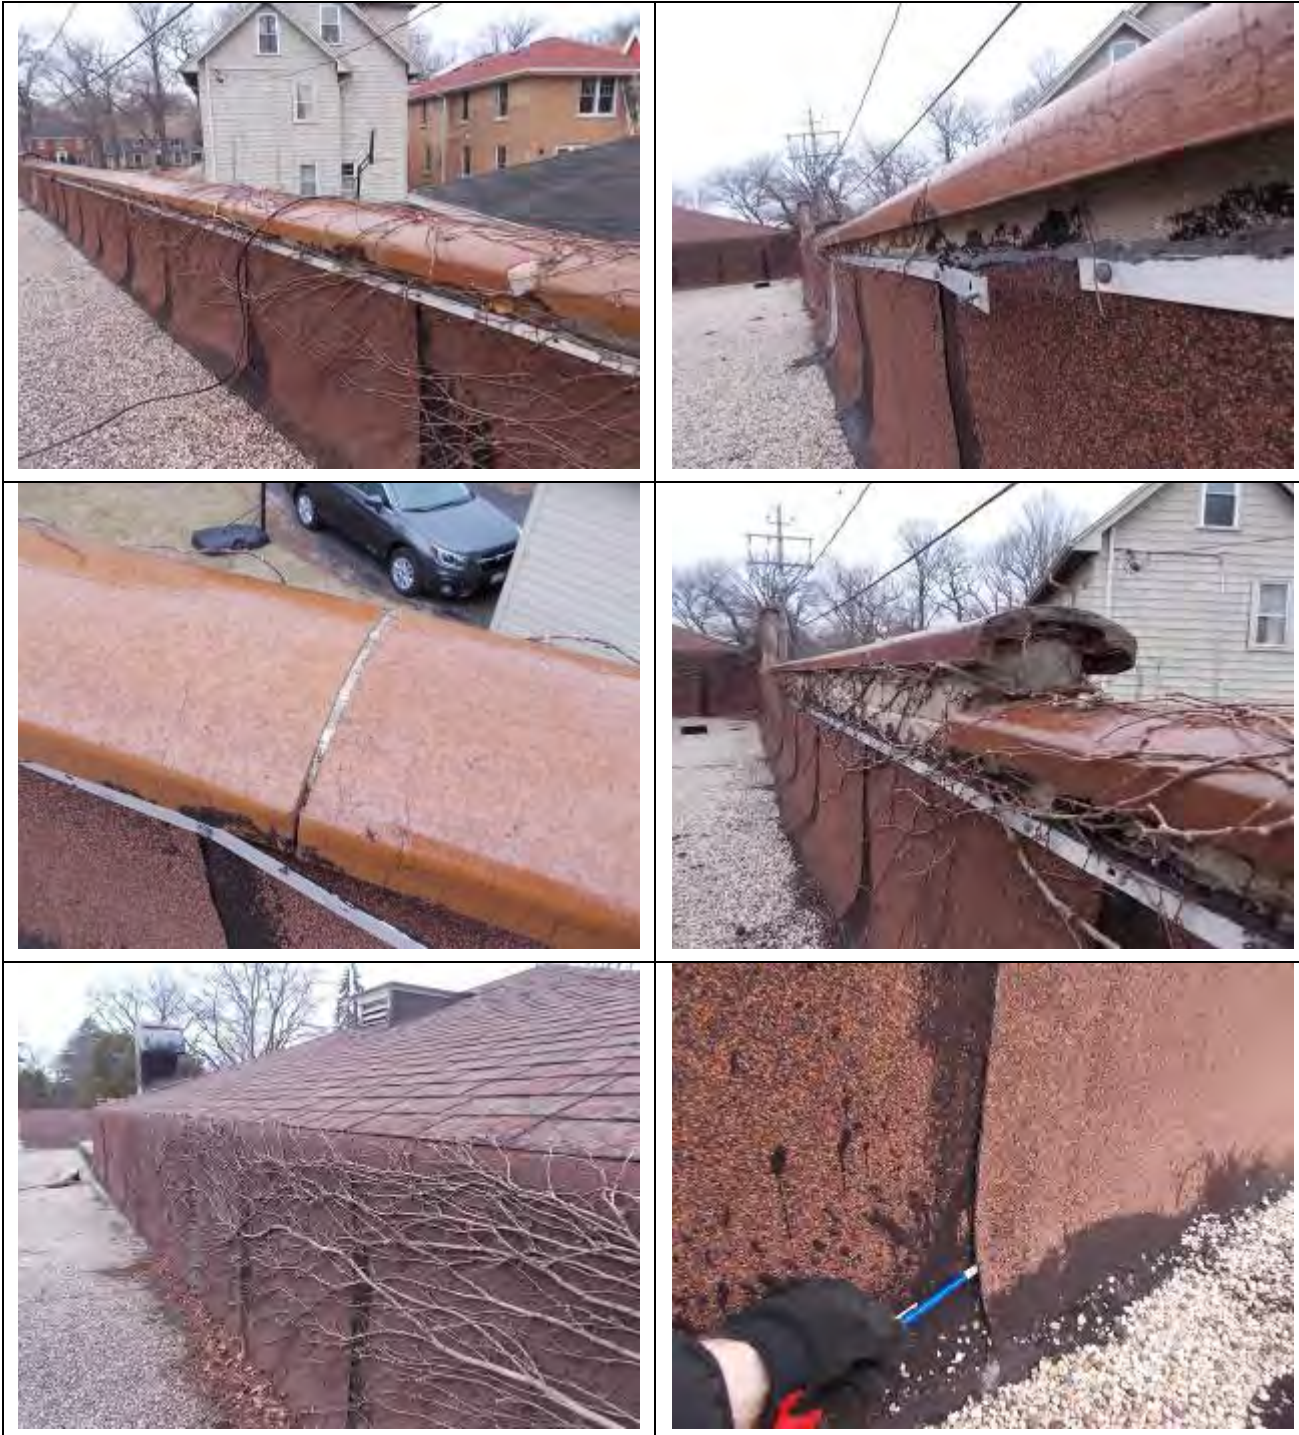
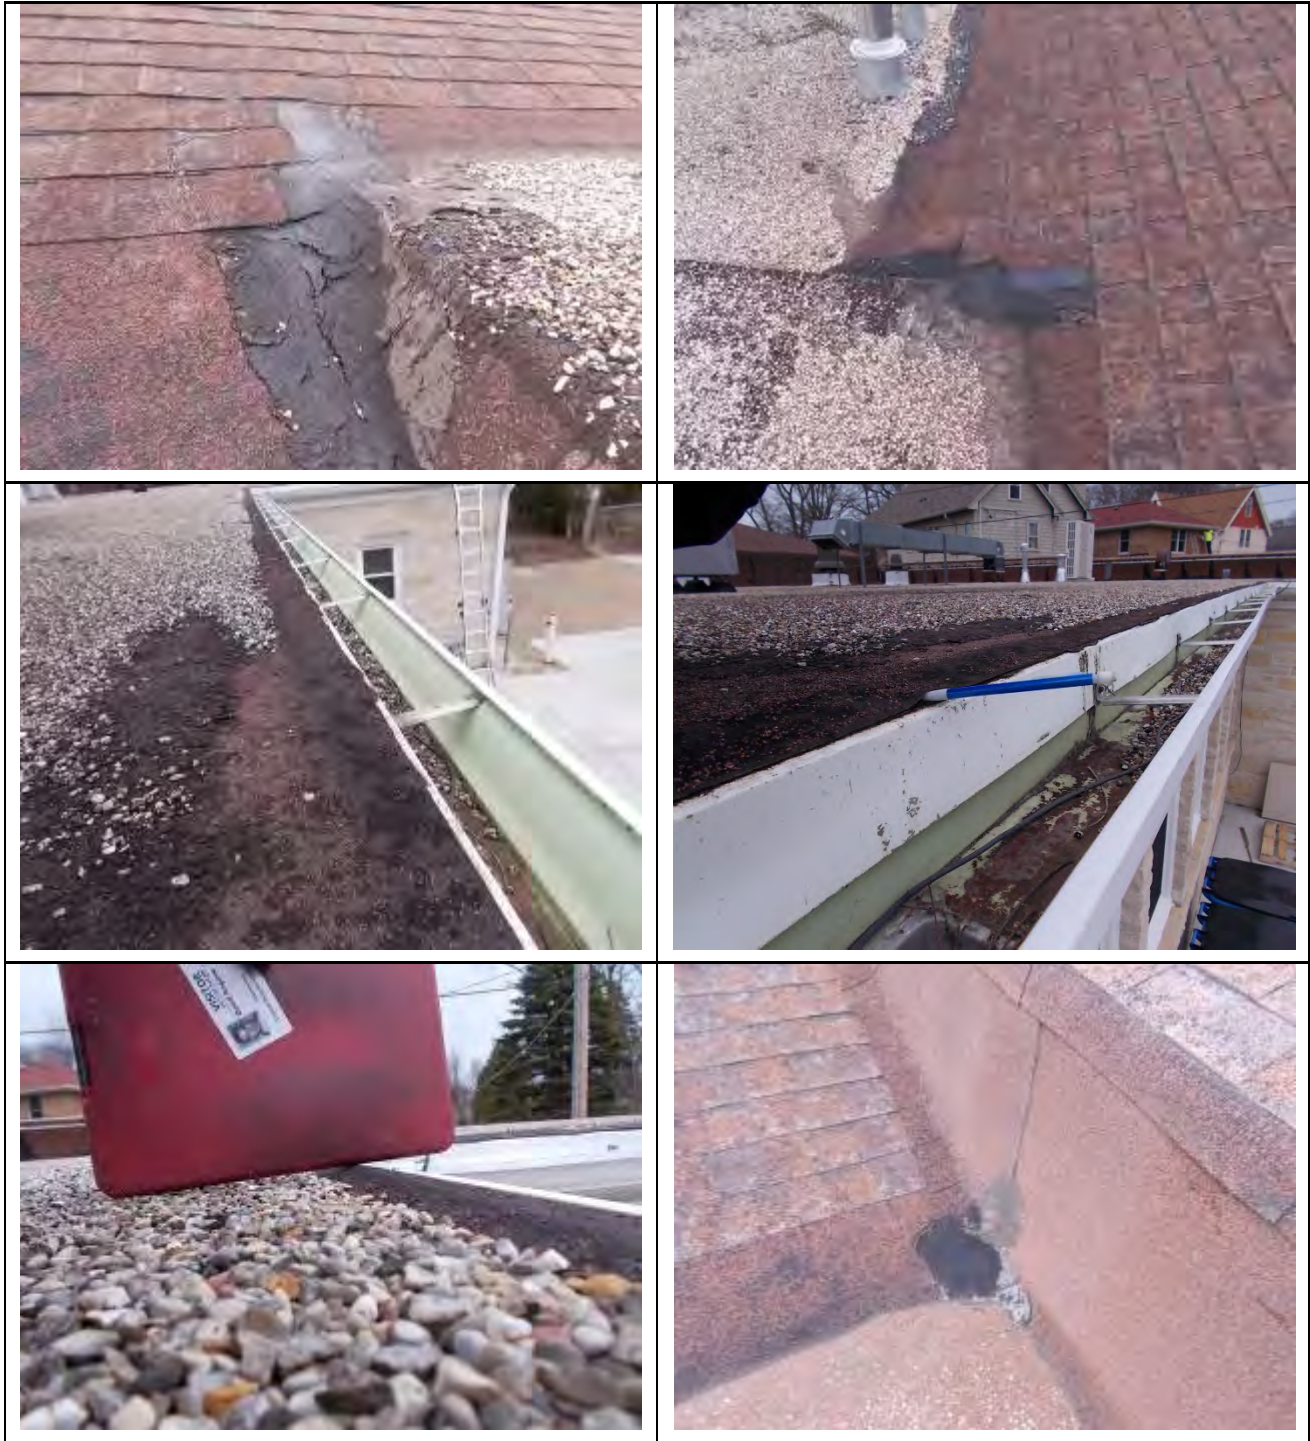
Roof Perimeters

The roof system terminates at its perimeters via sheet metal drip edge, gutters, and an isolated section of parapet wall. The flashings along the parapet wall are deteriorated and improperly terminated. The drip edge is deflecting upwards, causing a raised ridge along the gutter edge, impeding drainage. There are also vines growing over much of the perimeters.

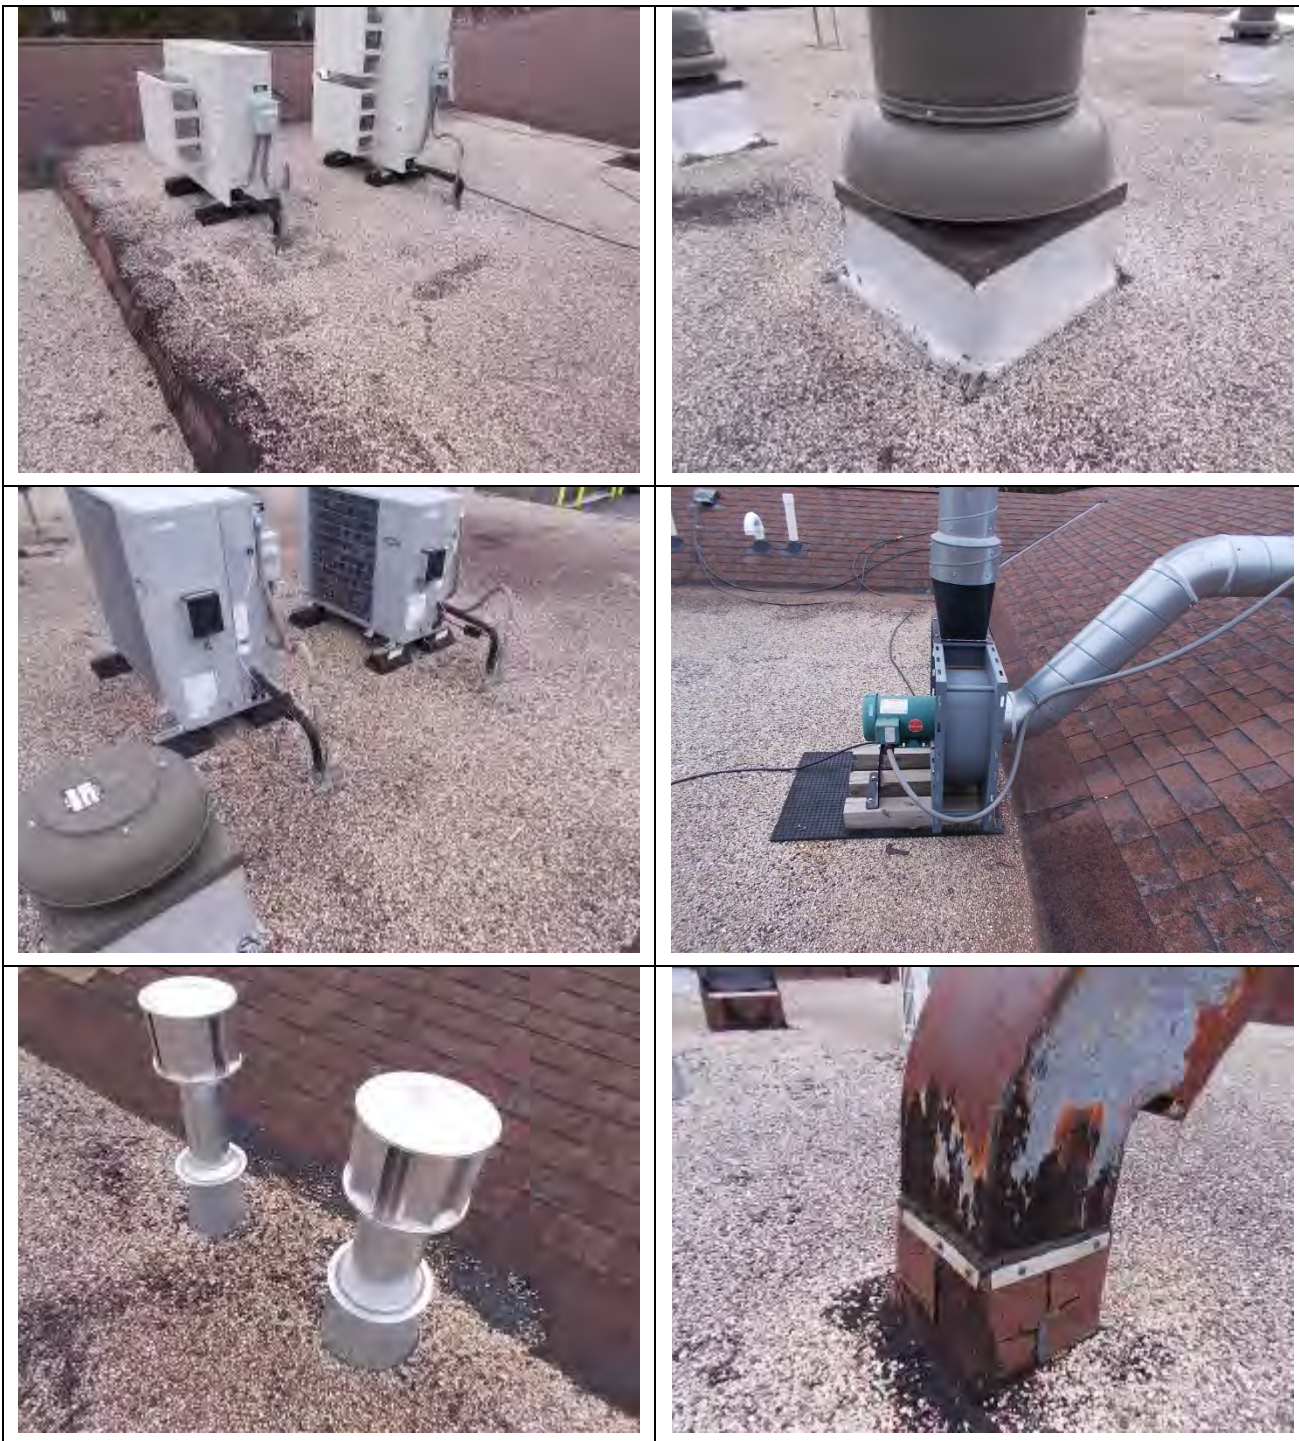
Roof Projections

The roof system is penetrated by hot stacks, curbs, soil stacks, ducts, and small pipes. Many of these penetrations are improperly flashed into the roof system.

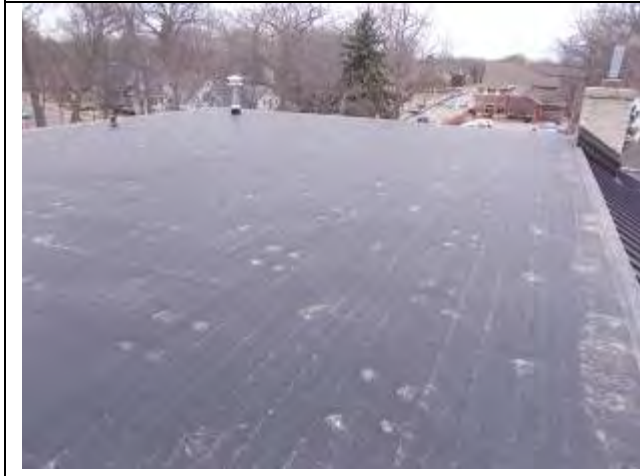
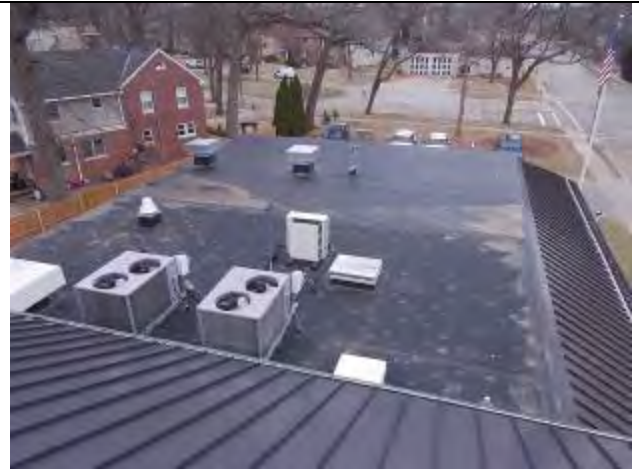
Roof Drainage

The roof system appears to be adequately drained via eave run-off onto the adjacent metal roofs, with some isolated areas of ponding water noted.

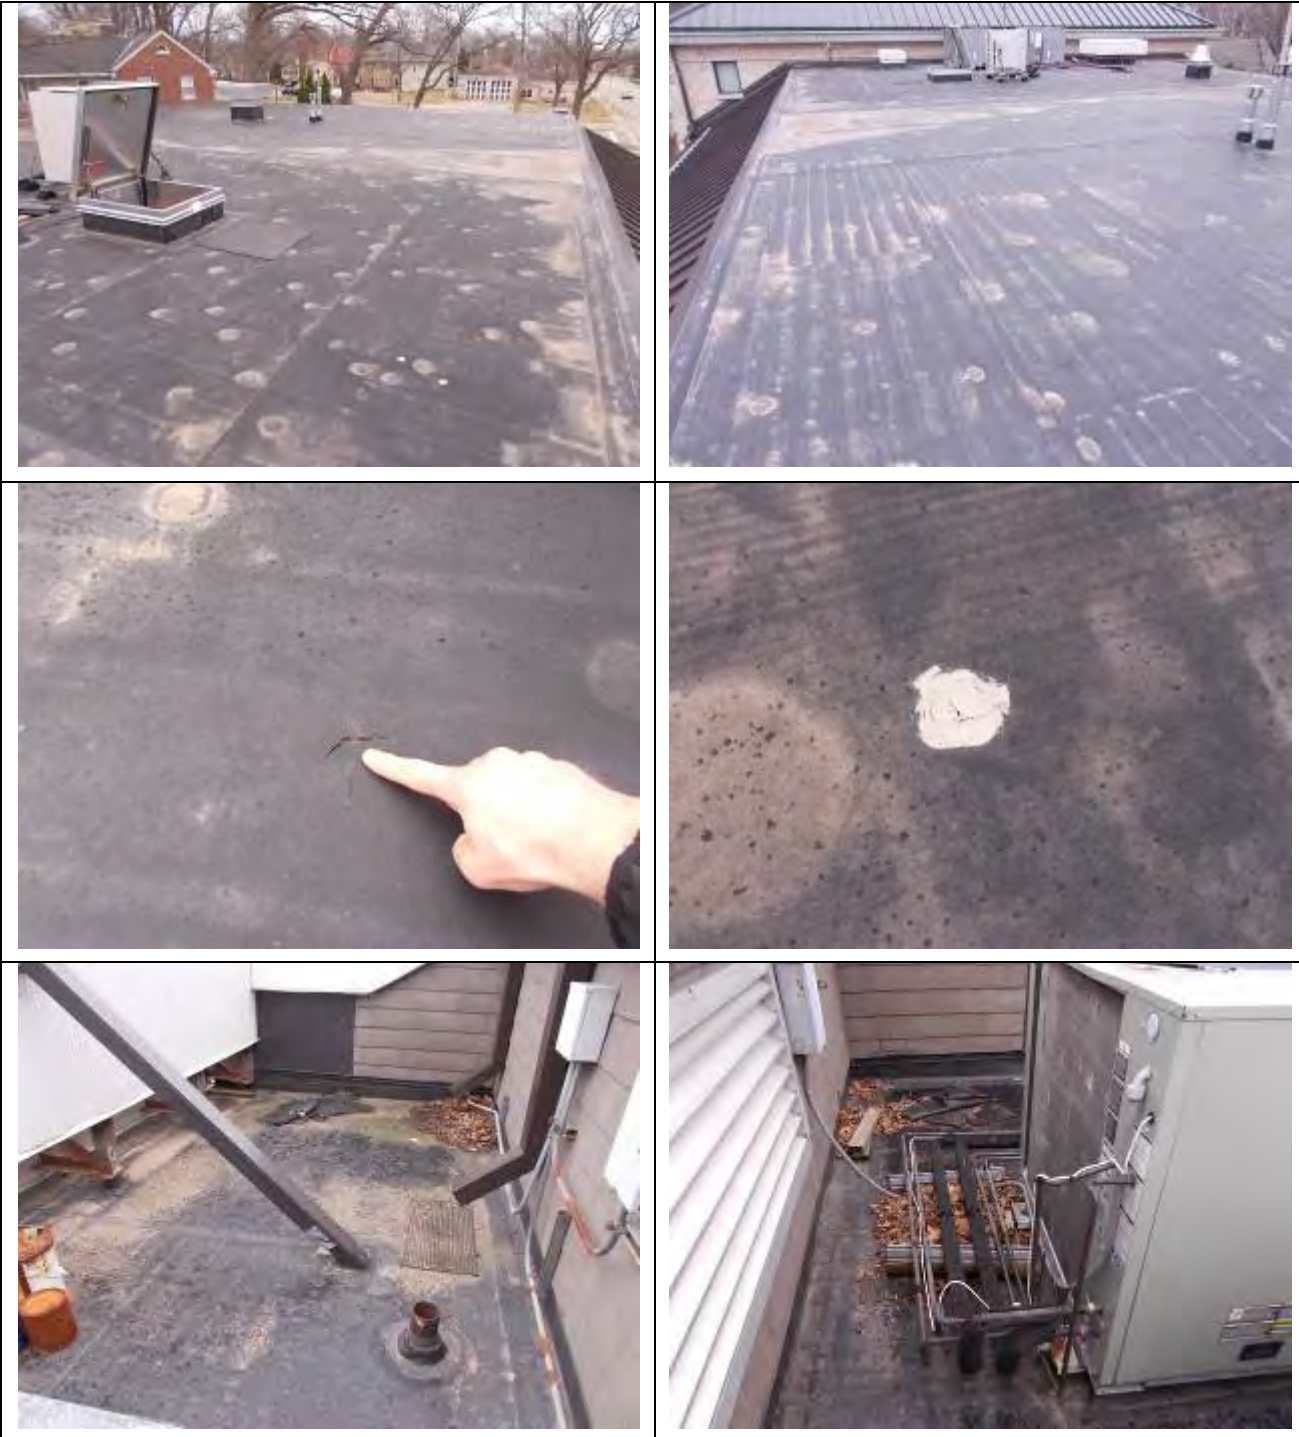
Roof Membrane

The EPDM single-ply membrane remains in serviceable condition. We noted several holes punctured through the membrane on Roof Area 1 and debris collecting on Roof Area 4.

The EPDM single-ply roof systems installed on Roof Areas 1-4 remain in serviceable condition, requiring only isolated repairs to address punctures and debris. Provided the roof systems receive timely preventative maintenance, followed by continued proactive annual maintenance, we believe they should be capable of performing properly for an additional 10-14 years.

Ownership should engage IRS to develop an Annual Maintenance & Repair Specification (AMRS) to address the required preventative maintenance items described in this report.

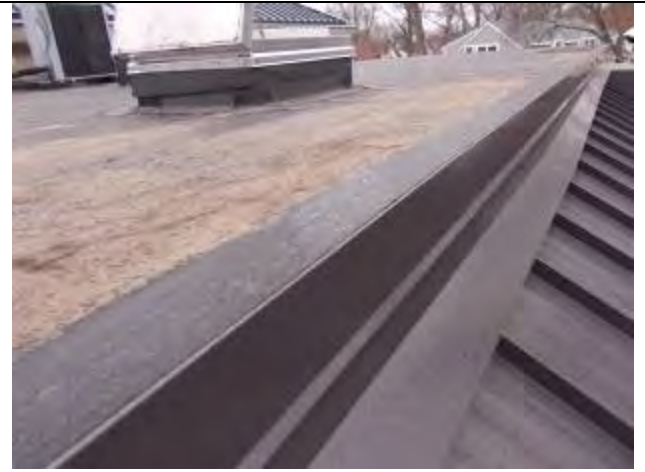
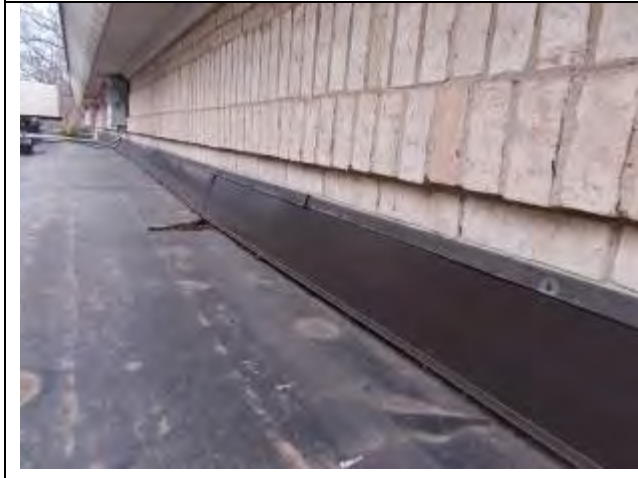
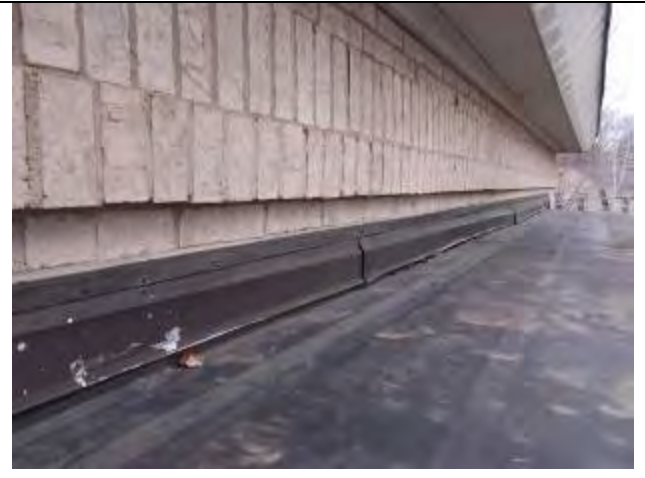
Roof Perimeters

The roof system terminates at its perimeters via counter flashing and metal edge, which remain in serviceable condition.

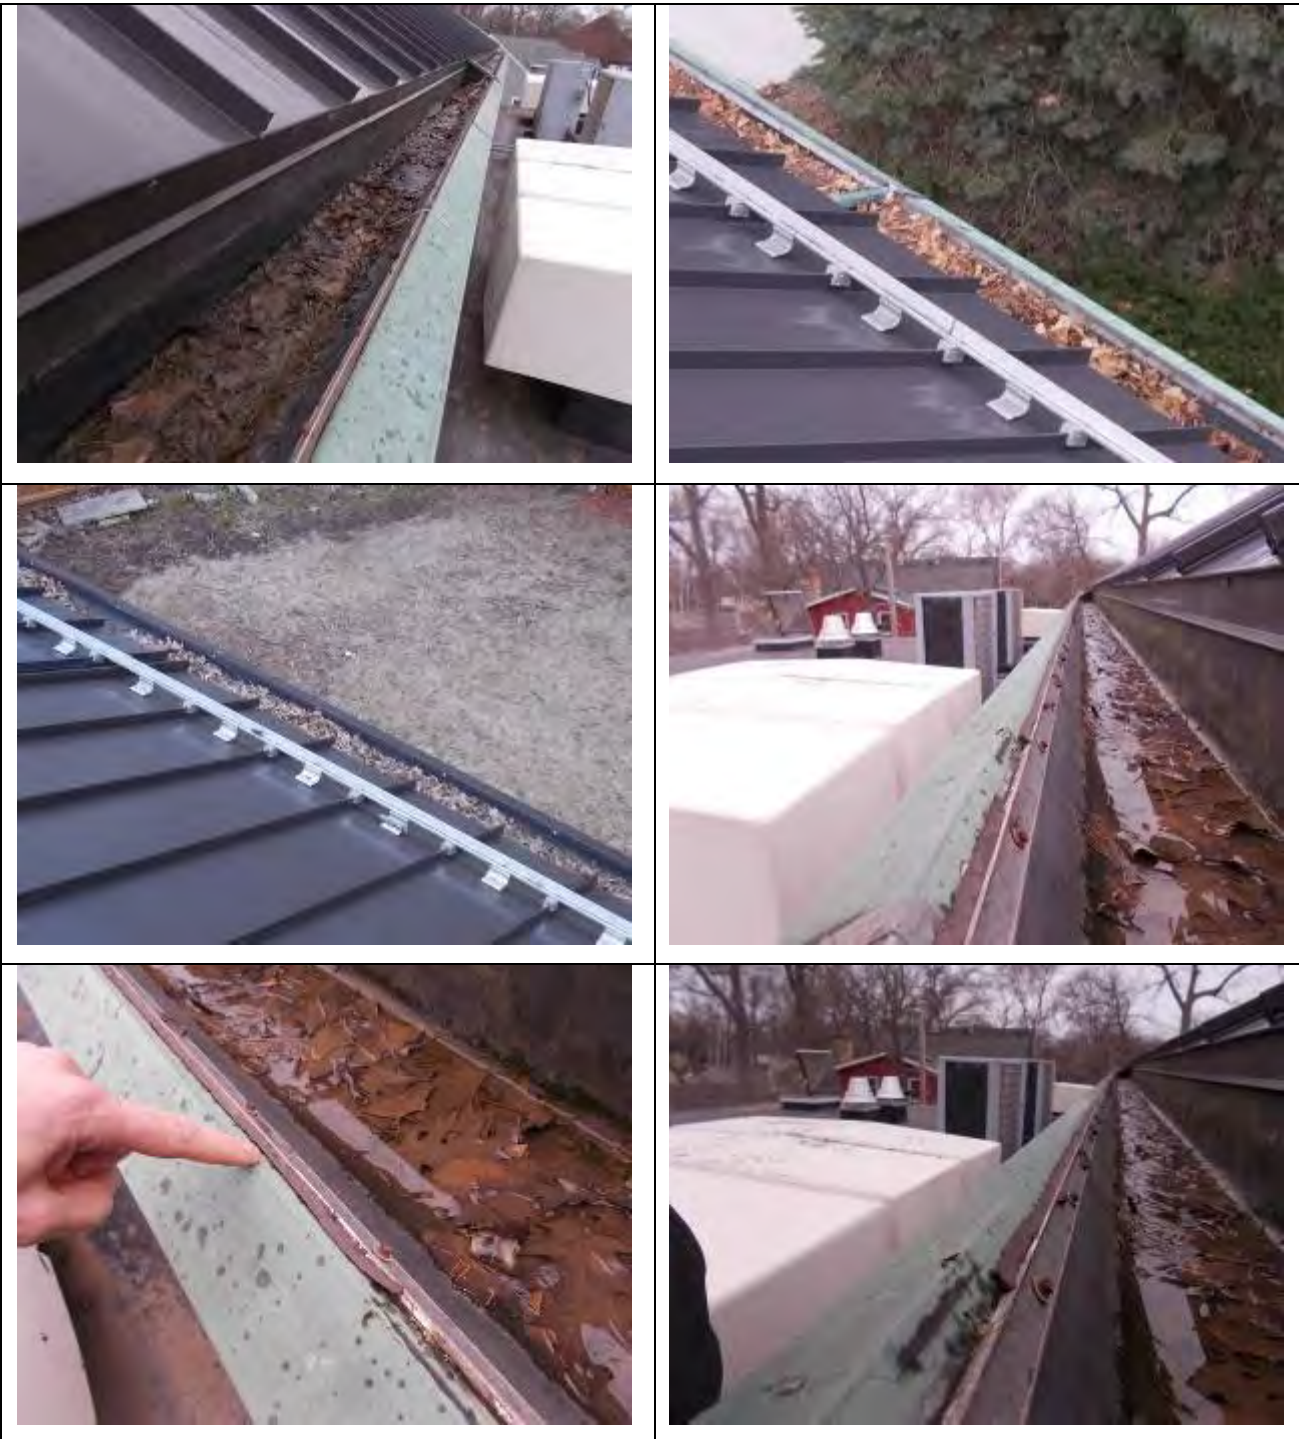
Roof Drainage

The roof system appears to be suitably drained via built-in gutters; however, we noted debris clogging the gutters and failed sealant along the termination-bar for the EPDM gutter lining.

The metal panel roof systems installed on Roof Areas 5-7 are in good condition, but do require repairs to address large amounts of debris and failed sealant along their built-in gutters. Provided the roof systems receive timely preventative maintenance, followed by continued proactive annual maintenance, we believe they should be capable of performing properly for an additional 20+ years.

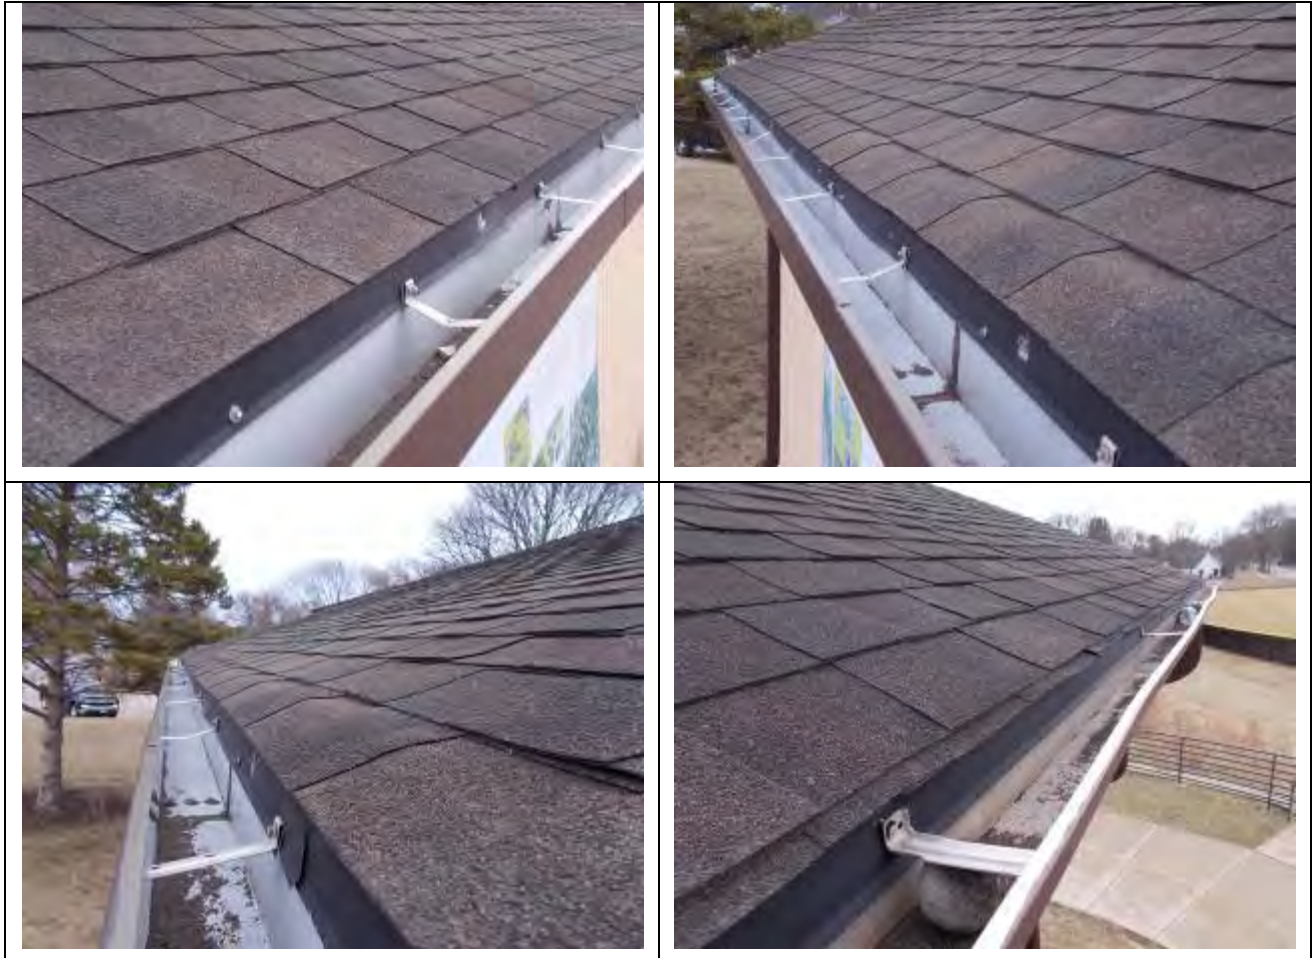
Roof Drainage

The roof system appears to be adequately drained via sheet metal gutters; however, we noted the shingles are buckled at the roof edge, creating a raised ridge along the gutter edge.

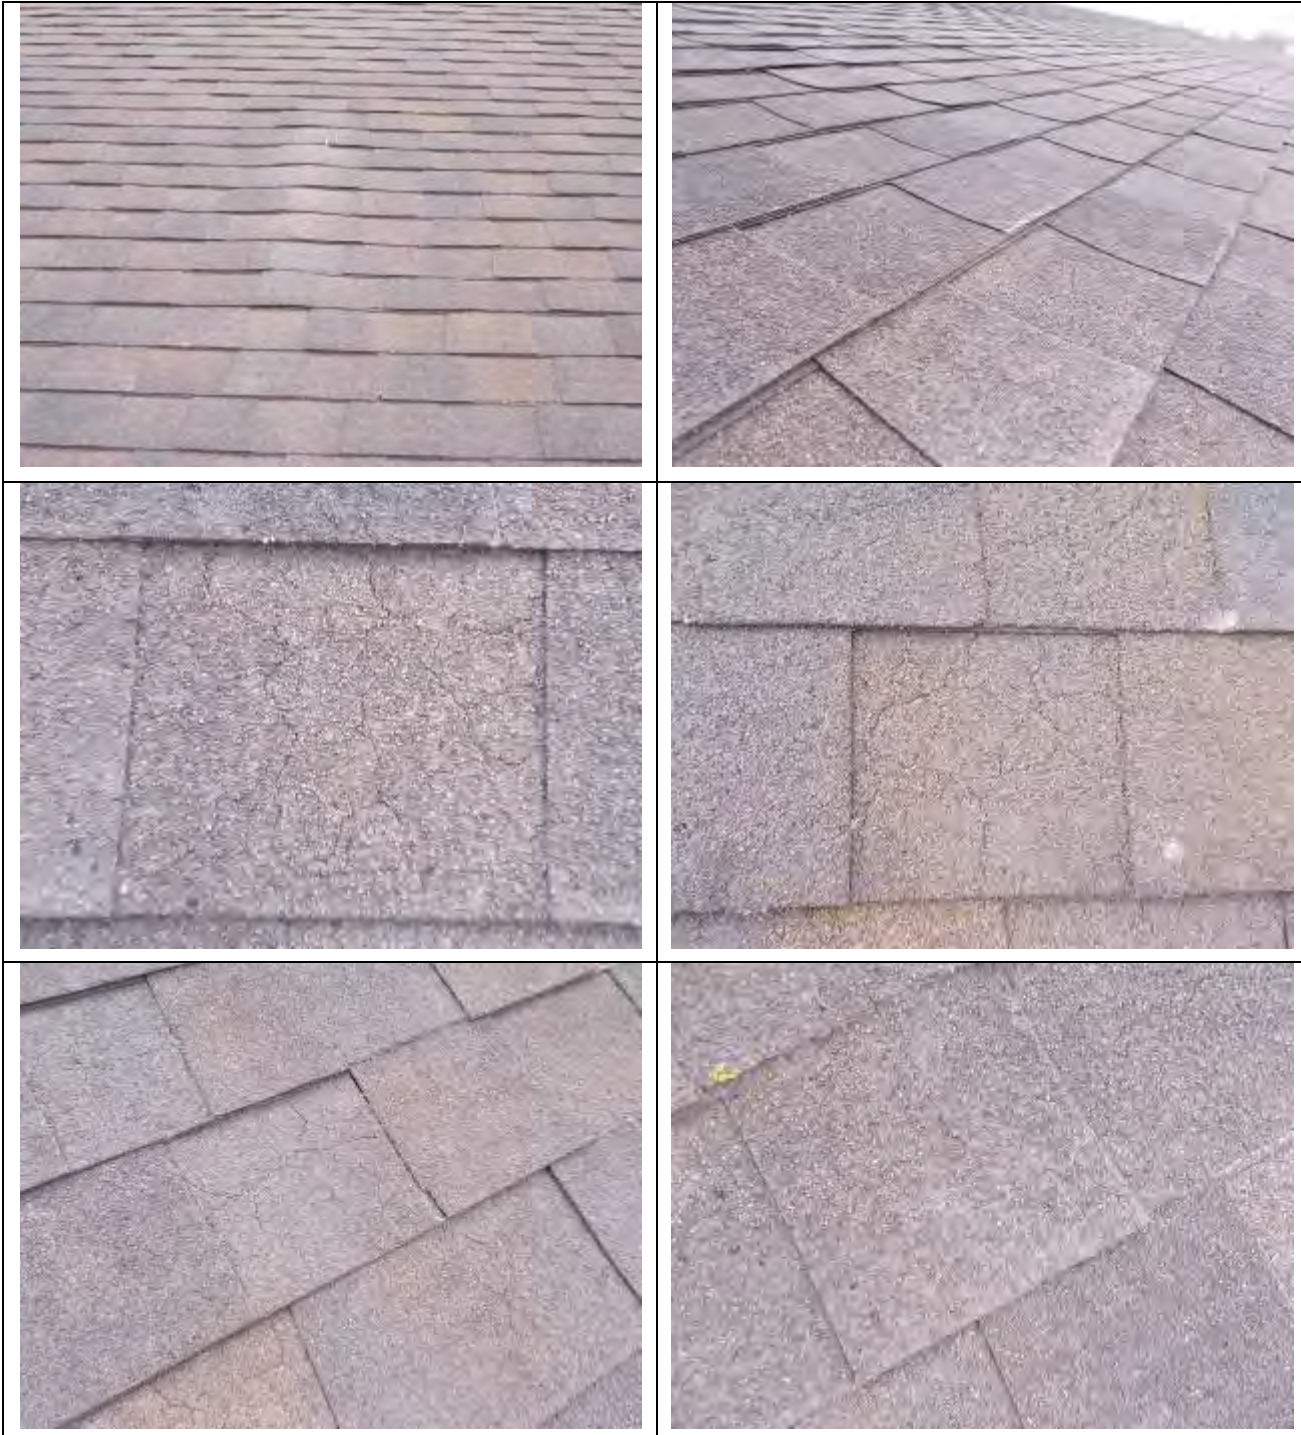
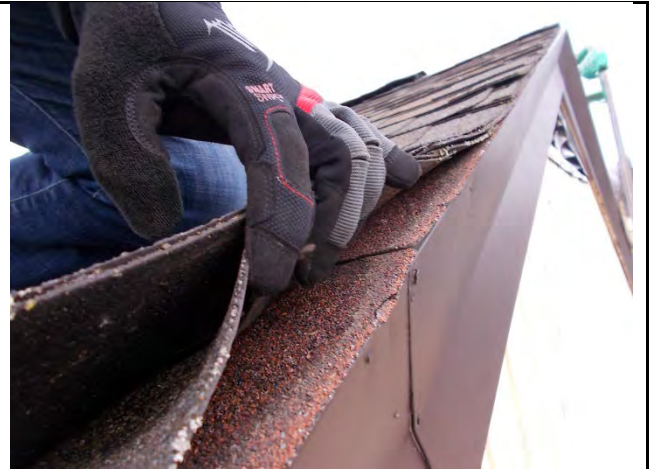
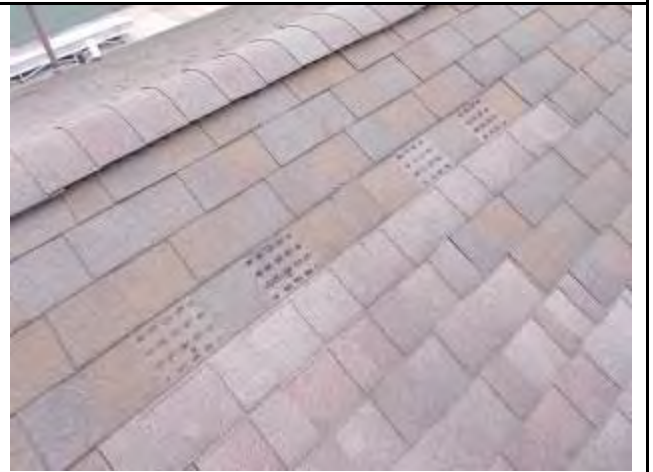
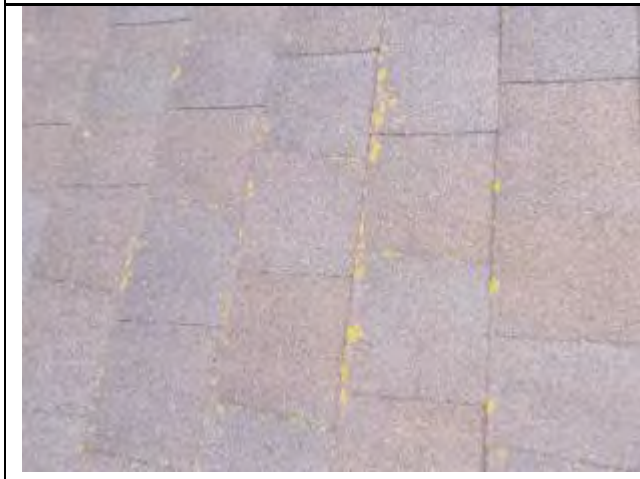
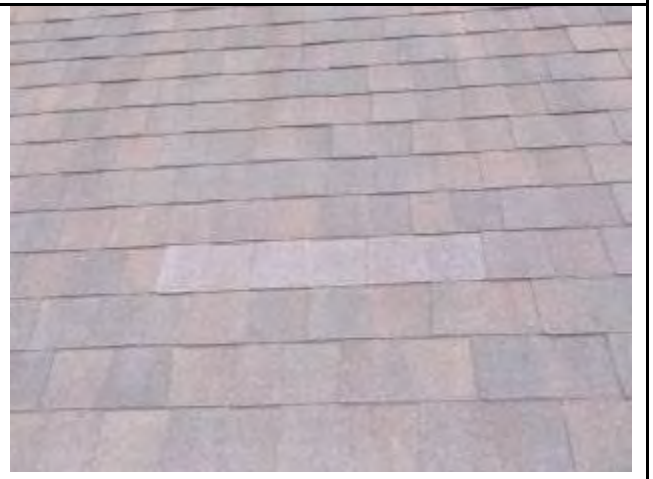
Roof Membrane

The shingles are nearing the end of their useful service life. We noted widespread haze cracking, granule loss, ridges, raised fasteners, and embrittlement of the shingles. The shingle was installed over the original shingles, so future roof replacement will require double tear-off.

The shingle roof system was installed over original 3-tab shingles. The shingles are very brittle and showing signs of nearing the end of their useful service life, based on the noted deficiencies. We believe the roof system will likely require replacement in the next 1-2 years.

Ownership should begin to plan and budget for replacement of the roof system in the next 1-2 years. In the meantime, complete emergency repairs on an as needed basis to address any leaks that arise.

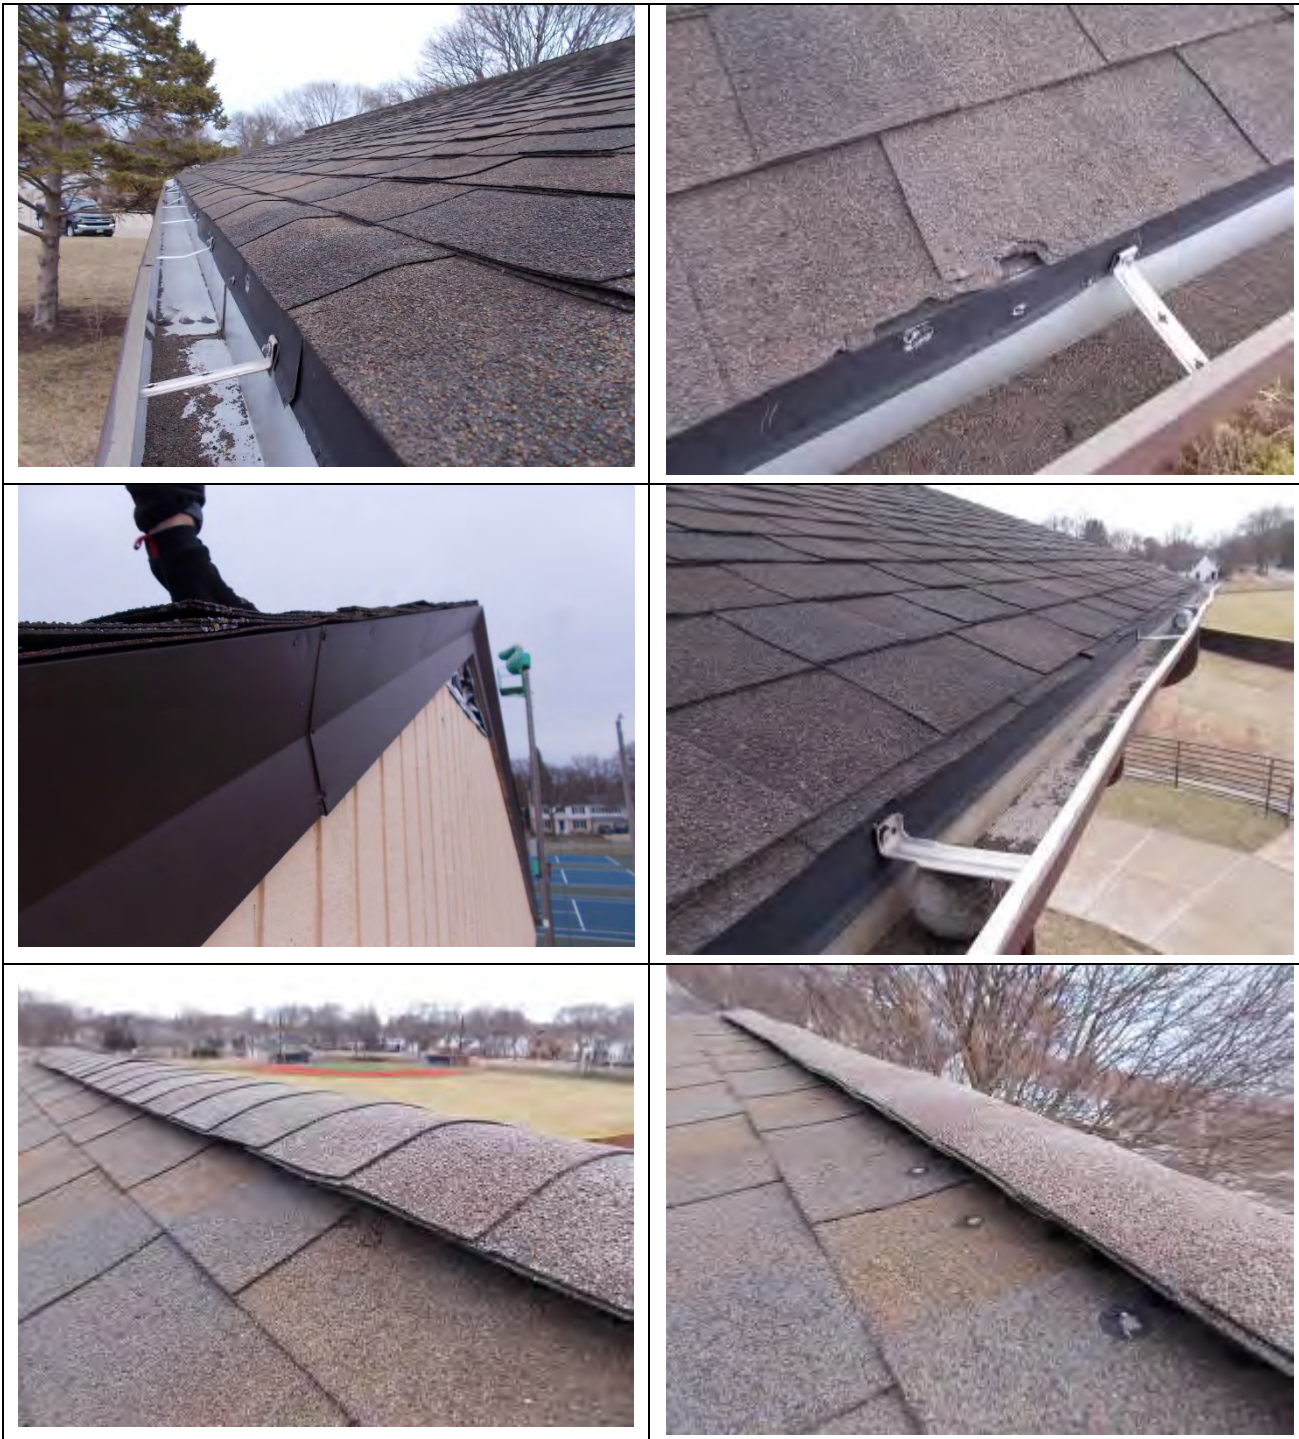
Roof Perimeters

The roof system is terminated at its perimeter via sheet metal drip edge and ridge shingles. We noted poor detailing, damaged shingles, and exposed fasteners.

Ownership should engage IRS to develop an Annual Maintenance & Repair Specification (AMRS) to address some of the preventative maintenance items (failed sealant, loose flashings, debris)

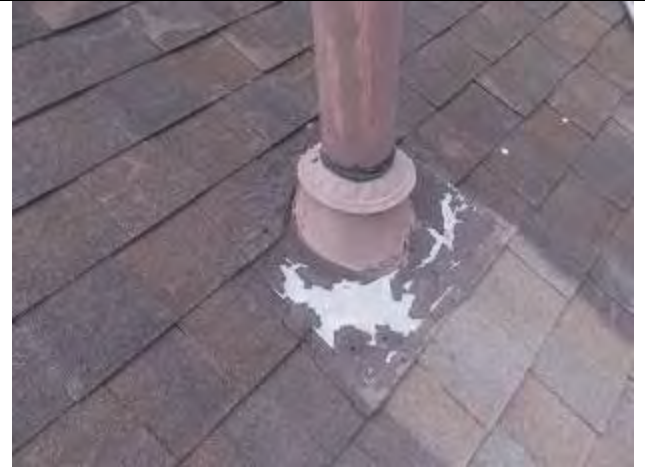
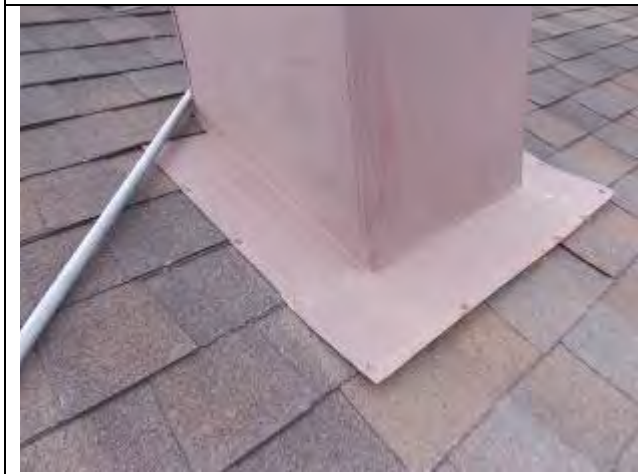
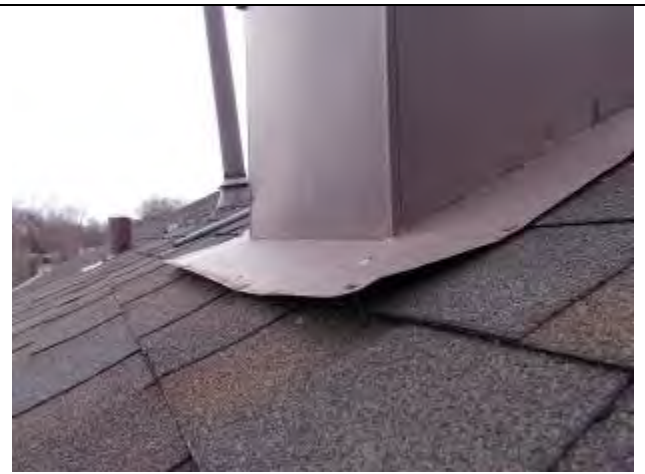
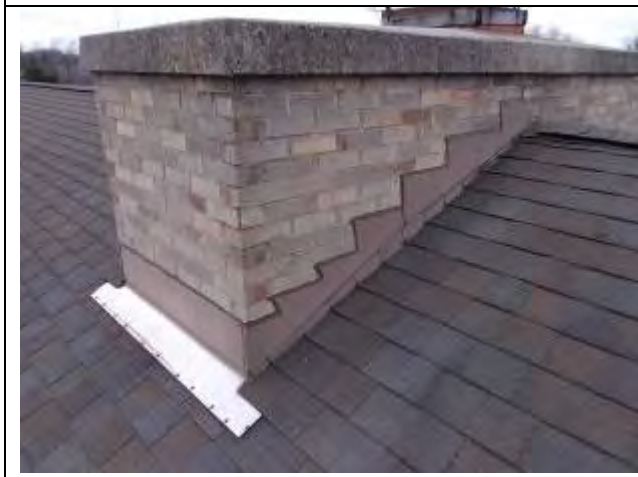
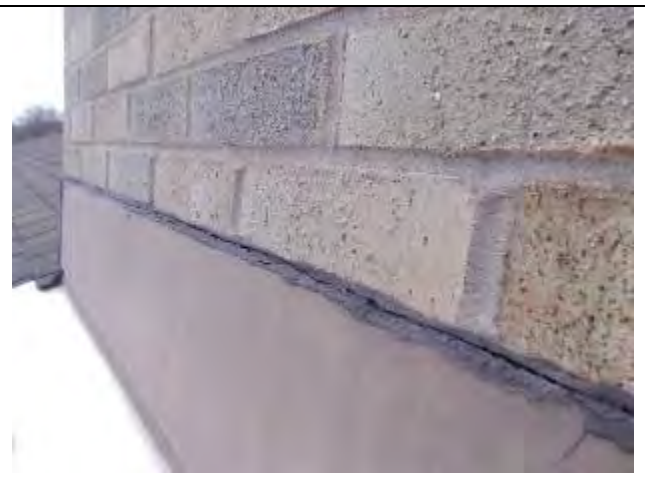
Roof Projections

The roof system is penetrated by hot stacks, soil stacks, and square curbs which are improperly flashed into the roof system and have received previous repairs. We also noted failed sealant at large masonry chimney.

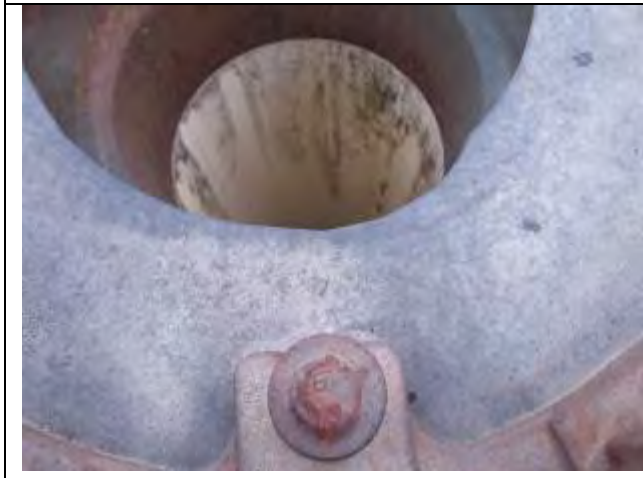
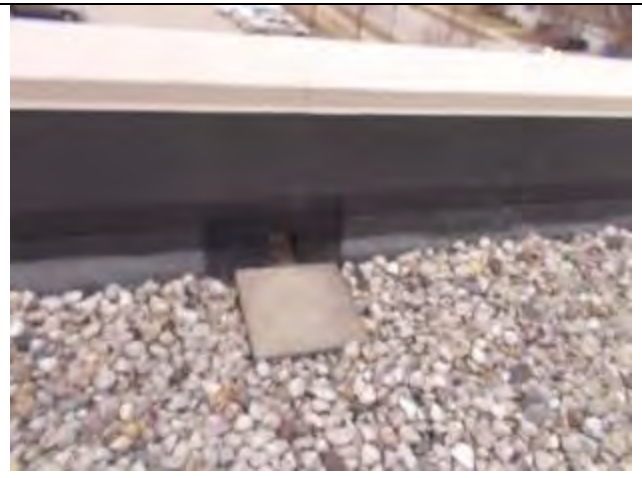
Roof Drainage

The roof system appears to be adequately drained via internal roof drains paired with overflow scuppers.

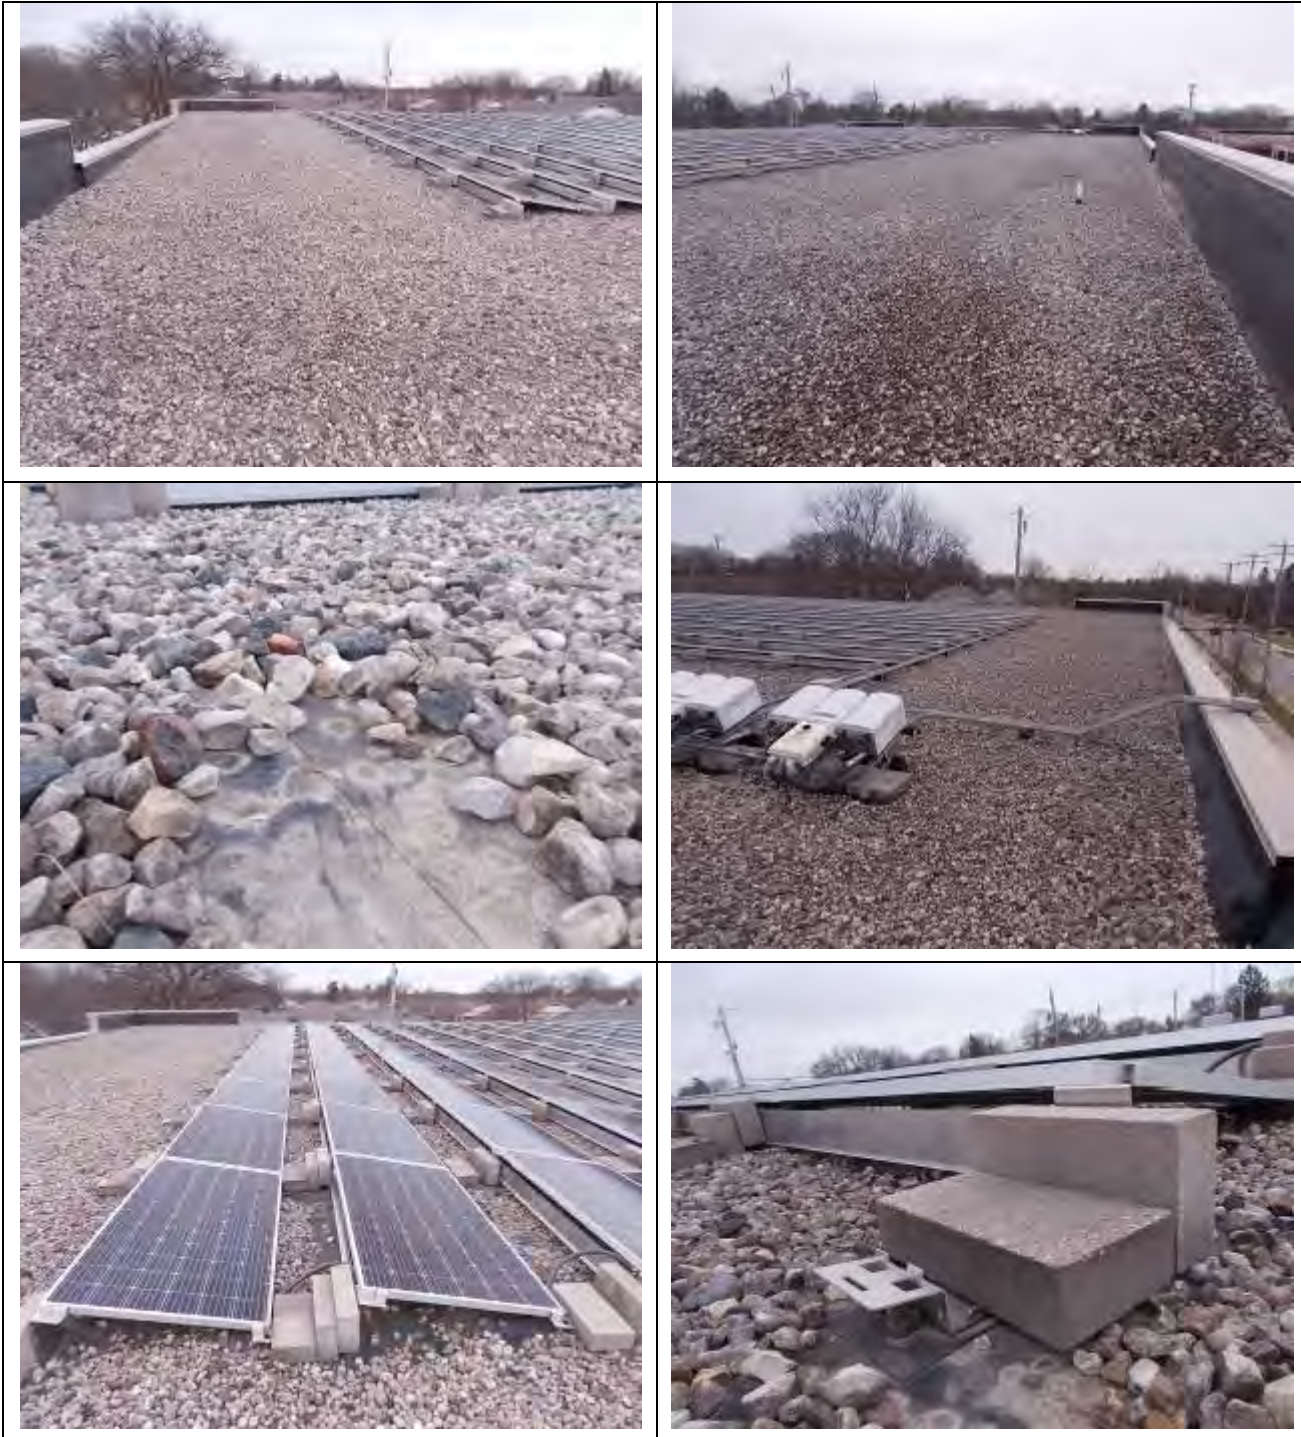
Roof Membrane

The EPDM single-ply membrane remains in serviceable condition. No notable deficiencies were found within the field of the roof membrane. A large portion of the membrane is covered by solar panels, which will make future roof replacement difficult.
