Village of Whitefish Bay Public Works Department

Re: Visual Roof Survey Report

VISUAL ROOF SURVEY

SIX (6) FACILITIES PER THE ATTACHED FACILITY LIST

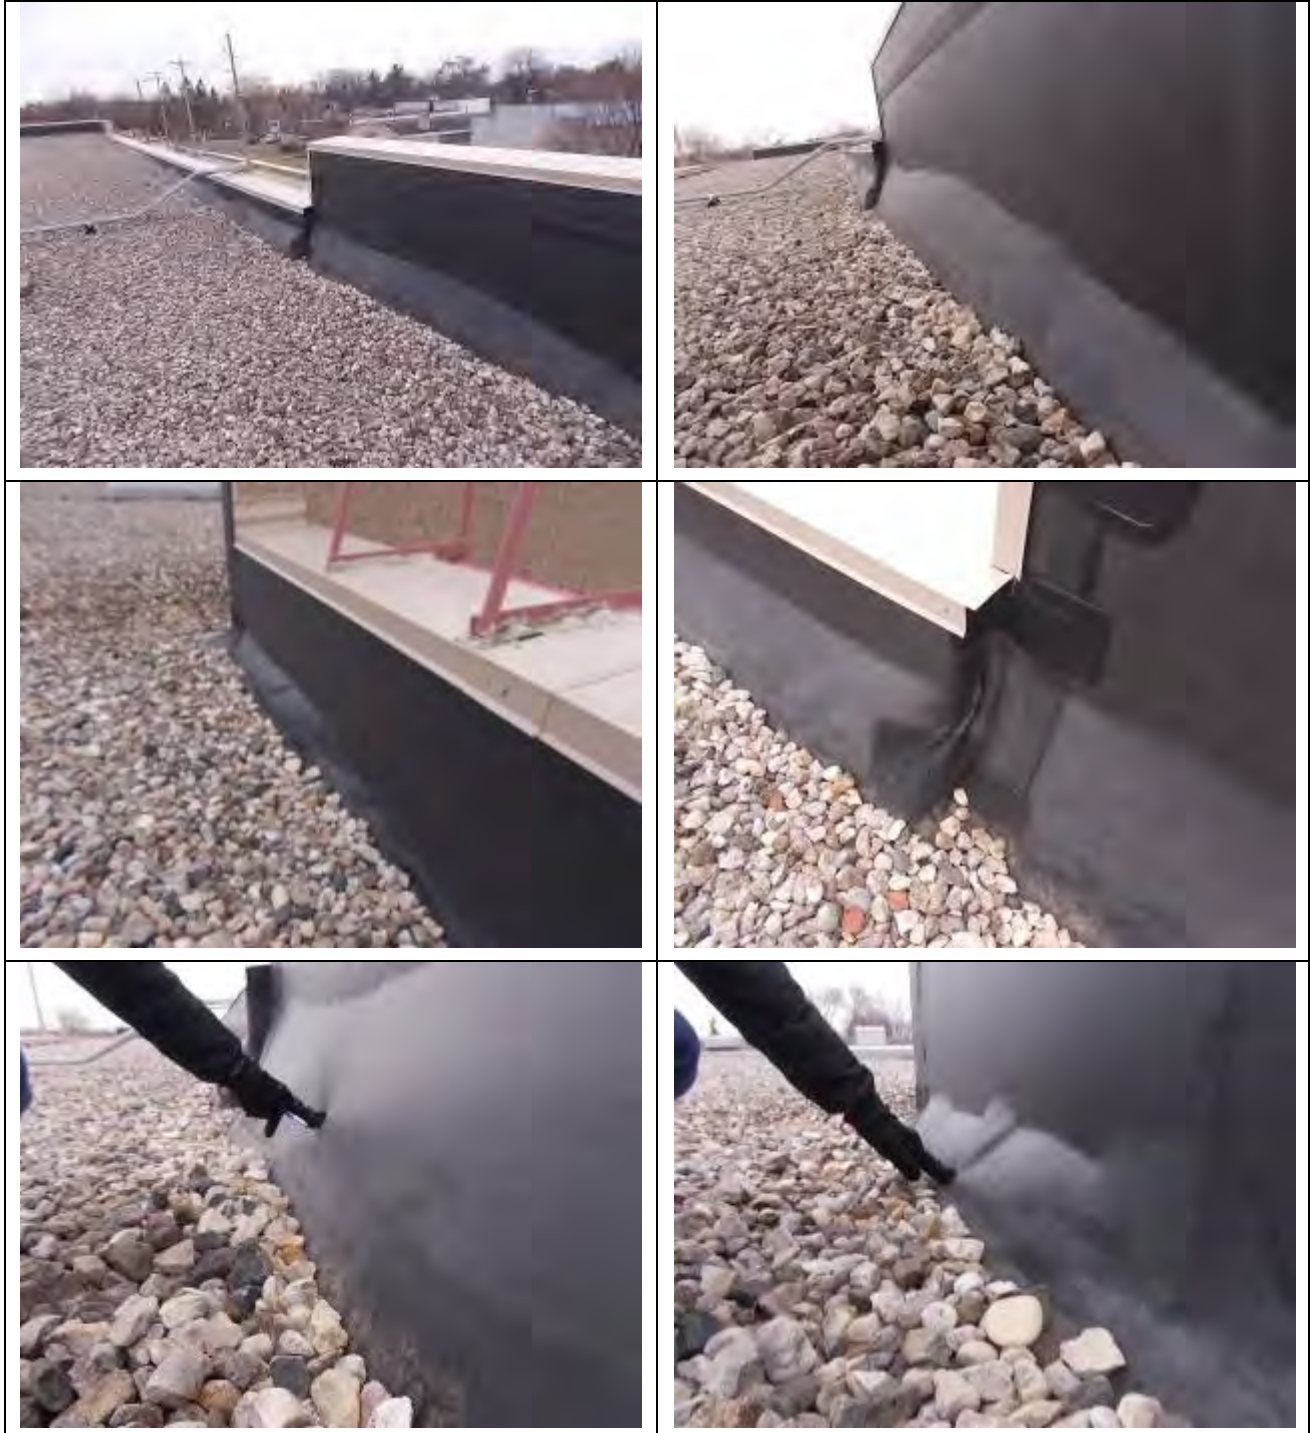
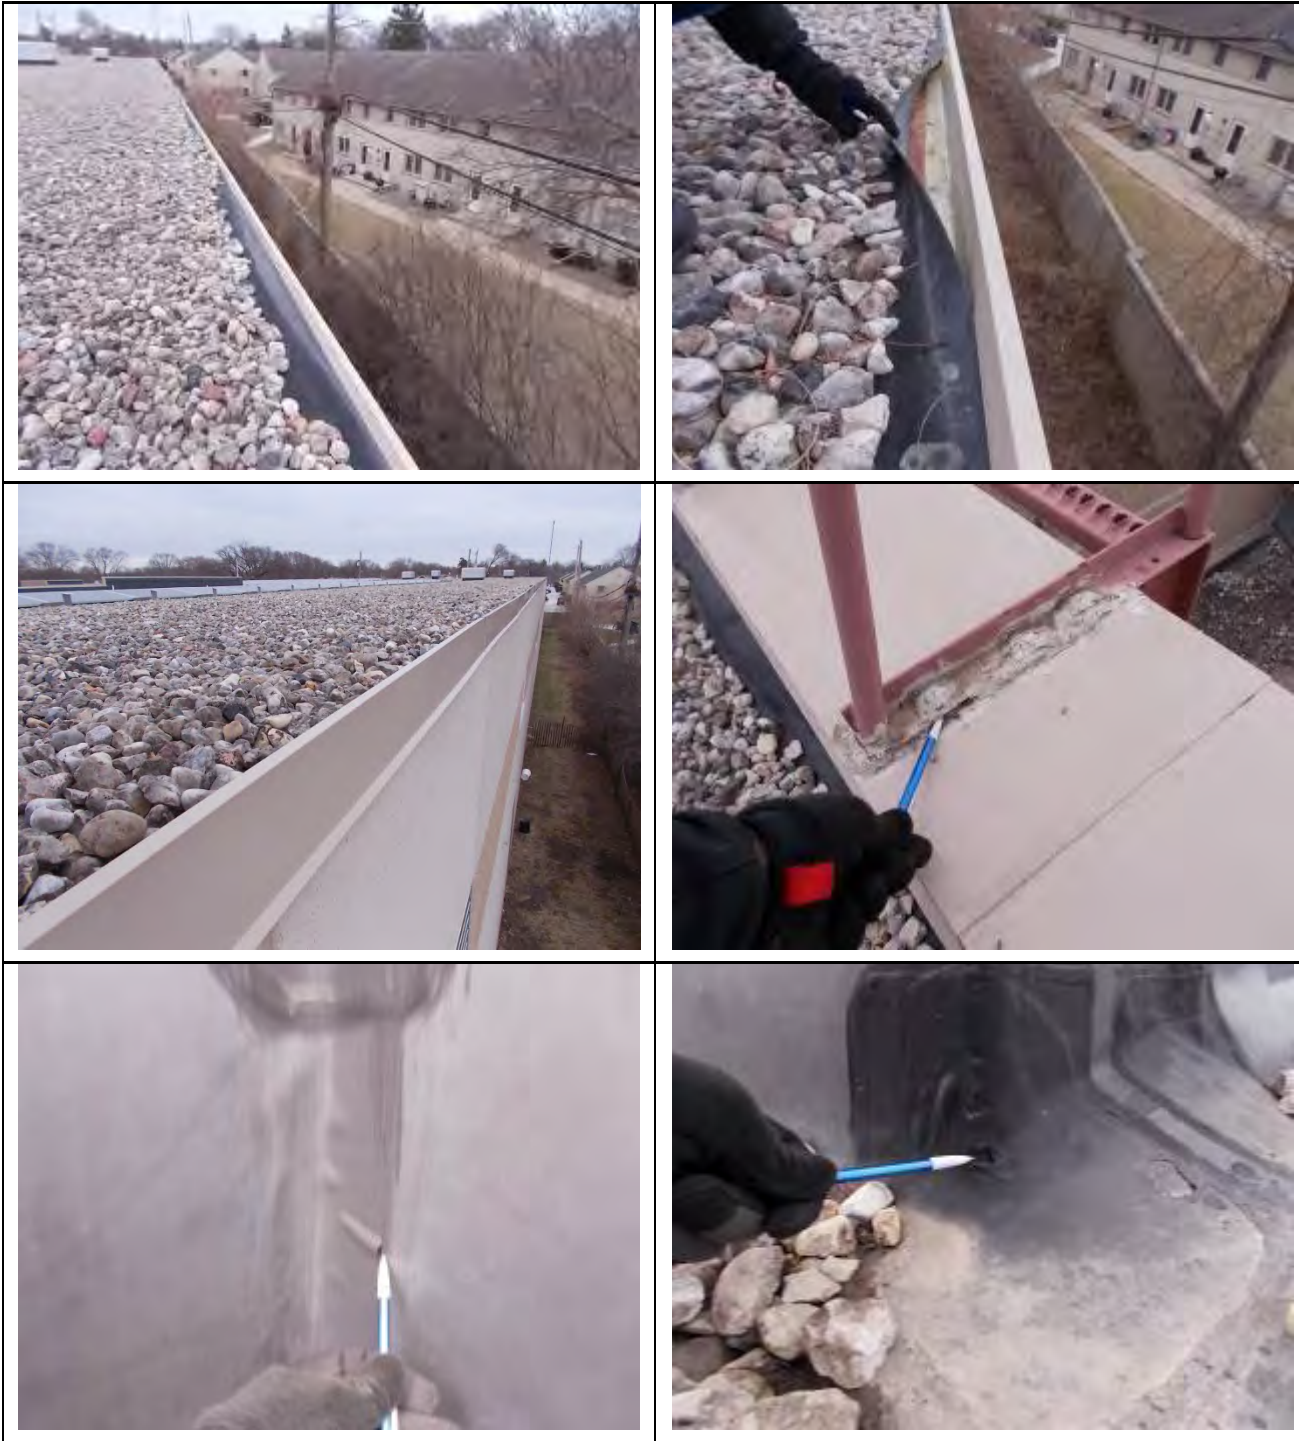
Roof Perimeters

The roof system terminates at its perimeters via cap flashing, copings, and counter flashing, which require remedial maintenance. At the parapet walls, it appears the perimeter base flashings are not properly adhered to the underlying securement strip (likely a workmanship error during installation). This is causing significant tenting of the base flashing as the membrane shrinks and pulls away from the wall. We also noted an area along the cap flashing where it appears the membrane was not installed to properly extend over the roof edge. This has caused it to become loose and pull away from the cap flashing, exposing the underlying substrate. We also noted other minor flashing and sealant deficiencies in several areas.

The EPDM single-ply roof system remains in serviceable condition, but does require significant remedial repairs along its perimeters to address the deficiencies described within this report. It is believed that the perimeter deficiencies are likely due to workmanship errors during installation; however, it is impossible to confirm this. Provided the roof system receives timely remedial maintenance, followed by continued proactive annual maintenance, we believe it should be capable of performing properly for an additional 6-9 years.

Ownership should engage IRS to develop an Annual Maintenance & Repair Specification (AMRS) to address the remedial maintenance items noted along the perimeters (replace tented base flashings).

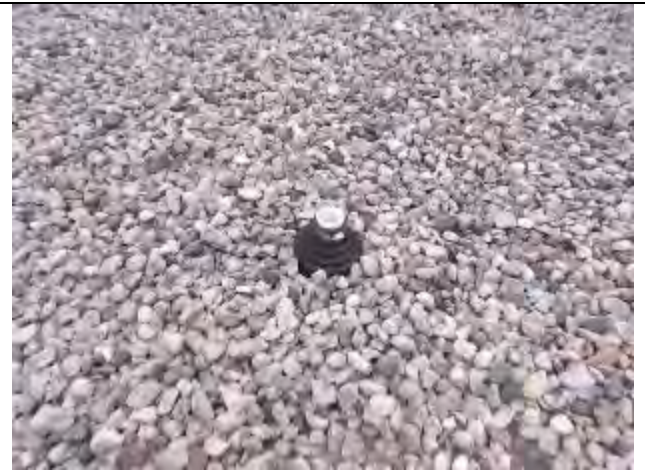
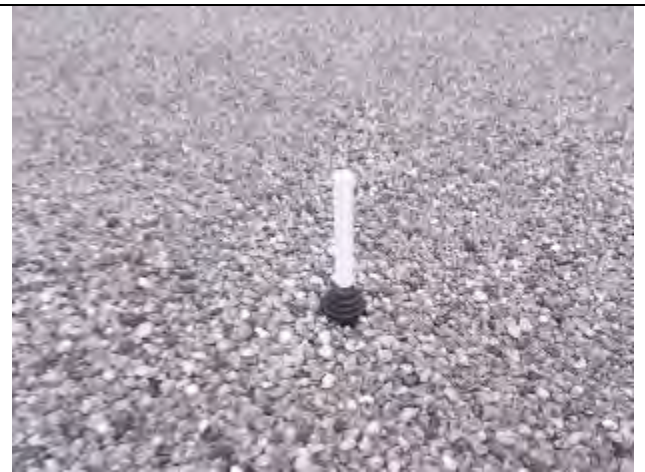
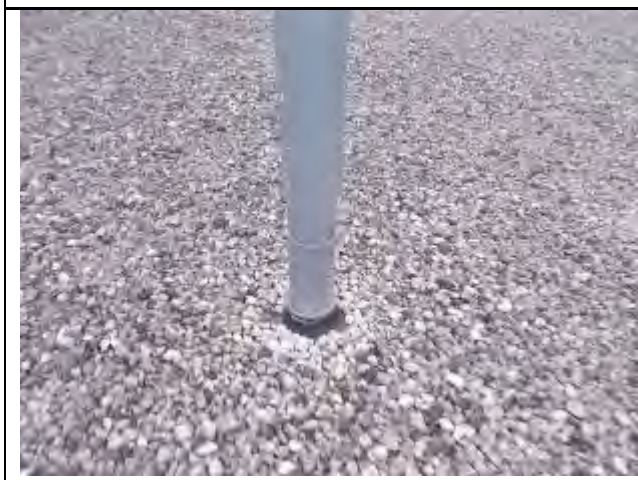
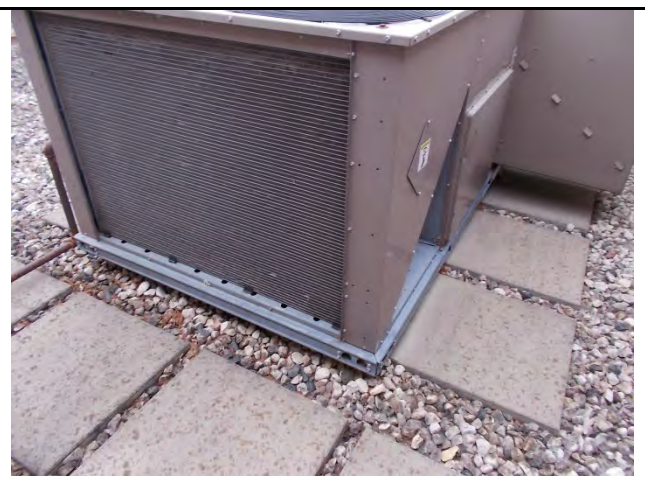
Roof Projections

The roof system is penetrated by hot stacks, pitch pockets, roof curbs, small pipes, soil stacks, and HVAC units. The flashings associated with each of these projections remain in serviceable condition, though we did note minor tenting at the curbs.

Ownership should engage IRS to develop an Annual Maintenance & Repair Specification (AMRS) to address the minor preventative maintenance items (holes, open flashing seams, failed sealant).

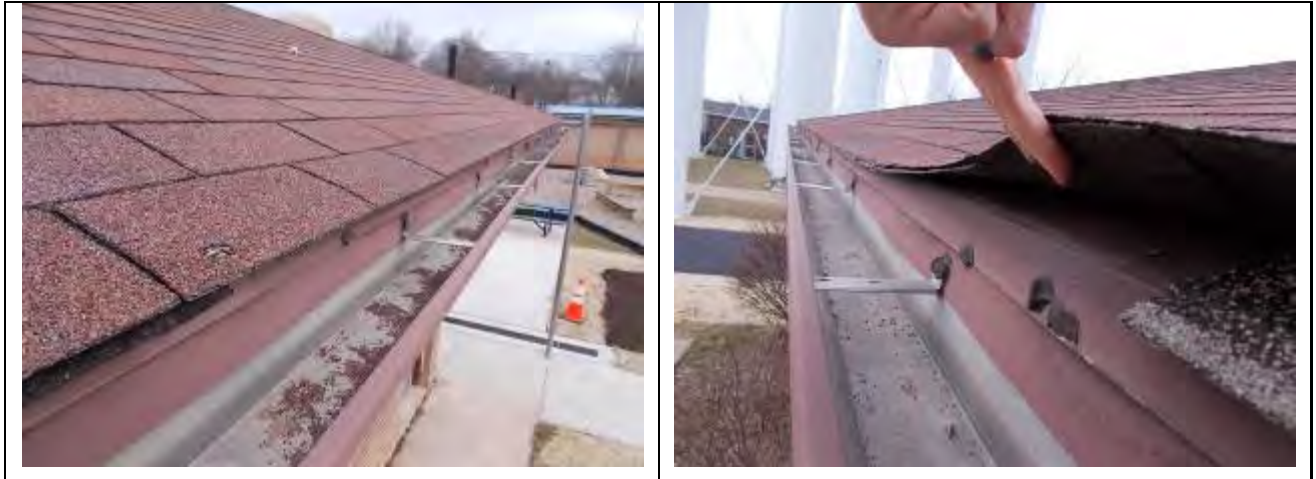
Roof Drainage

The roof system appears to be adequately drained via sheet metal gutters.

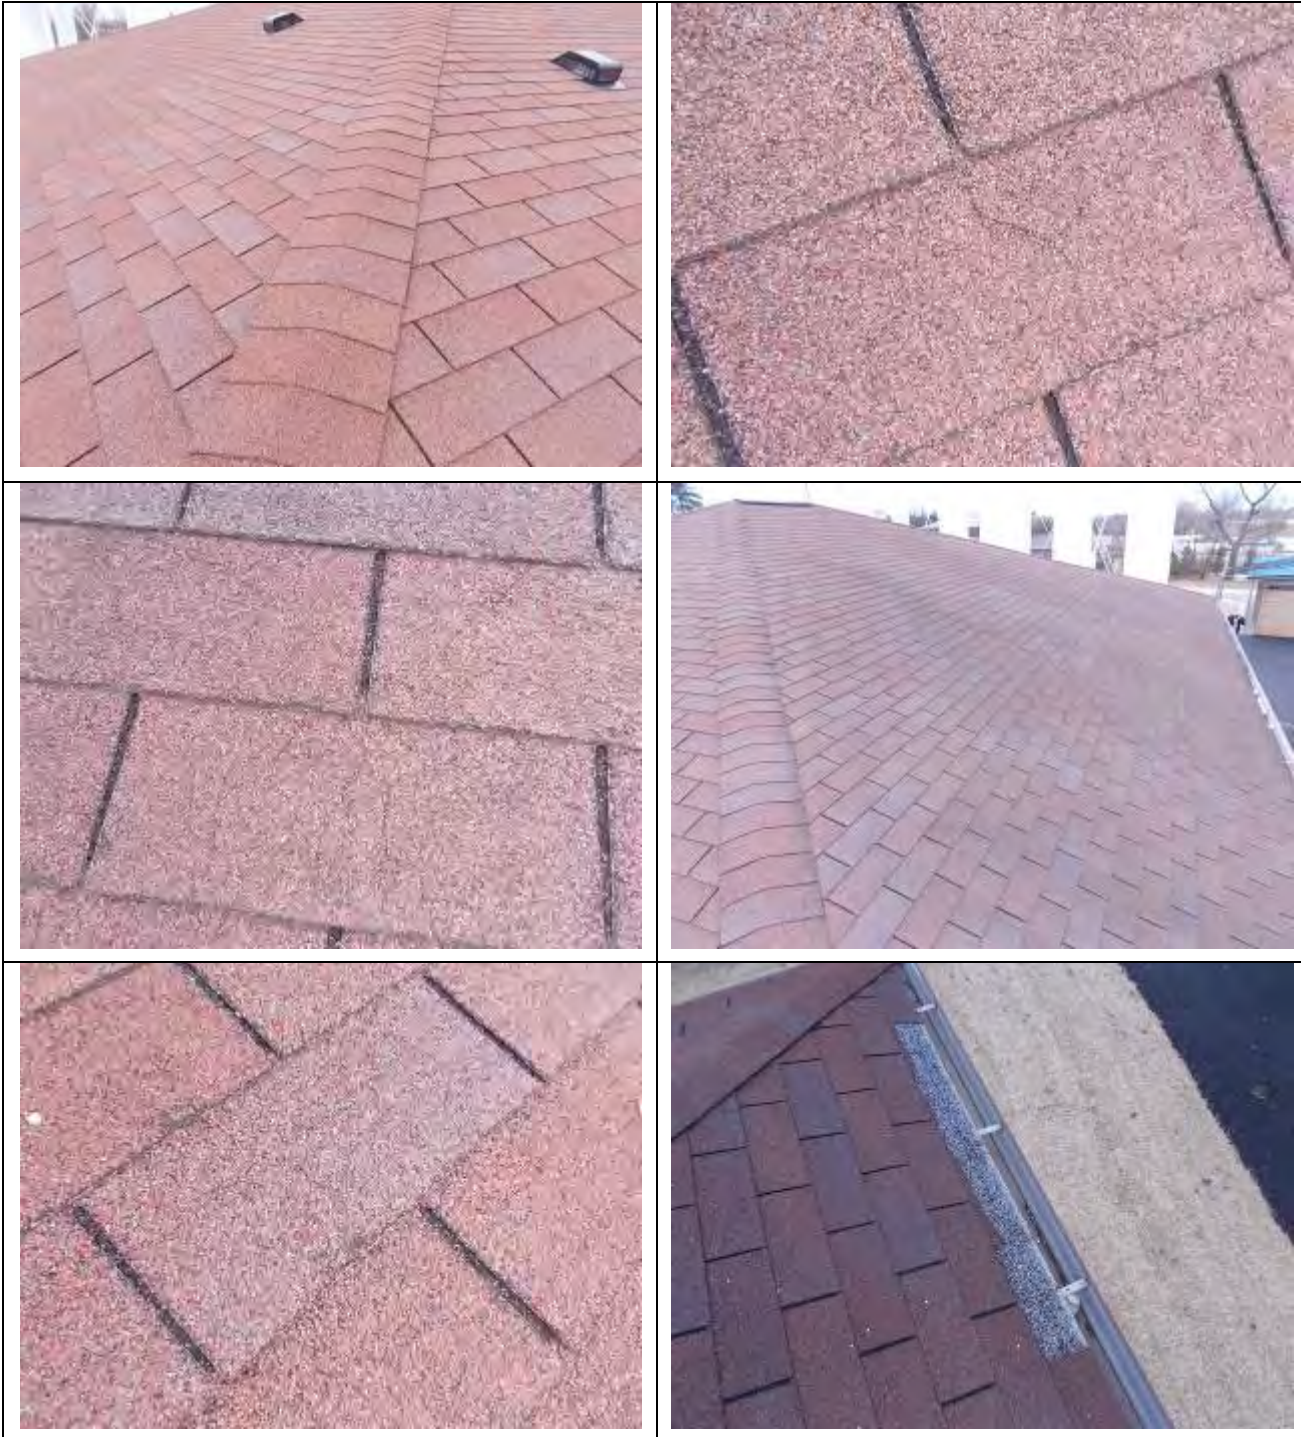
Roof Membrane

The shingles remain in serviceable condition; but are showing signs of aging. We noted granule loss, missing tabs, minor haze cracking, and embrittlement of the shingles.

The shingles are very brittle and showing signs of nearing the end of their useful service life, based on the noted deficiencies. We believe the roof system will likely require replacement in the next 3-5 years.

Ownership should begin to plan and budget for replacement of the roof system in the next 3-5 years. In the meantime, complete emergency repairs on an as needed basis to address any leaks that arise.

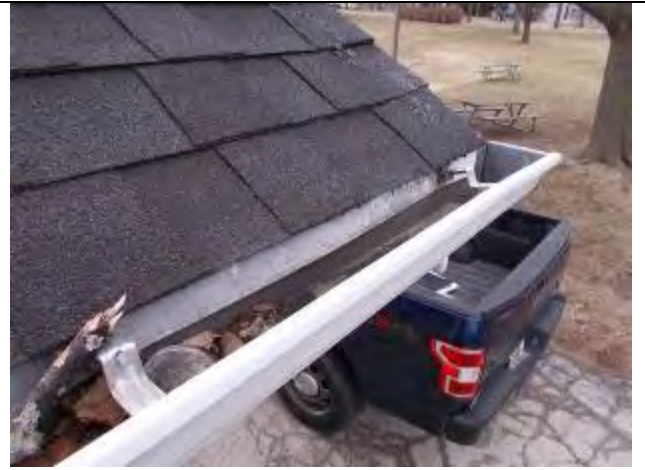
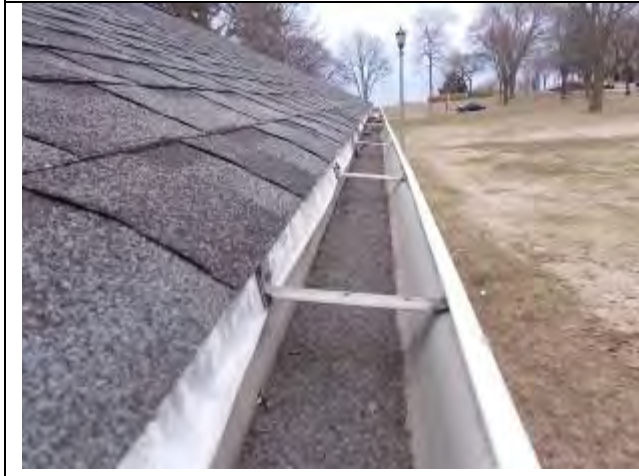
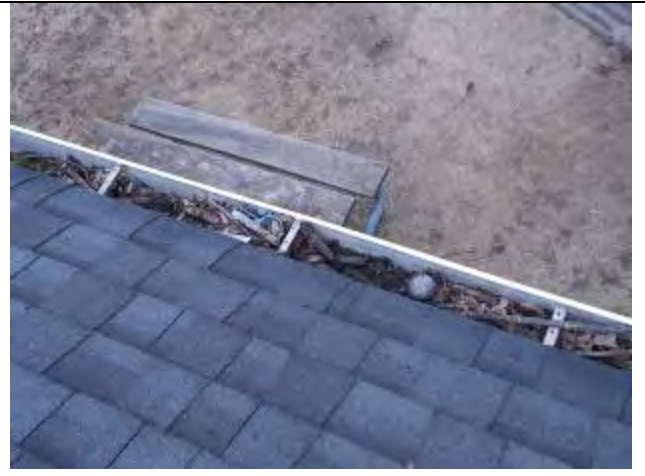
Roof Drainage

The roof system appears to be adequately drained via sheet metal gutters; however, we noted debris in the gutters.

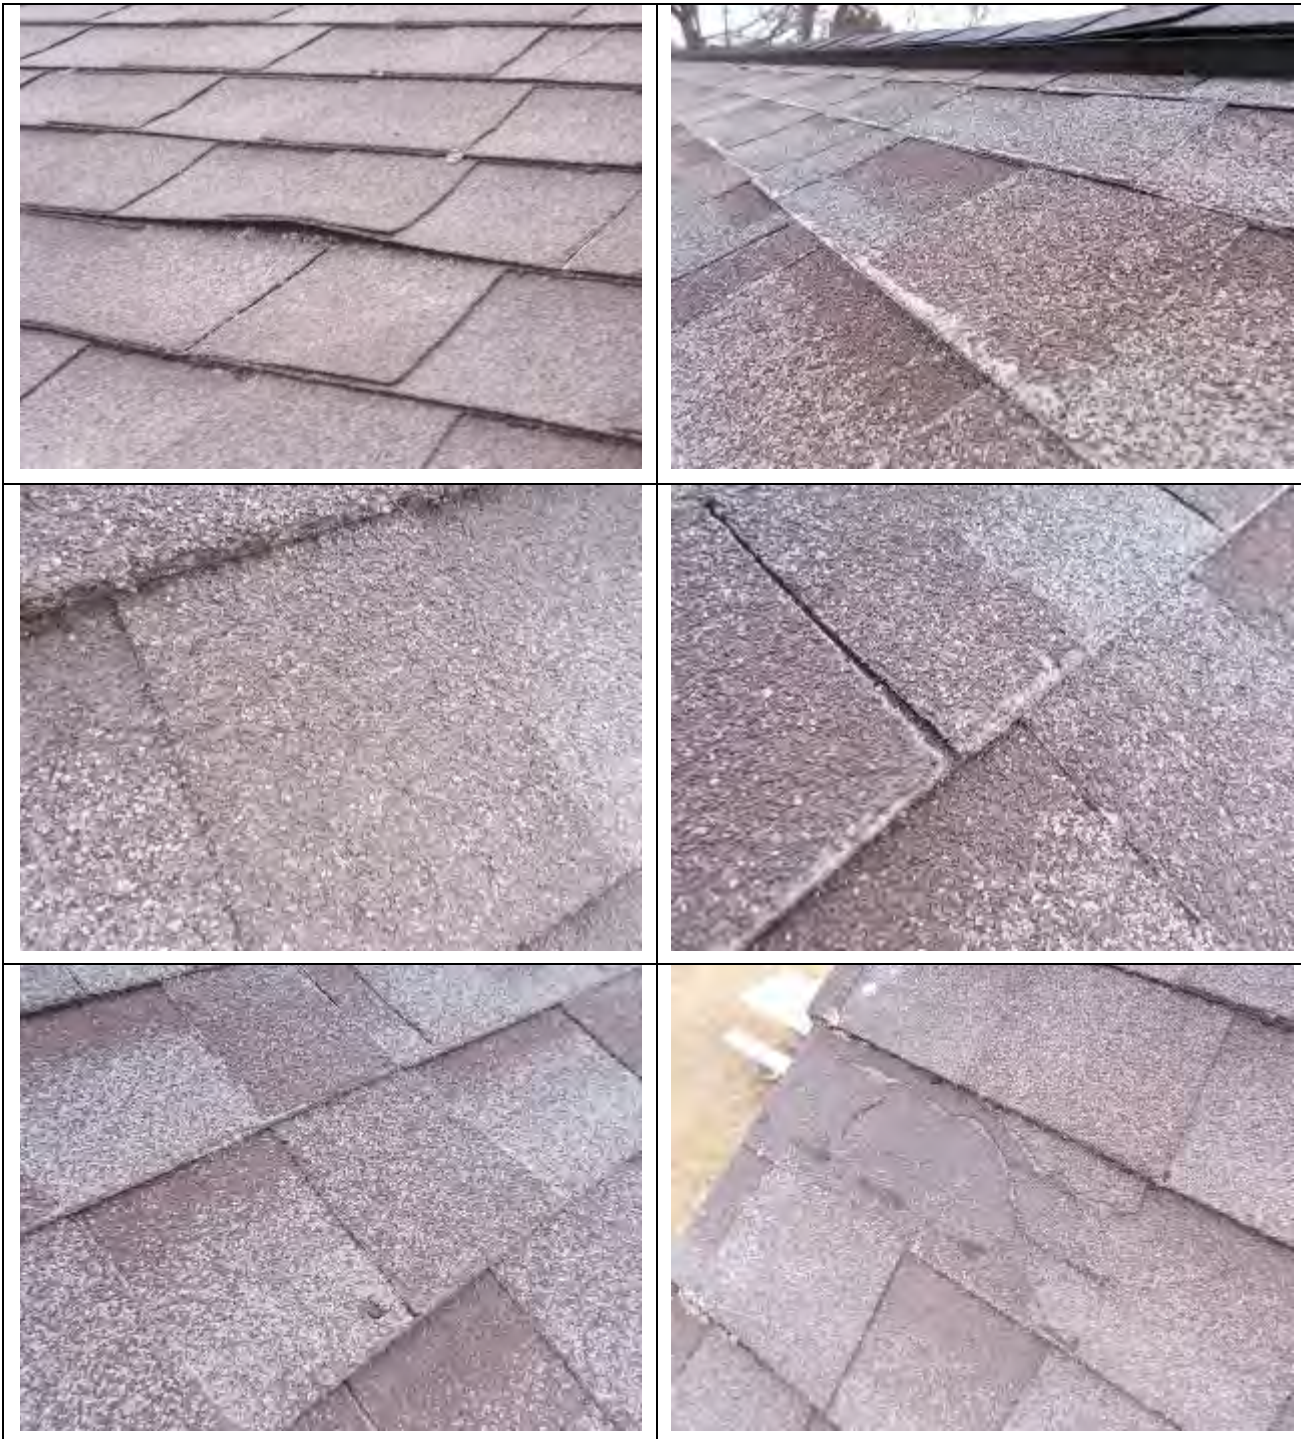
Roof Membrane

The shingles remain in serviceable condition; but are showing signs of aging. We noted granule loss, missing tabs, raised fasteners, minor haze cracking, and embrittlement of the shingles.

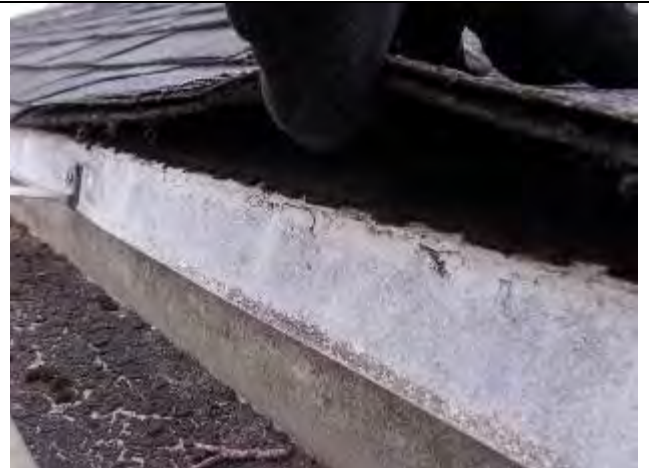
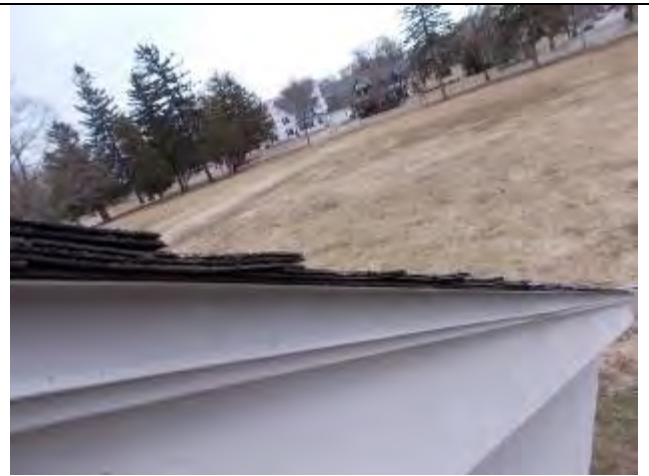
Roof Perimeters

The roof system is terminated at its perimeters via sheet metal drip edge and gutters, which are filled with debris.

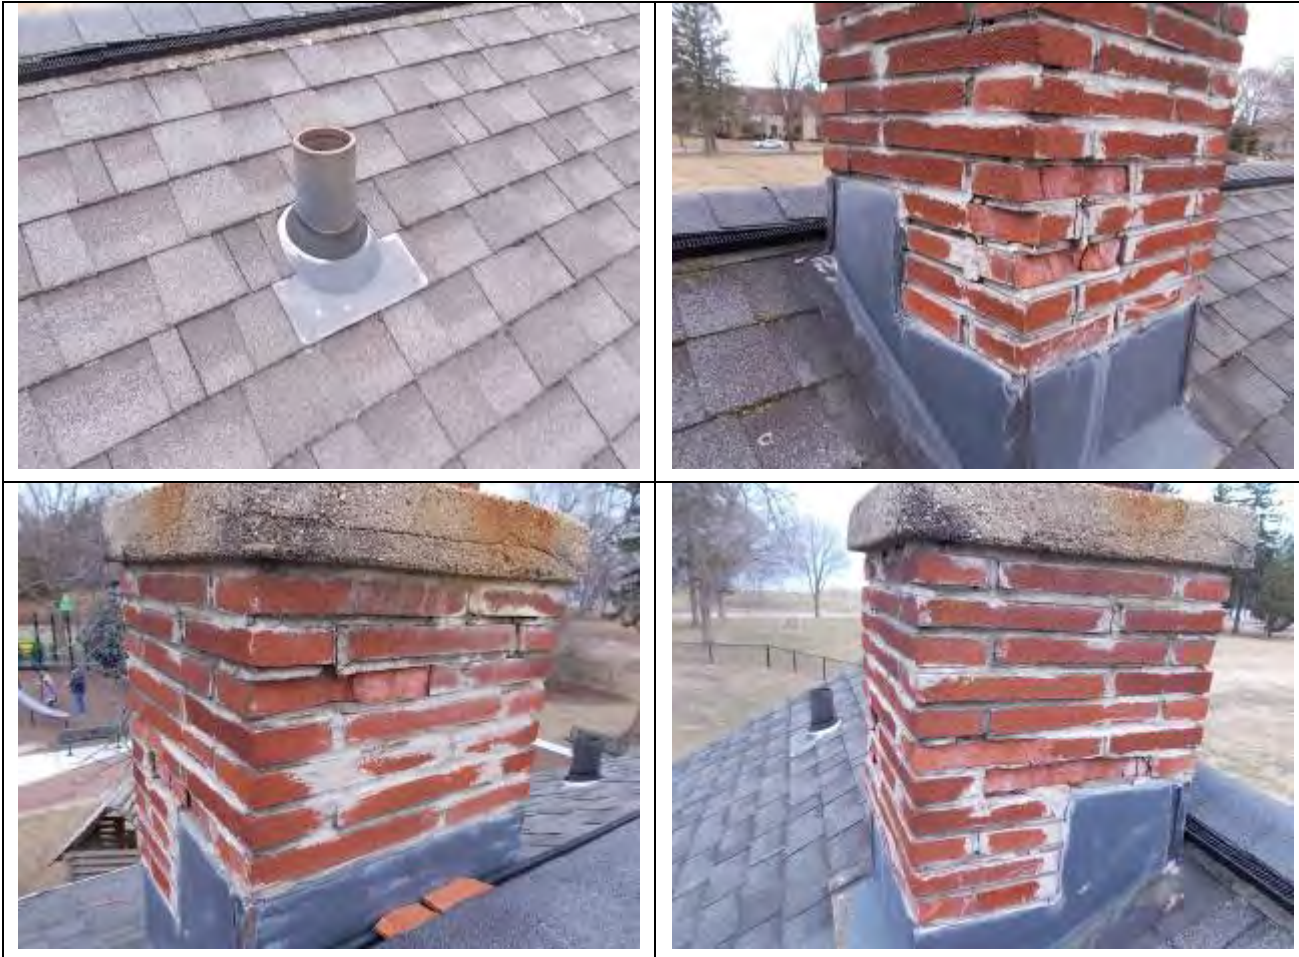
Roof Projections

The roof system is penetrated by a soil stack and a masonry chimney. The chimney is deteriorated and should be repaired by a masonry contractor.
