Village of Whitefish Bay Public Works Department

Re: Visual Roof Survey Report

VISUAL ROOF SURVEY

SIX (6) FACILITIES PER THE ATTACHED FACILITY LIST

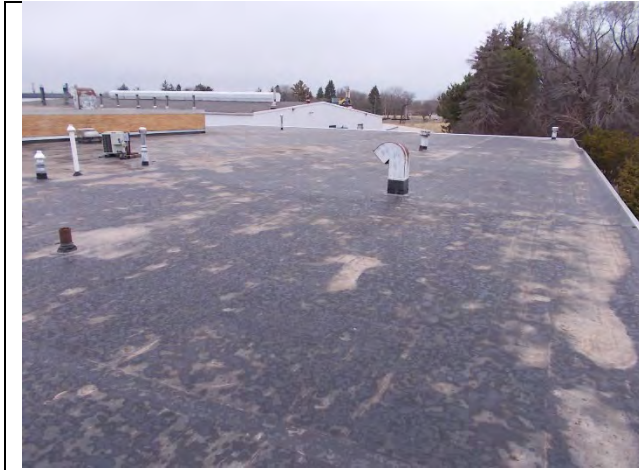
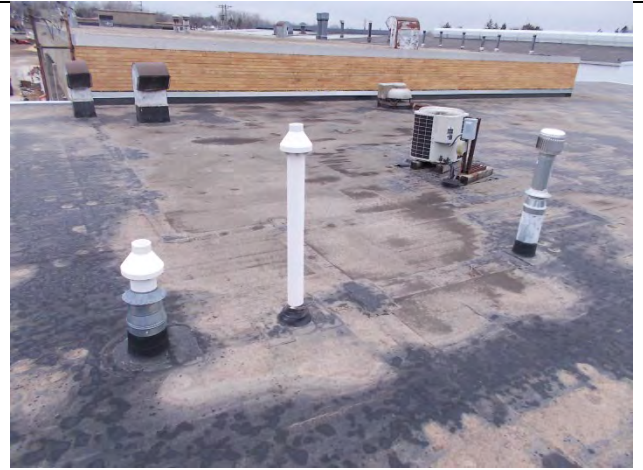
The roof system appears to be drained moderately well via a single roof drain. We noted evidence of ponding water around the drain, which is likely worsened by debris clogging the drain strainer.

The EPDM single-ply roof system on Roof Area 1 remains in serviceable condition. It appears to be adequately drained and does not require any repairs at this time (besides debris removal from around the roof drain). Provided the roof system receives continued proactive annual maintenance, we believe it should be capable of performing properly for an additional 6-9 years, or more.

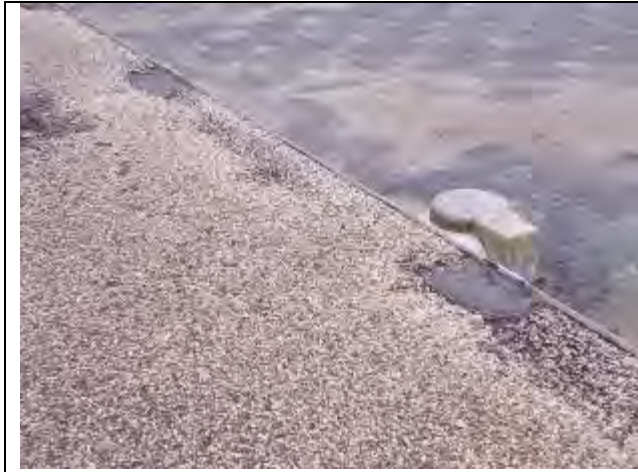
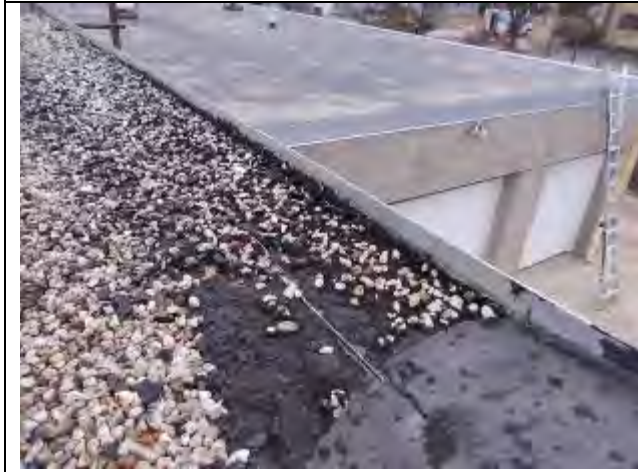
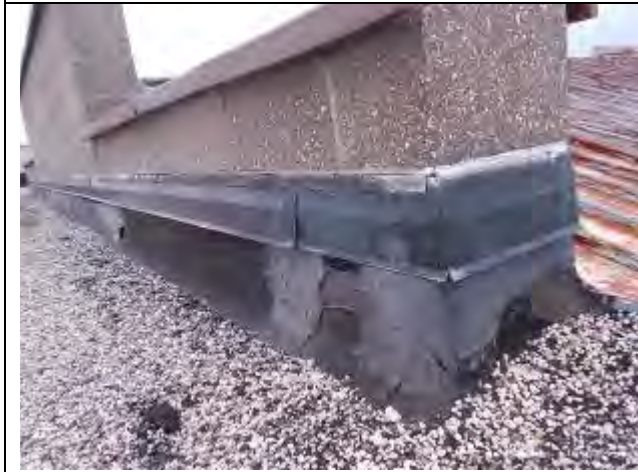
The roof system terminates at its perimeters via counter flashing and metal edge which are in poor condition and require replacement. The flashings associated with these perimeters require replacement.

Ownership should begin to plan and budget for replacement of Roof Area 2 as soon as budget allows. In the meantime, complete only emergency repairs on an as needed basis to address any leaks that arise.

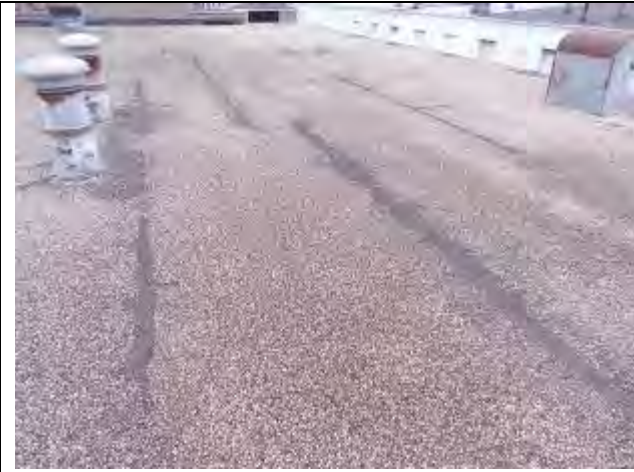
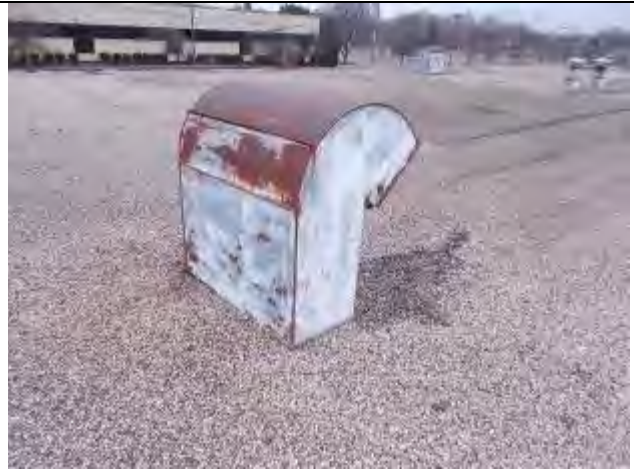
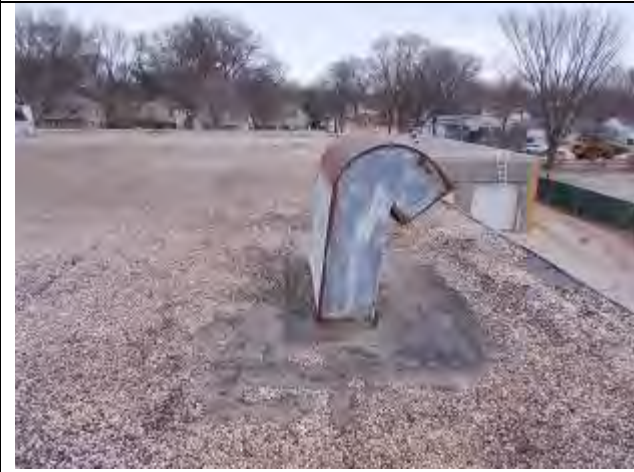
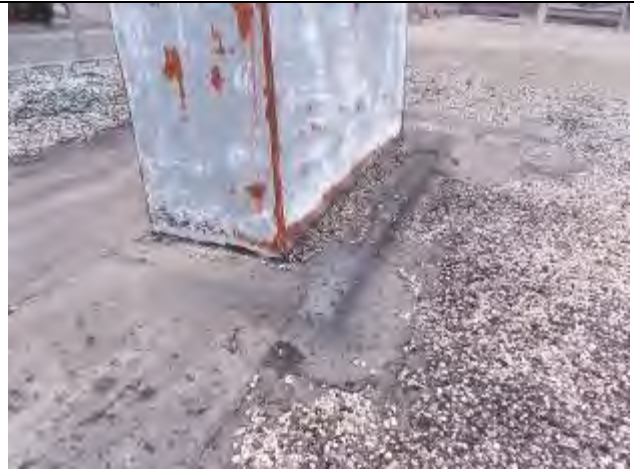
The roof system is penetrated by pipe vents and ducts. The flashings associated with each of these projections require replacement.

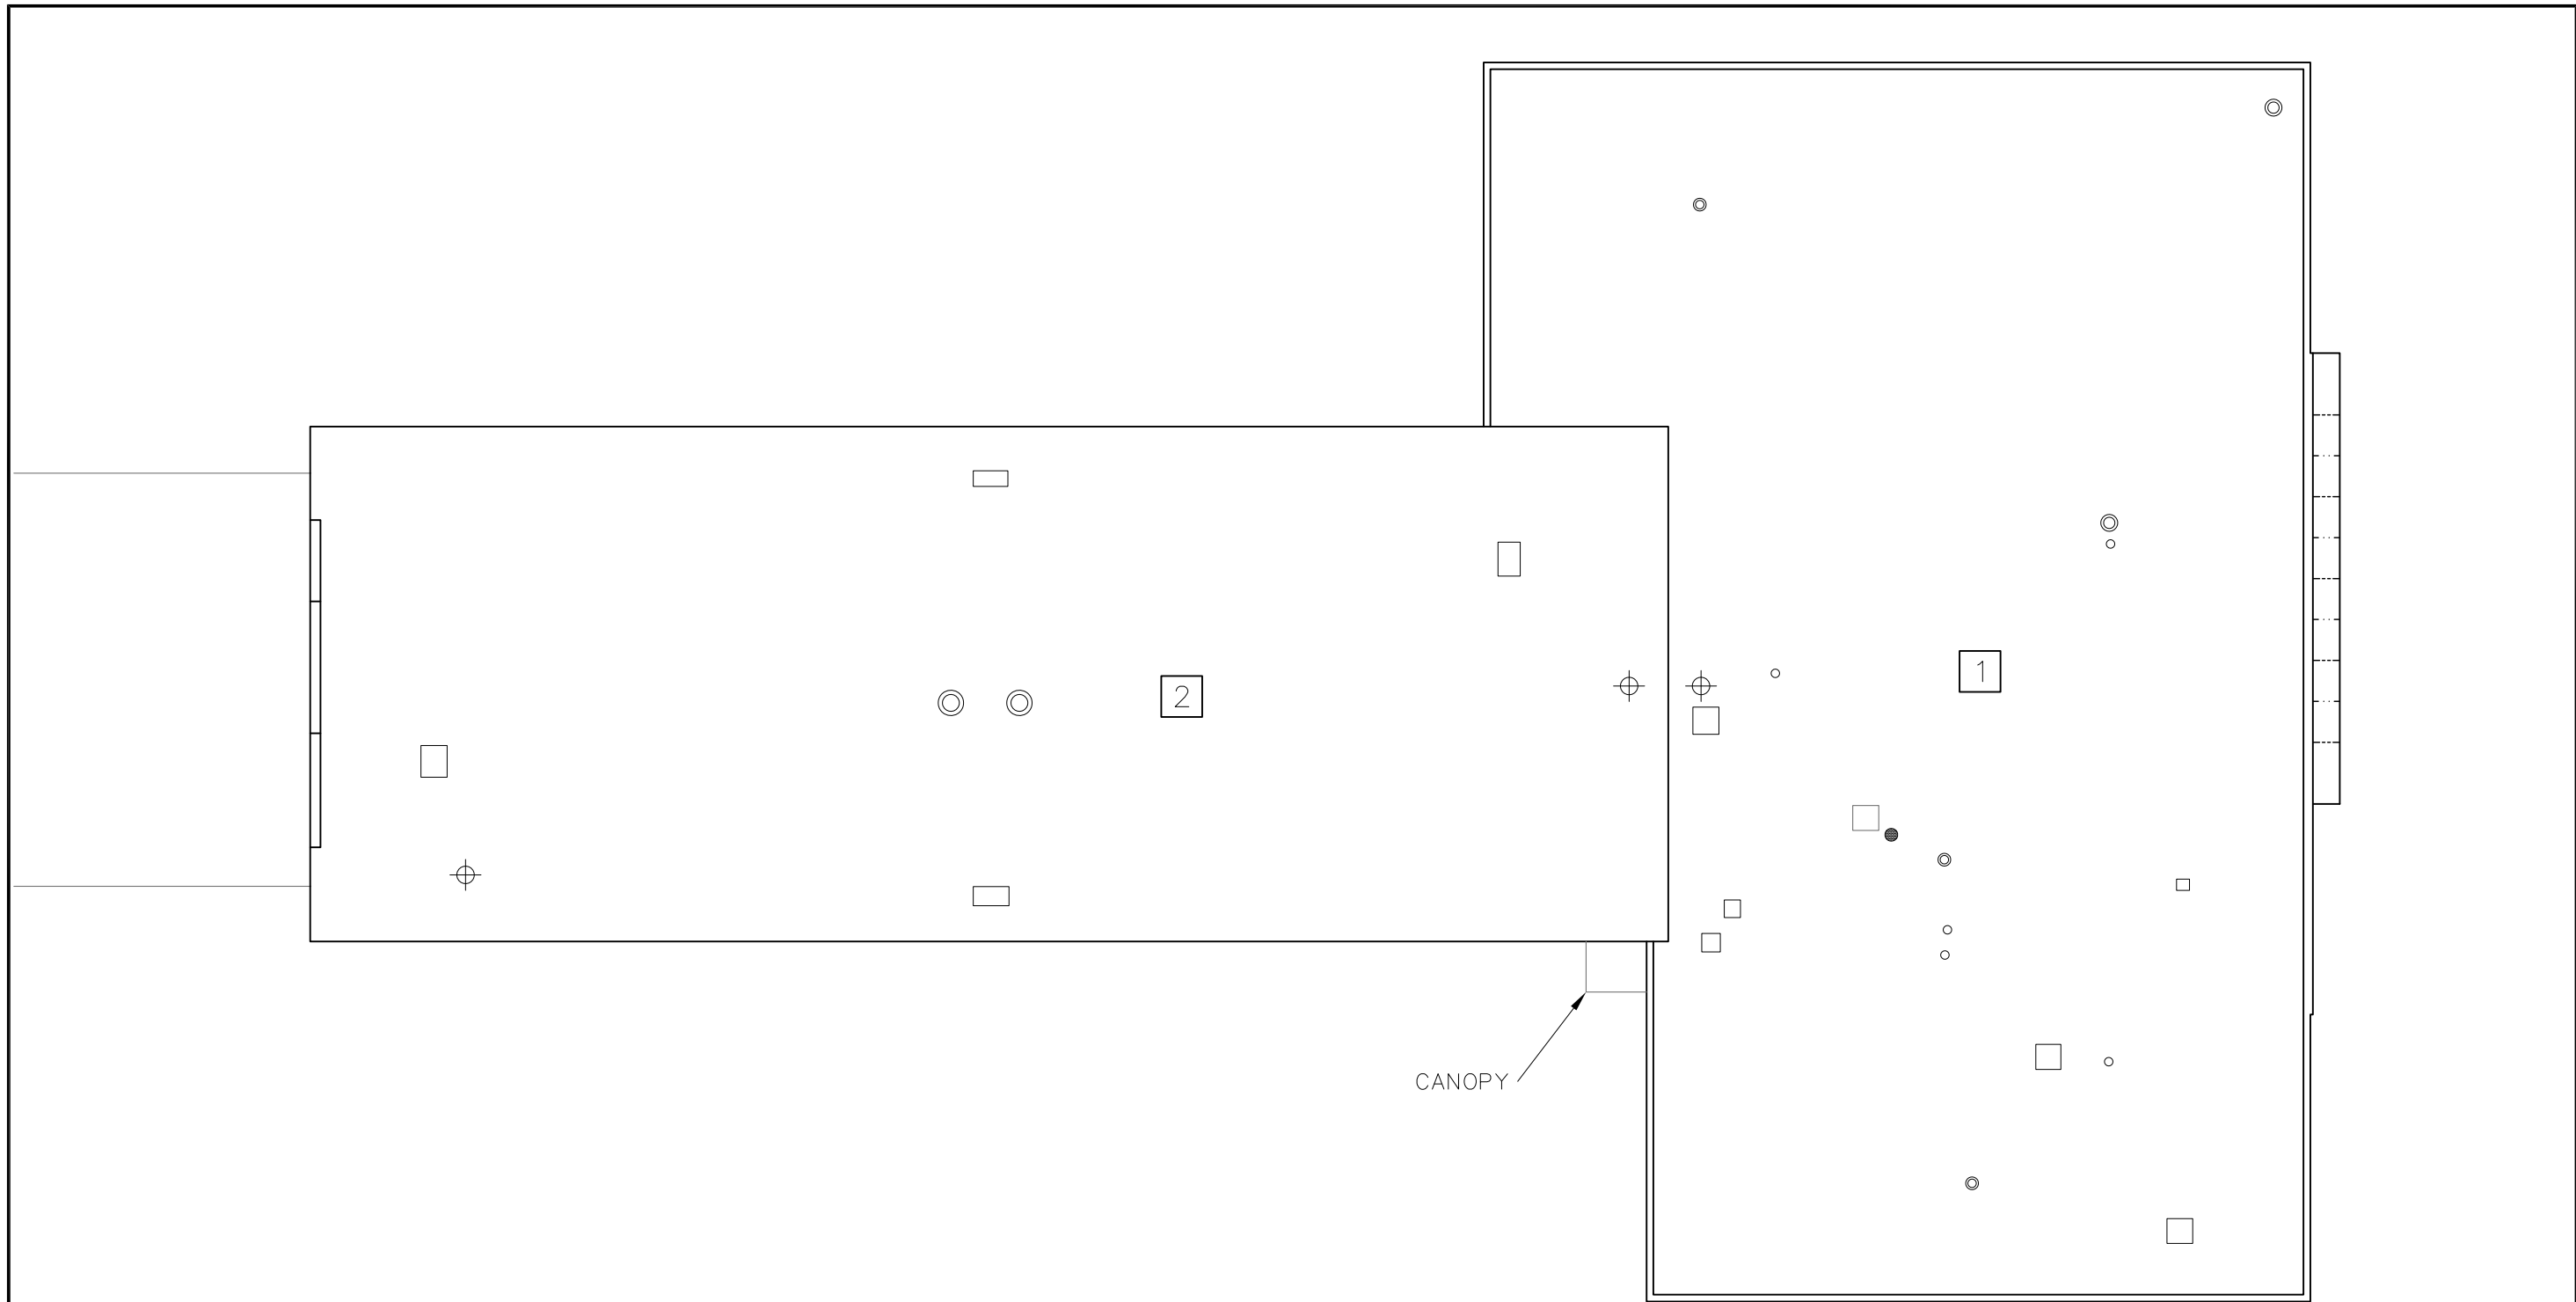
ROOF PLAN

During our survey, we noted deficiencies within adjacent masonry walls and a deteriorated/abandoned canopy. Ownership should consider removing the unused canopy and completing repairs to the masonry wall to prevent leakage into the adjacent roof system.

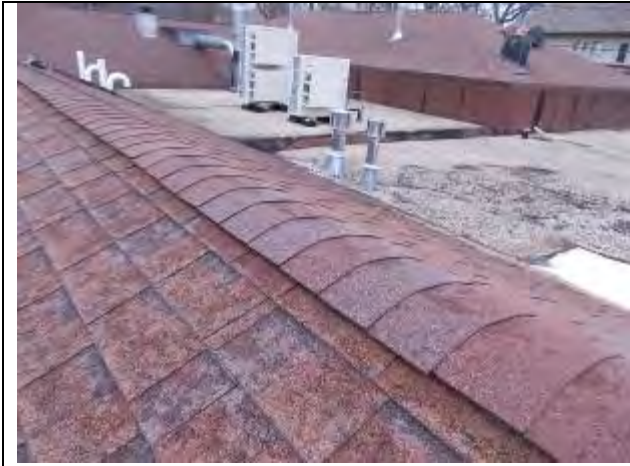
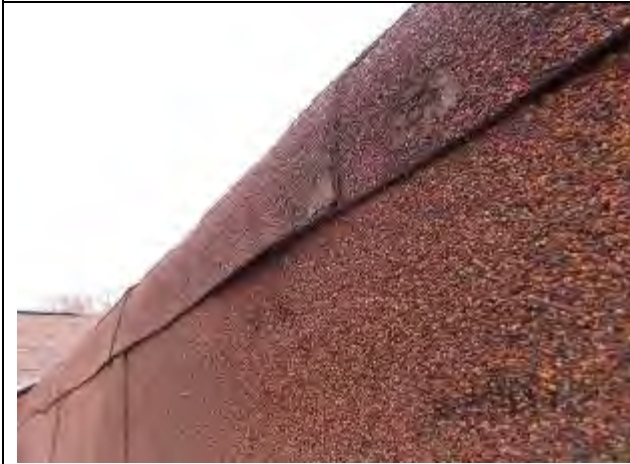
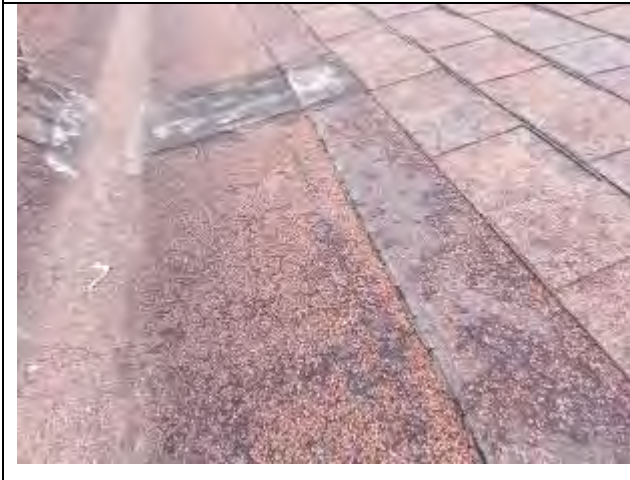
The roof system is improperly terminated where it transitions to Roof Area 2 (lacking sheet metal drip edge). There is also a low-slope saddle at a parapet wall that is deteriorated.

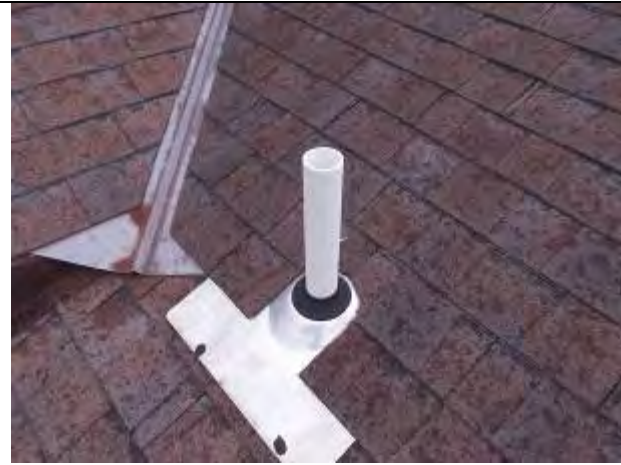
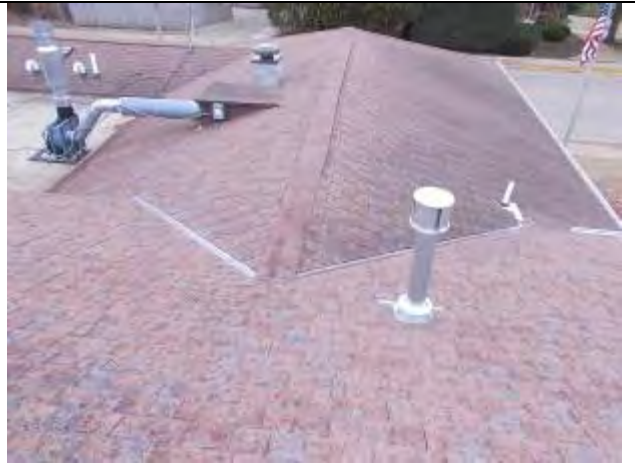
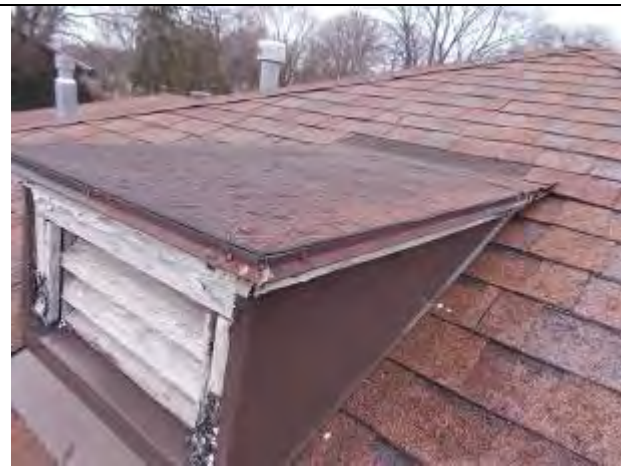
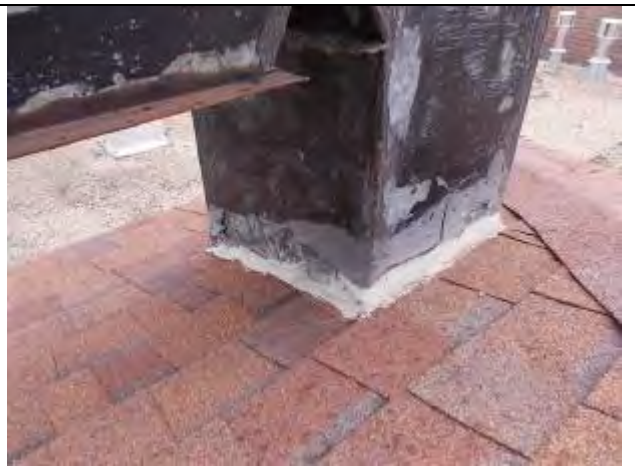
The roof system is penetrated by hot stacks, soil stacks, ducts, attic vents, and square curbs which are improperly flashed into the roof system and have received previous repairs.

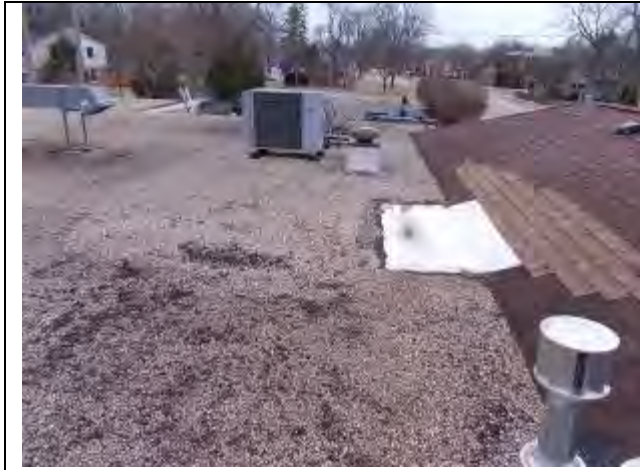
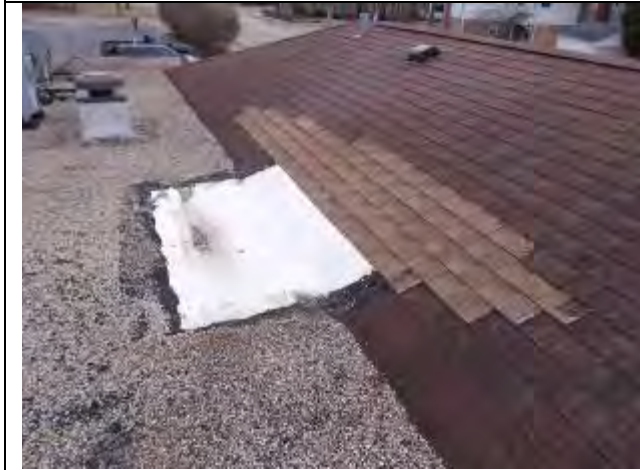
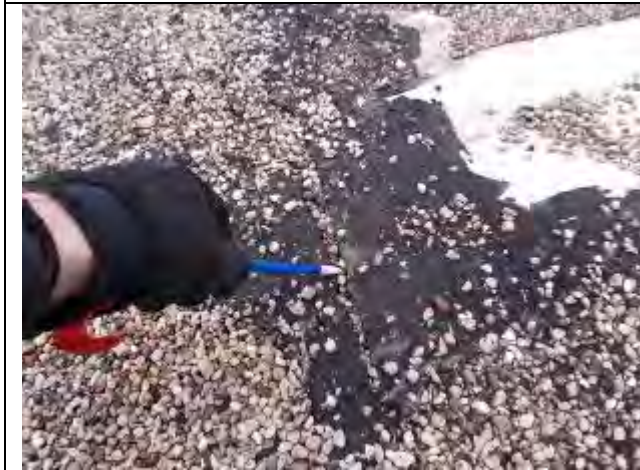
The built-up roof membrane is beginning to near the end of its useful service life. We noted previous repairs, splitting, eroded surfacing, and general deterioration.

The asphalt BUR system on Roof Area 2 is also beginning to near the end of its useful service life, based on the observed deficiencies. It should be scheduled for replacement in conjunction with Roof Area 1.

Ownership should begin to plan and budget for replacement of all Roof Areas in the next 3-5 years. In the meantime, complete only emergency repairs on an as needed basis to address any leaks that arise.

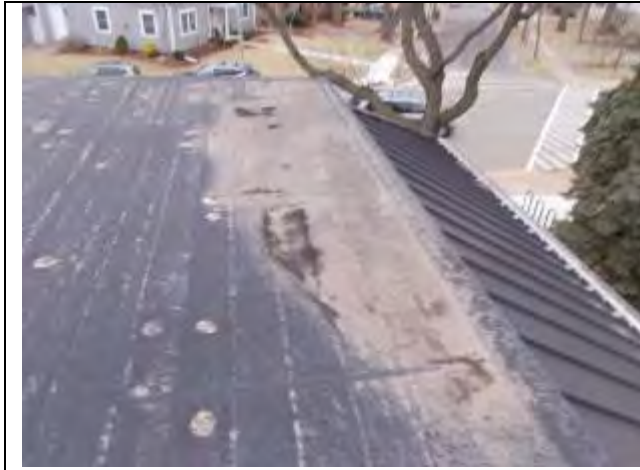
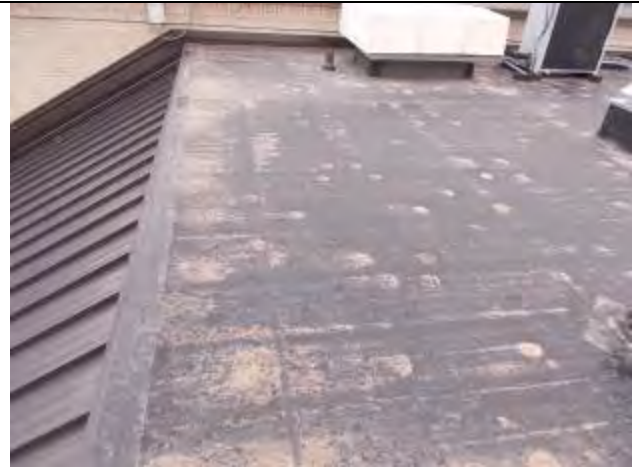
The roof system appears to be adequately drained via eave run-off onto the adjacent metal roofs, with some isolated areas of ponding water noted.

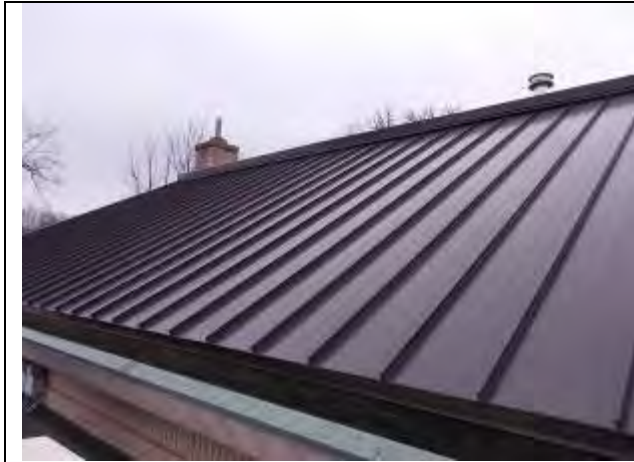
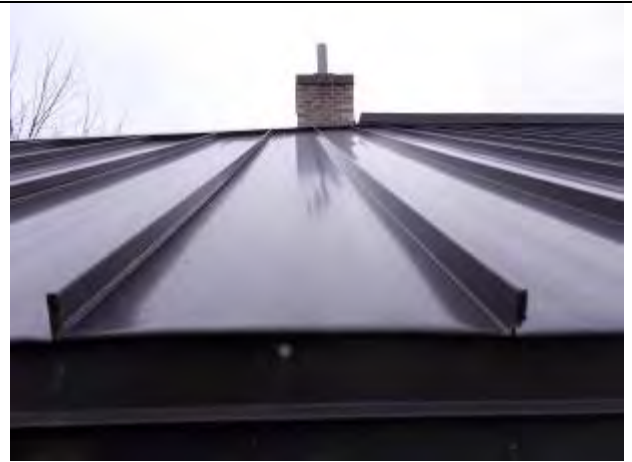
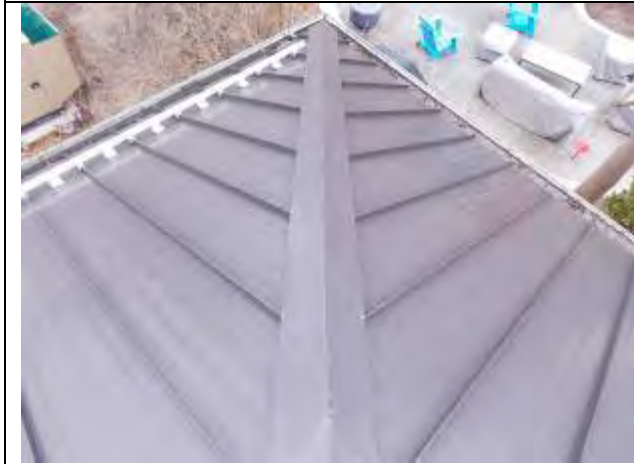
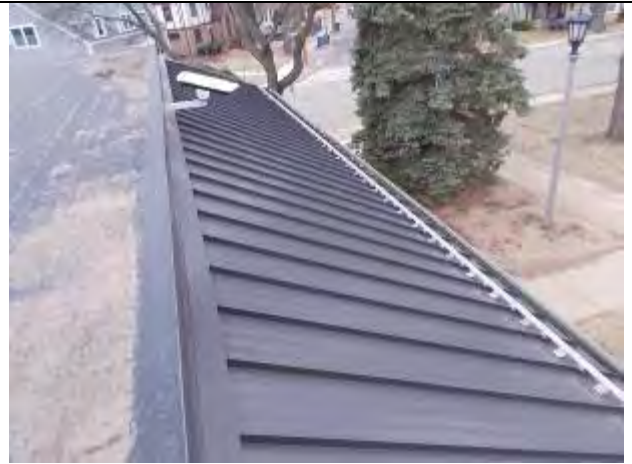
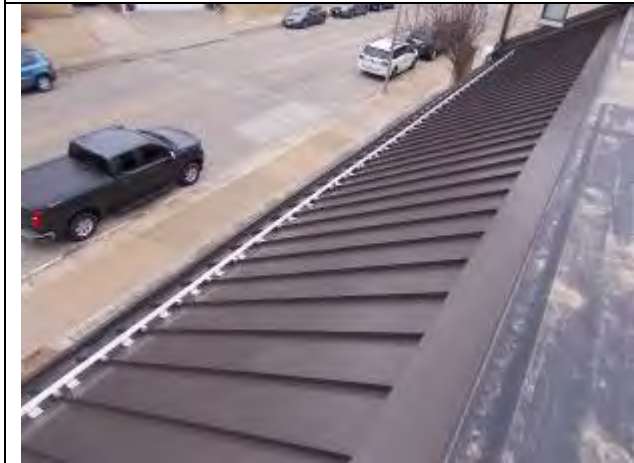
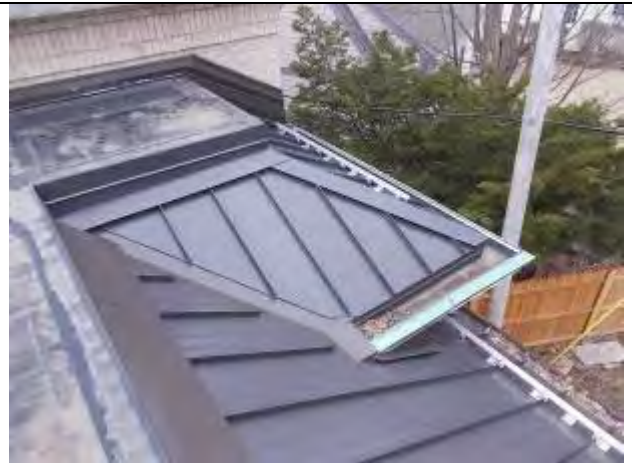
Roof Membrane

The standing seam metal roof panels remain in serviceable condition, with no obvious deficiencies noted.

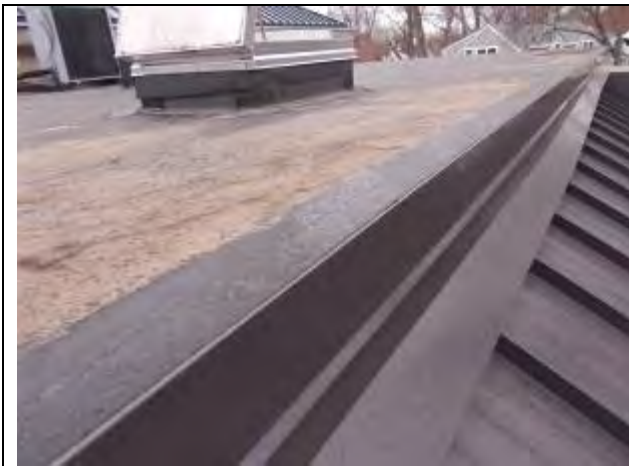
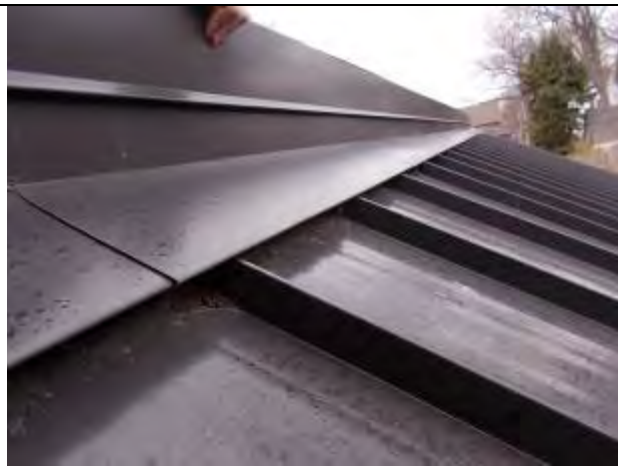
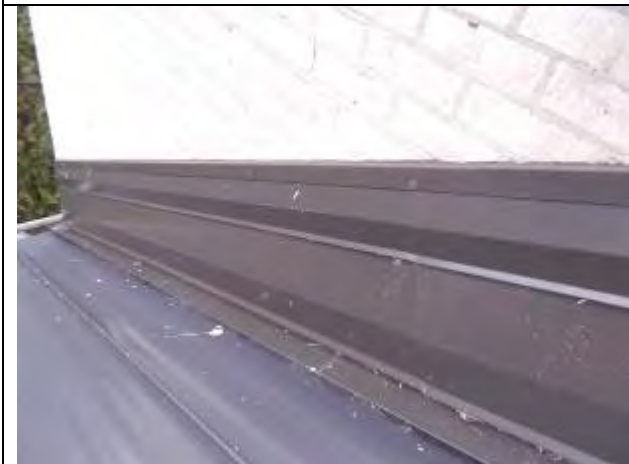
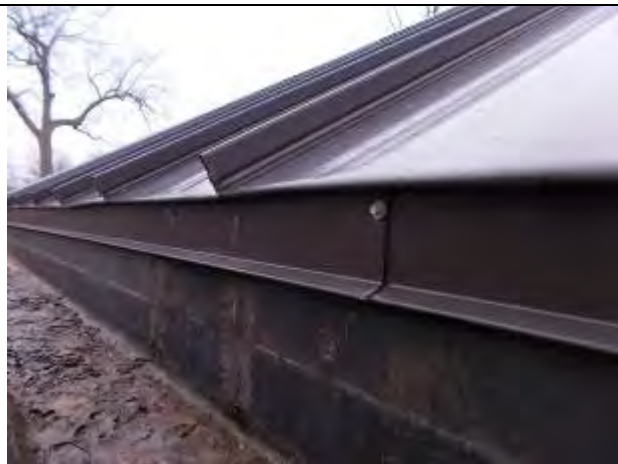
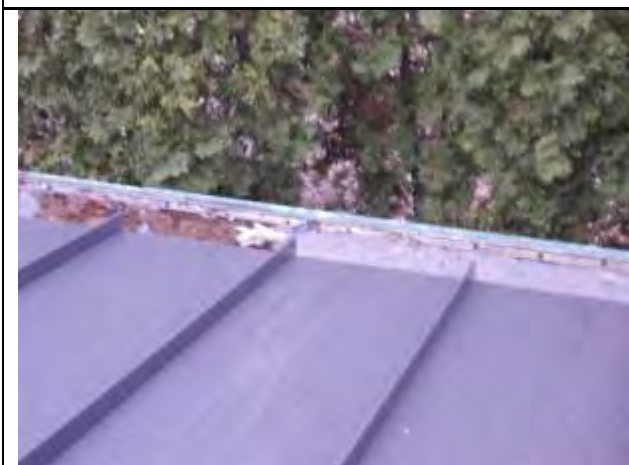
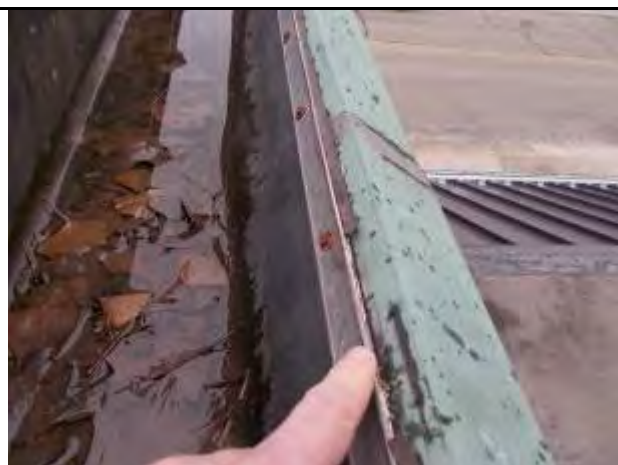
Roof Perimeters

The roof system terminates at its perimeters via counter flashing, metal edge flashing, and built-in gutters. No obvious deficiencies were noted along the perimeters, except for the debris and failed sealant within the gutters, mentioned above.

The metal panel roof systems installed on Roof Areas 5-7 are in good condition, but do require repairs to address large amounts of debris and failed sealant along their built-in gutters. Provided the roof systems receive timely preventative maintenance, followed by continued proactive annual maintenance, we believe they should be capable of performing properly for an additional 20+ years.

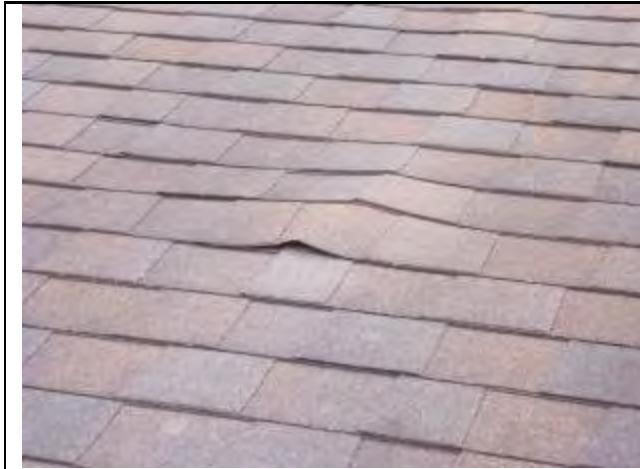
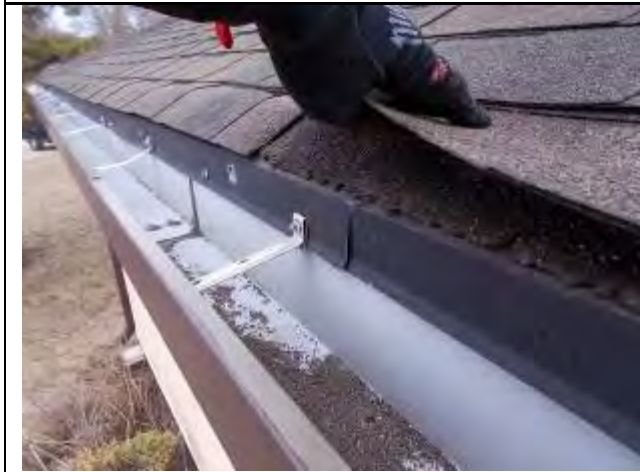
Roof Membrane (continued)

The shingles are nearing the end of their useful service life. We noted widespread haze cracking, granule loss, ridges, raised fasteners, and embrittlement of the shingles. The shingle was installed over the original shingles, so future roof replacement will require double tear-off.

The shingle roof system was installed over original 3-tab shingles. The shingles are very brittle and showing signs of nearing the end of their useful service life, based on the noted deficiencies. We believe the roof system will likely require replacement in the next 1-2 years.

Ownership should begin to plan and budget for replacement of the roof system in the next 1-2 years. In the meantime, complete emergency repairs on an as needed basis to address any leaks that arise.

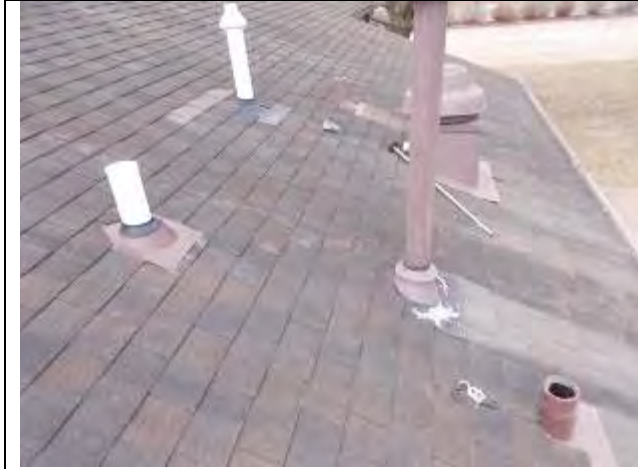
Roof Projections

The roof system is penetrated by hot stacks, soil stacks, and square curbs which are improperly flashed into the roof system and have received previous repairs. We also noted failed sealant at large masonry chimney.

Ownership should engage IRS to develop an Annual Maintenance & Repair Specification (AMRS) to address some of the preventative maintenance items (failed sealant, loose flashings, debris)

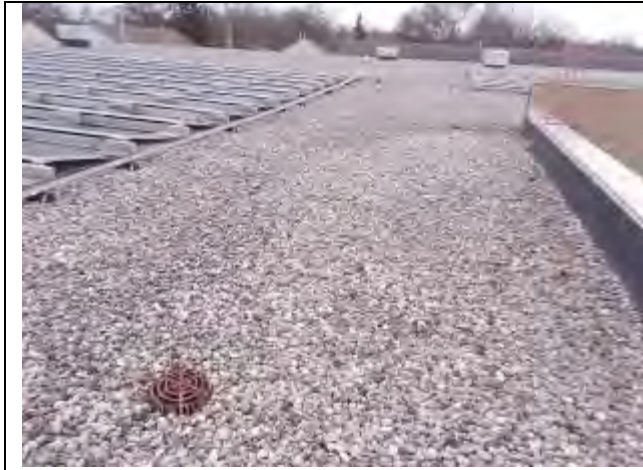
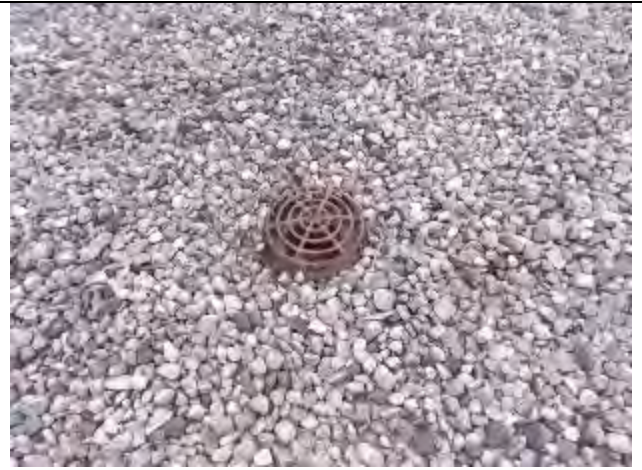
Roof Drainage

The roof system appears to be adequately drained via internal roof drains paired with overflow scuppers.

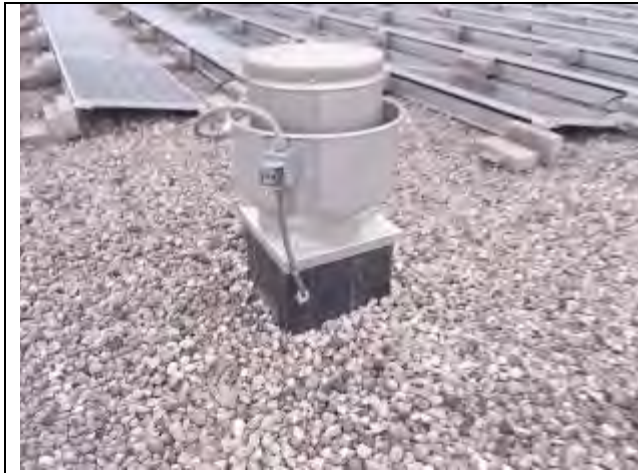
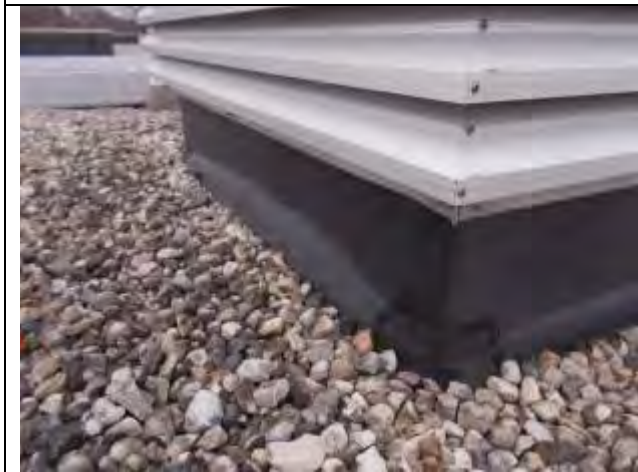
Roof Projections

The roof system is penetrated by hot stacks, pitch pockets, roof curbs, small pipes, soil stacks, and HVAC units. The flashings associated with each of these projections remain in serviceable condition, though we did note minor tenting at the curbs.

Ownership should engage IRS to develop an Annual Maintenance & Repair Specification (AMRS) to address the minor preventative maintenance items (holes, open flashing seams, failed sealant).

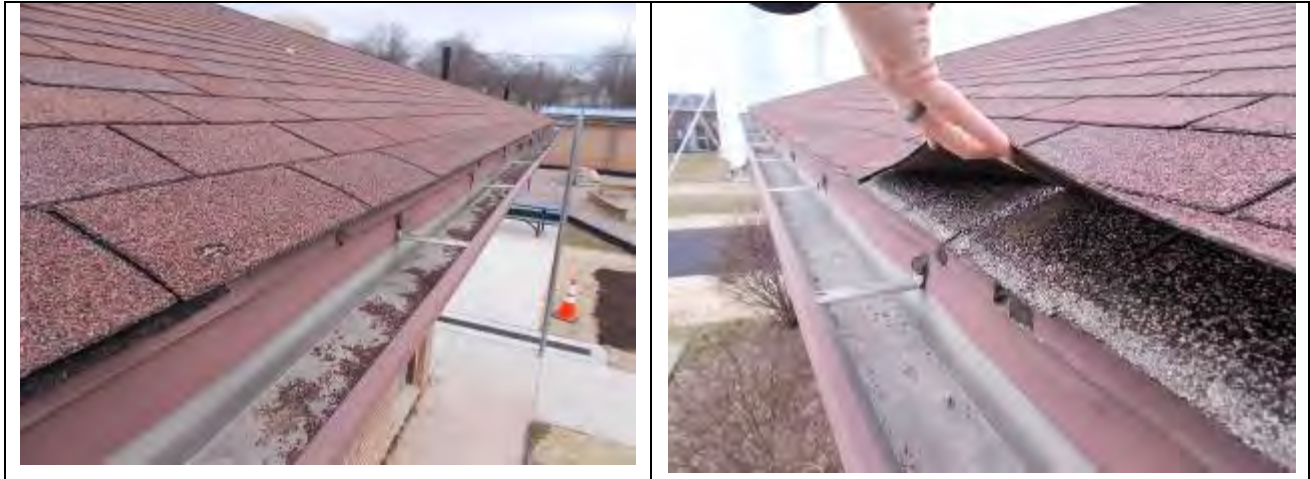
Roof Perimeters

The roof system is terminated at its perimeter via sheet metal drip edge and gutter.

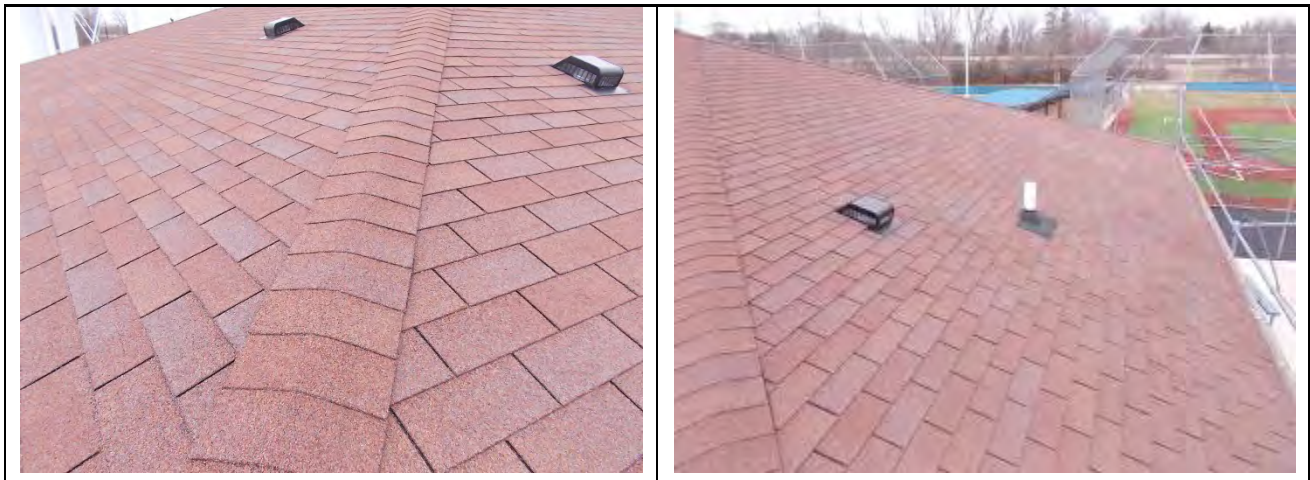
Roof Projections

The roof system is penetrated by attic vents and a soil stack.

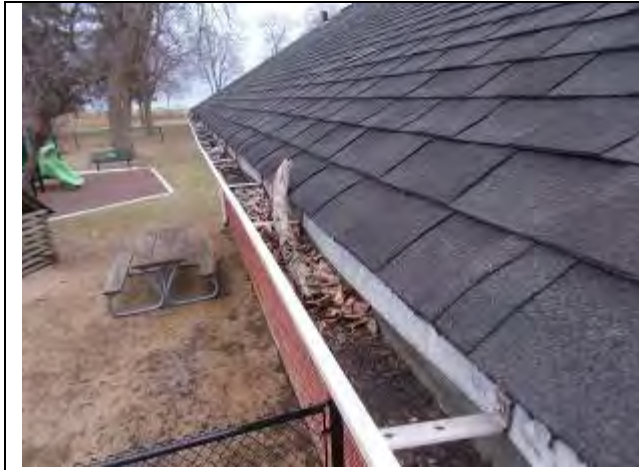
Roof Drainage

The roof system appears to be adequately drained via sheet metal gutters; however, we noted debris in the gutters.

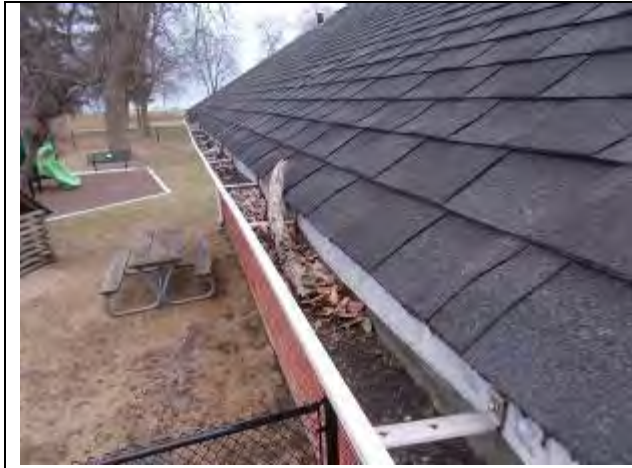
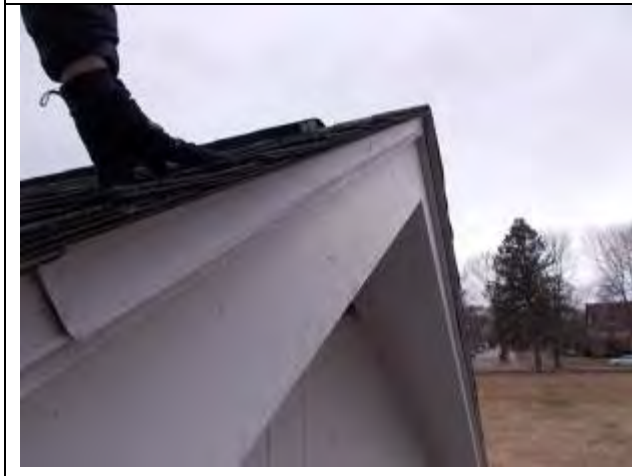
Roof Perimeters

The roof system is terminated at its perimeters via sheet metal drip edge and gutters, which are filled with debris.
